Improved cylinder head gasket for type H engine

Saab 99 Service Information

Nr/No. 234-52 sE

Fuel hoses of more diffusion-resistant material

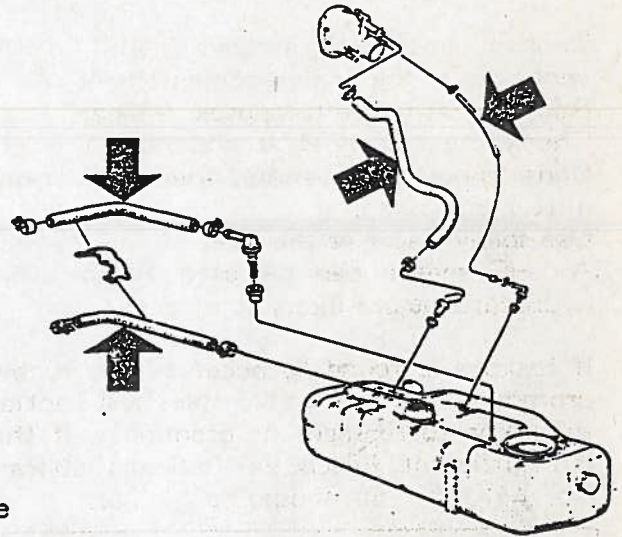
Two reasons may be responsible for fuel smell occurring in the interior:

1. Leakage at connections and rubber grommets will cause a distinct smell of fuel.
2. Diffusion through the hoses will produce a smell that is difficult to define.

The picture shows the arrangement on the Saab 900

If the customer should complain of the interior smelling of fuel, start by carrying out a tightness test.

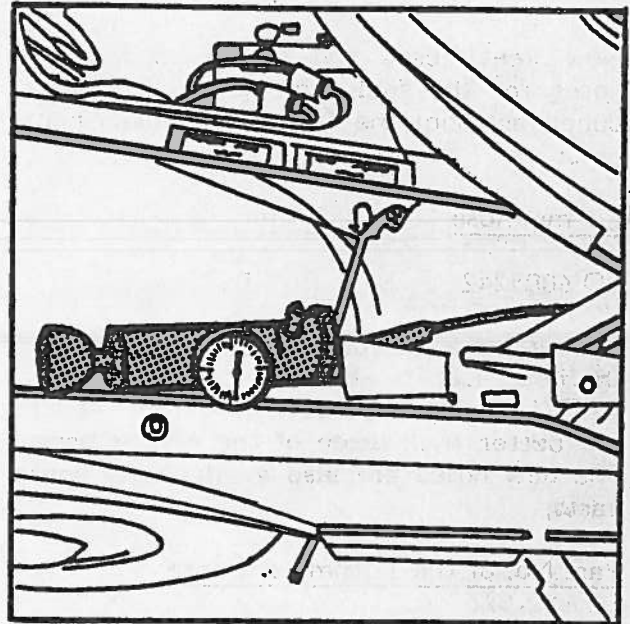
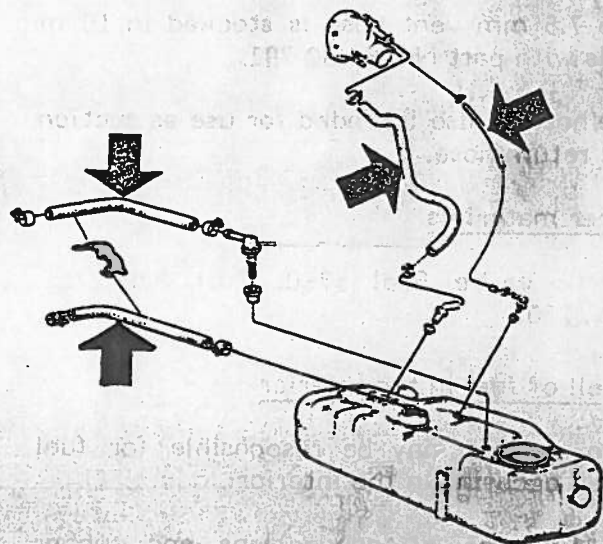
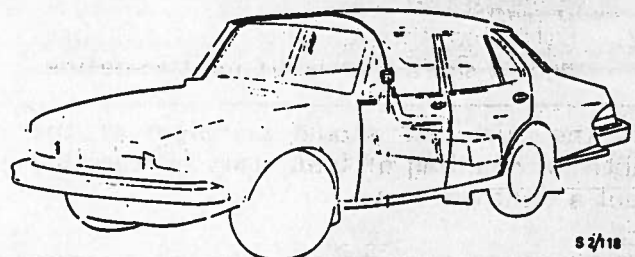
Vent hose in the roof of the car

The location of the vent hose in the engine compartment has no effect on the problem of smell.

The location has been carefully tested to prevent frosting, dust problems, etc. As a result, its location must not be altered.

Change the vent hoses and the suction and return hoses to the new type. For particulars of the part number, see the preceding page.

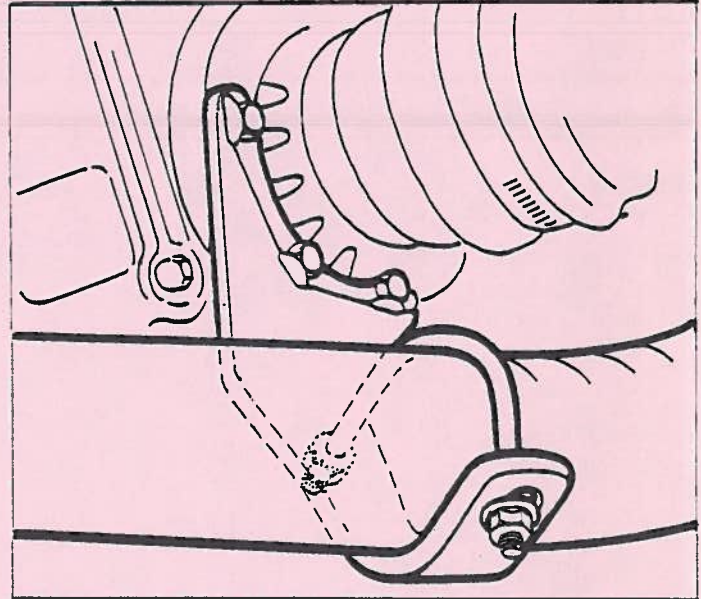
A new exhaust pipe mounting that supersedes the earlier version has been produced as a spare part. The new mounting should be fitted to cars on which oil leakage occurs at the rear final drive cover.

1. Remove the exhaust pipe mounting.
2. Remove the final drive cover and replace the gasket. Check the fit of the studs. If the studs have worked loose, they should be replaced by bolts Art.No. 80 82 935.
3. Fit the new mounting on the right-hand side at the differential bearing seat. Use the new longer bolts, Art.No. 80 82 992, and locking washer Art.No. 75 14 631. Check that the exhaust pipe runs correctly and is not strained. Fit the clamp.

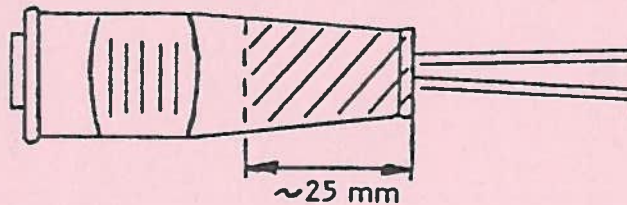
When a fan motor of the previous type is replaced by the new unit 7540263, it is necessary to modify the electrical connector to prevent chafing of the leads.

Shorten the rubber sleeve around the connector by 25 mm with a knife or scissors. Take care not to damage the cable insulation.

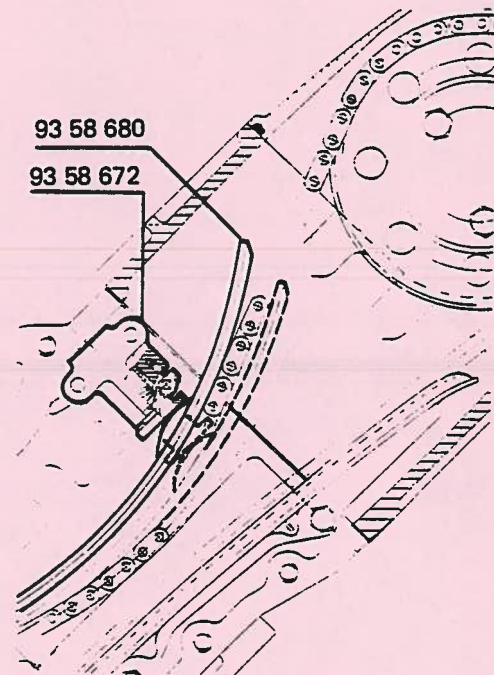
The most significant difference is that the present chain tensioner consisting of a single component is replaced by one comprising two components, i.e. tensioner 93 58 672 and the associated chain guide 93 58 680 pivoted on the same cylindrical pin as the present chain tensioner.

When repairing cam transmissions especially on carb. engines, this new tensioner should always be used instead of the old type (93 58 136).

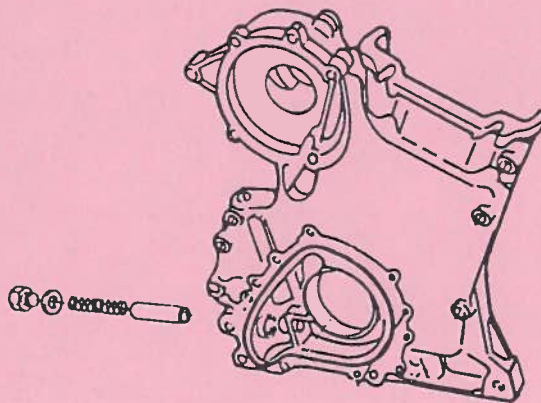
The later valve and its corresponding bore in the timing cover is 0.2mm larger than the earlier type and it is essential, therefore, that an early valve is not used in a late timing cover or low oil pressure will result.

To reduce the possibility of confusion, the early timing cover has been superseded to the late cover (7508351) and matching relief valve (7508328).

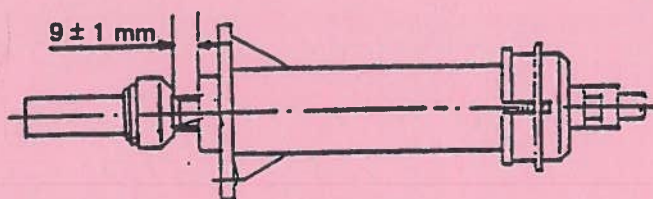
On M82 and early M83 cars, it is possible that the thermostatic pre-heater element, situated at the carb. intake can work loose.

Adjust the element so there is a gap of 9mm between it and the plastic sleeve - see diagram. Lock the element in place with a few drops of Loctite 1S496 and reassemble.
