Speeding Bullet

by John Anello, "Auto Tech on Wheels"

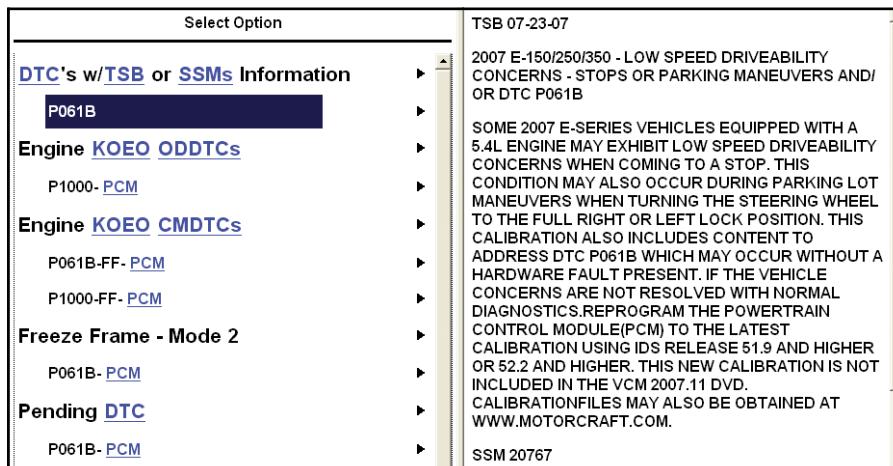
Figure 4: Code P061B -The software update addresses this code, but does not resolve it.

The final step was to shut off the key and then turn it back on to reboot the new PCM software. I then started the vehicle, but it did not run very well and the MIL/Check Engine light came back on. When I went back into the codes menu, the same code P061B had reappeared in memory (Figure 4). The software update I installed addressed this code (as you can read in the service bulletin link 07-23-07 for this situation) when I highlighted it at the upper left side of the IDS screen (Figure 5), but the software update did not resolve this vehicle's issue.

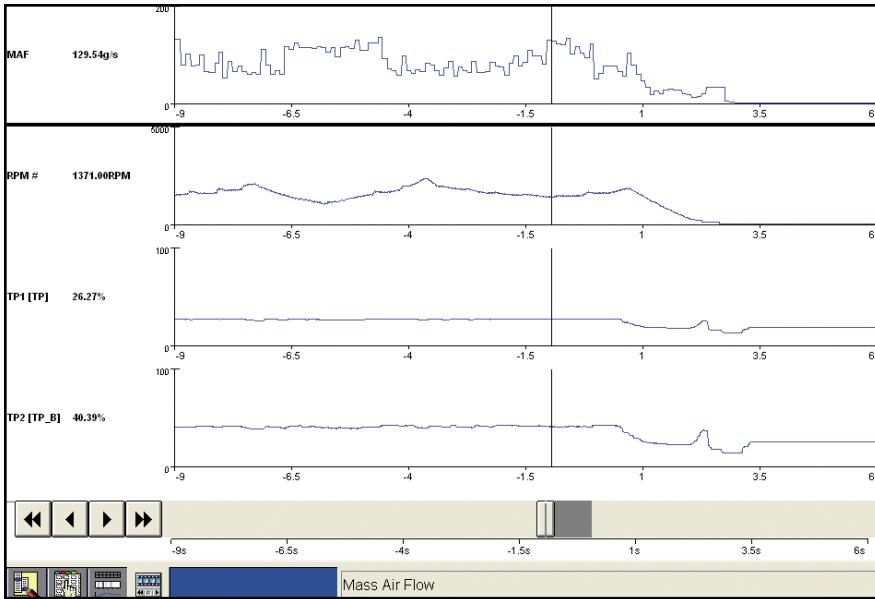
Figure 6: MAF, rpm, and TPS parameters in a graph mode to view what the the PCM was seeing.

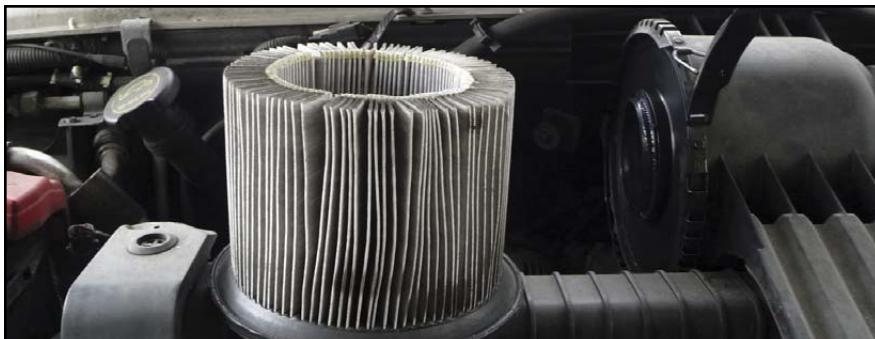
Figure 8: pulling off the air cleaner cover, we found part of the air filter missing.

When I pulled the air cleaner cover off, I was surprised to see part of the air filter missing (Figure 8) -- the bullet-shaped cone. Then I inspected the MAF sensor and was shocked to see the missing air filter bullet jammed into the MAF inlet (Figure 9). I removed it from the MAF housing (Figure 10) to clear the passage, put the air cleaner housing back in place to prevent any cross-flow air from passing over the sensor, and started the engine. Now, it ran like the powerful Triton it claimed to be. I re-checked my data graph, and could now see that the MAF sensor read a normal 25 GPS at a given value of 2,489 rpm at about a 20% throttle opening

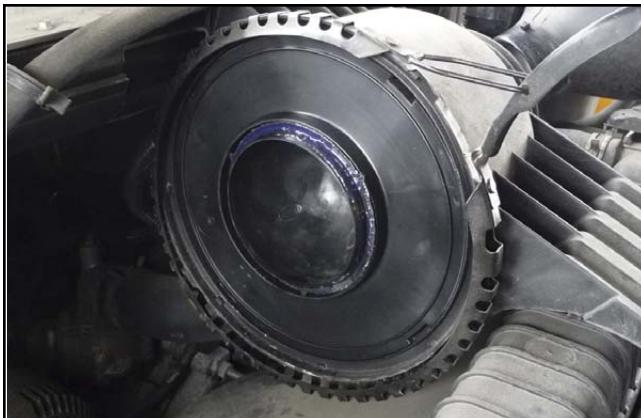
Figure 9: Inspecting the MAF sensor, the missing air filter bullet jammed into the MAF inlet!

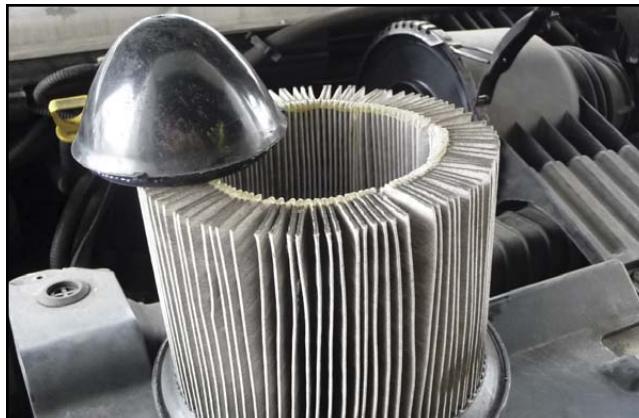
Figure 12: This air filter speeding bullet had an adhesive failure.

(Figure 11). This poor engine had had a serious air volume flow problem. This air filter speeding bullet had an adhesive failure (Figure 12), flipped over, got sucked through the filter element, and jammed itself into the MAF housing. This created a venturi effect and allowed a rush of air to flow past the MAF's sensing device, which falsified the sensor signal. This is a rare thing to happen, but it teaches us two lessons: Beware of cheap, off-brand parts, and always check the basics before you move on to reprogramming, or any other high-tech procedure!

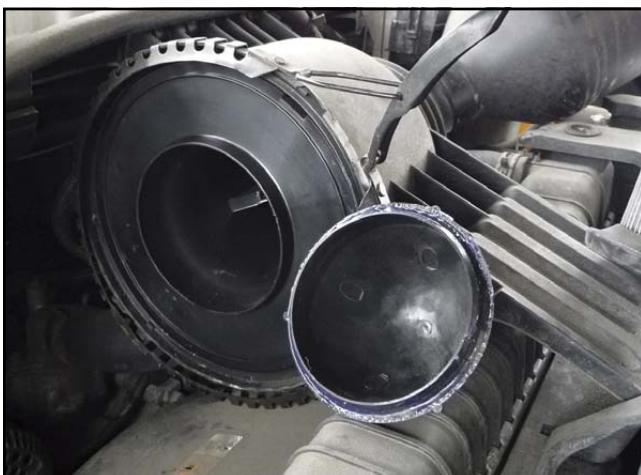
Figure 10: Removing the MAF housing to clear the passage.

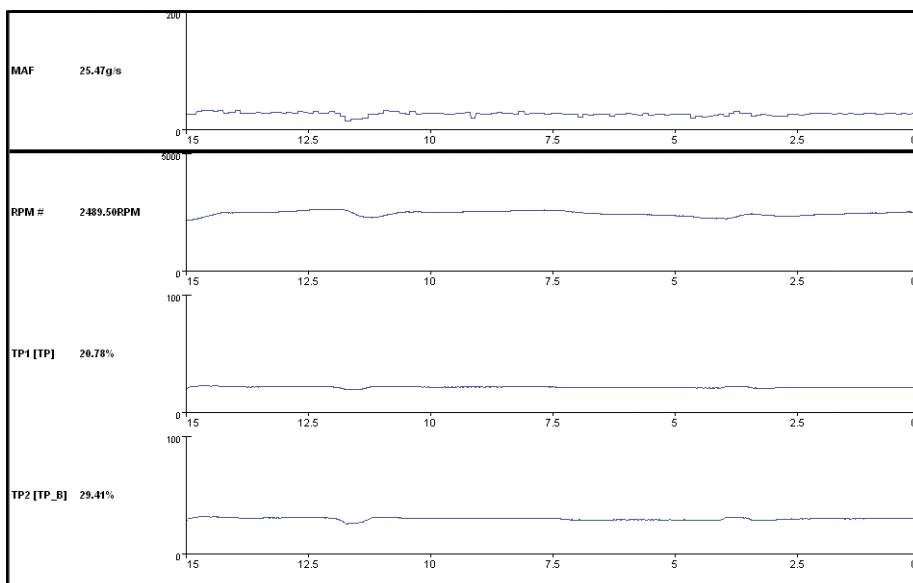
Figure 11: Rechecking the data graph, and now the MAF sensor reads a normal 25 GPS...
