Aging Aircraft Concerns on Comanche Airplanes

ICS National Convention

15 August 2007

Hans Neubert

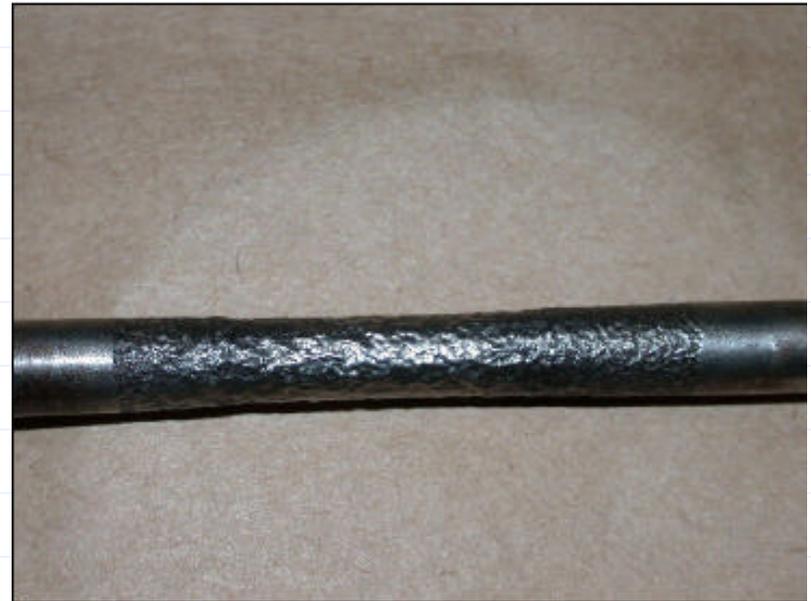
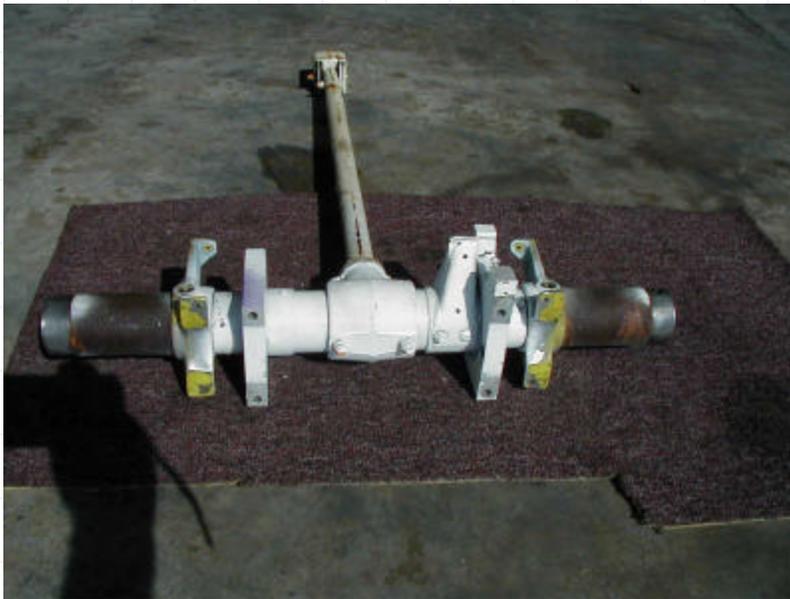
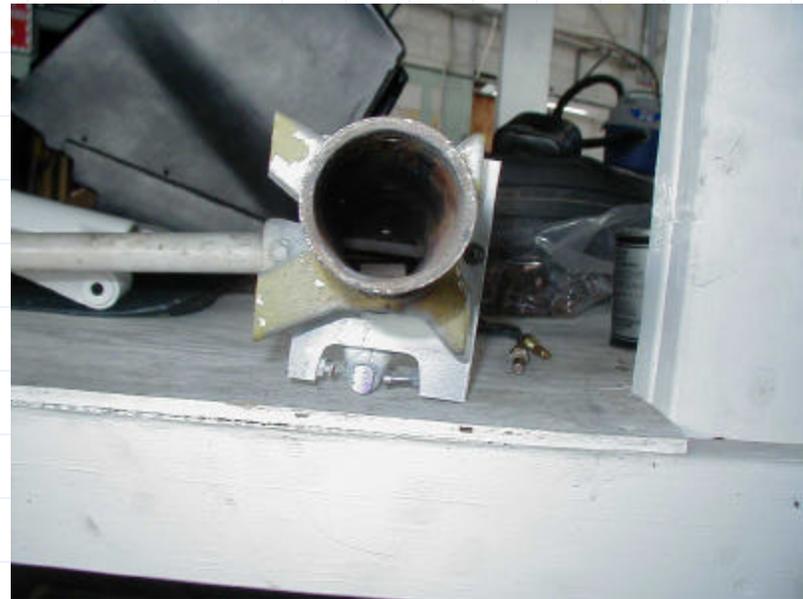
Samples of Torque Tube Corrosion

- ◆ Corrosion has been observed between the torque tube and the attaching bolts
 - Piper Service Letters 667A and 772
 - Advisory Directive 74-13-10 issued by FAA
- ◆ Inspection requires replacement of existing attaching stabilator bolts with corrosion resistant bolts
 - Replacement of bolts with CRES bolts is terminating action of the AD

FACILITY	REPRESENTATIVE	FINDINGS OF CORROSION
Webco Aircraft	Bob Weber	"I have reviewed SAIB #CE-04-08 and have never encountered anything remotely similar to what these pictures show"
Aircraft Engineering, Inc.	Bill Turley	"In some instances, some corrosion found, but never to the extent displayed in the SAIB"
Iliff Aircraft Repair & Service	Charles Iliff	"We have never found any serious amount of corrosion"
Johnston Aircraft Service	Dave Johnston	"We have never seen, experienced or heard of the amount of corrosion shown in the pictures accompanying the SAIB"
Clifton Aero	Tim Talley	"We have not found on our inspections, the severe rust pits [shown in the SAIB] on the O.D. of the stabilator torque tube"
Penn-Air Inc.	Dan Claycomb	"We find corrosion, but none that could be considered unairworthy"
Liebfried Aviation Inc.	Andy Liebfried	"The difficulty in a re-occurring inspection is that disassembly will provide more damage at the hands of inexperienced technicians than a quality process and treatment for the tube on a one time or long term inspection basis"

Swift Aviation Services	August Mazzella	"We have never discovered as extensive corrosion as depicted and feel that, as repetitive an inspection would be unnecessary and may cause more damage to the area, outweighing the benefit"
Squire Aircraft, Inc.	Bob Squire	"While doing an annual inspection I always check all components of the empennage and I have not found any evidence of corrosion on the torque tube as pictured in SAIB CE-04-08"

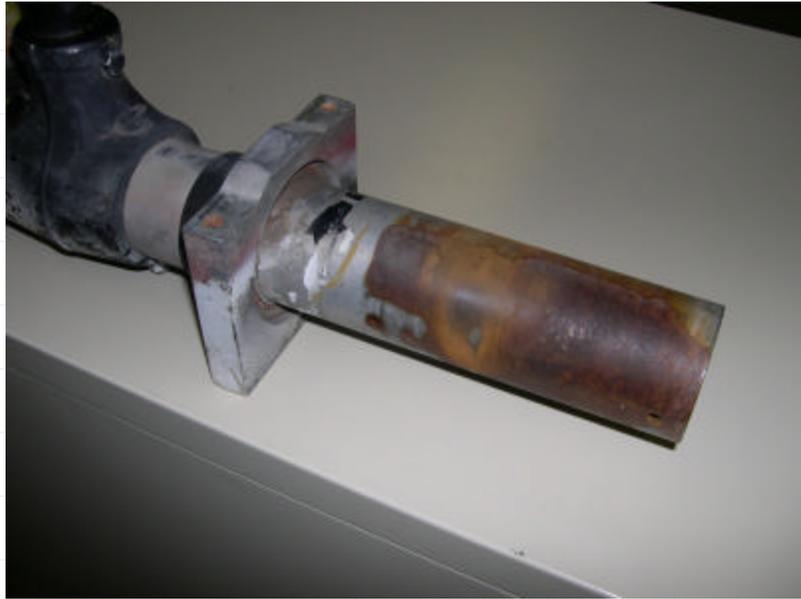
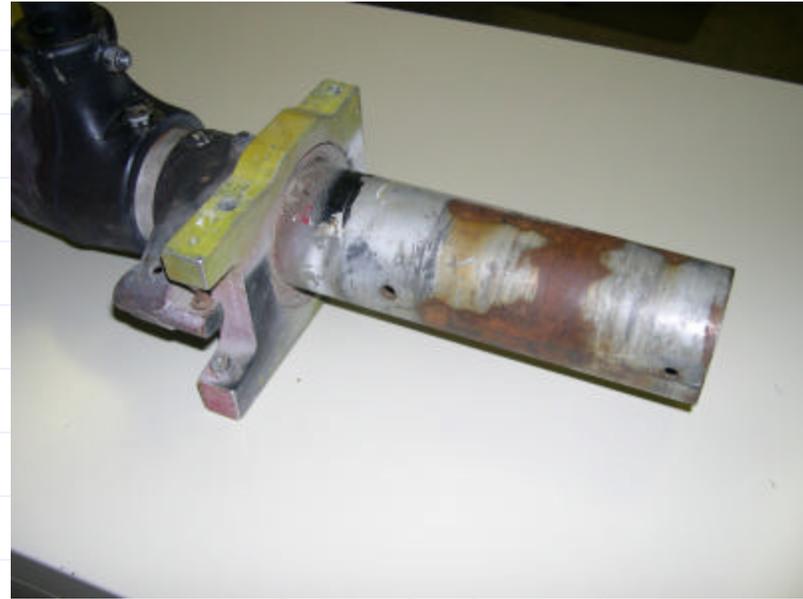
Initial Condition

- ◆ PA 24-250 unserviceable unit received from Altus
- ◆ Torque Tube cleaned up using 180 grit media
- ◆ Precise measurements made after clean up
- ◆ Coated with zinc chromate and paint
- ◆ Adapter fittings, load reaction fittings and base plate fabricated

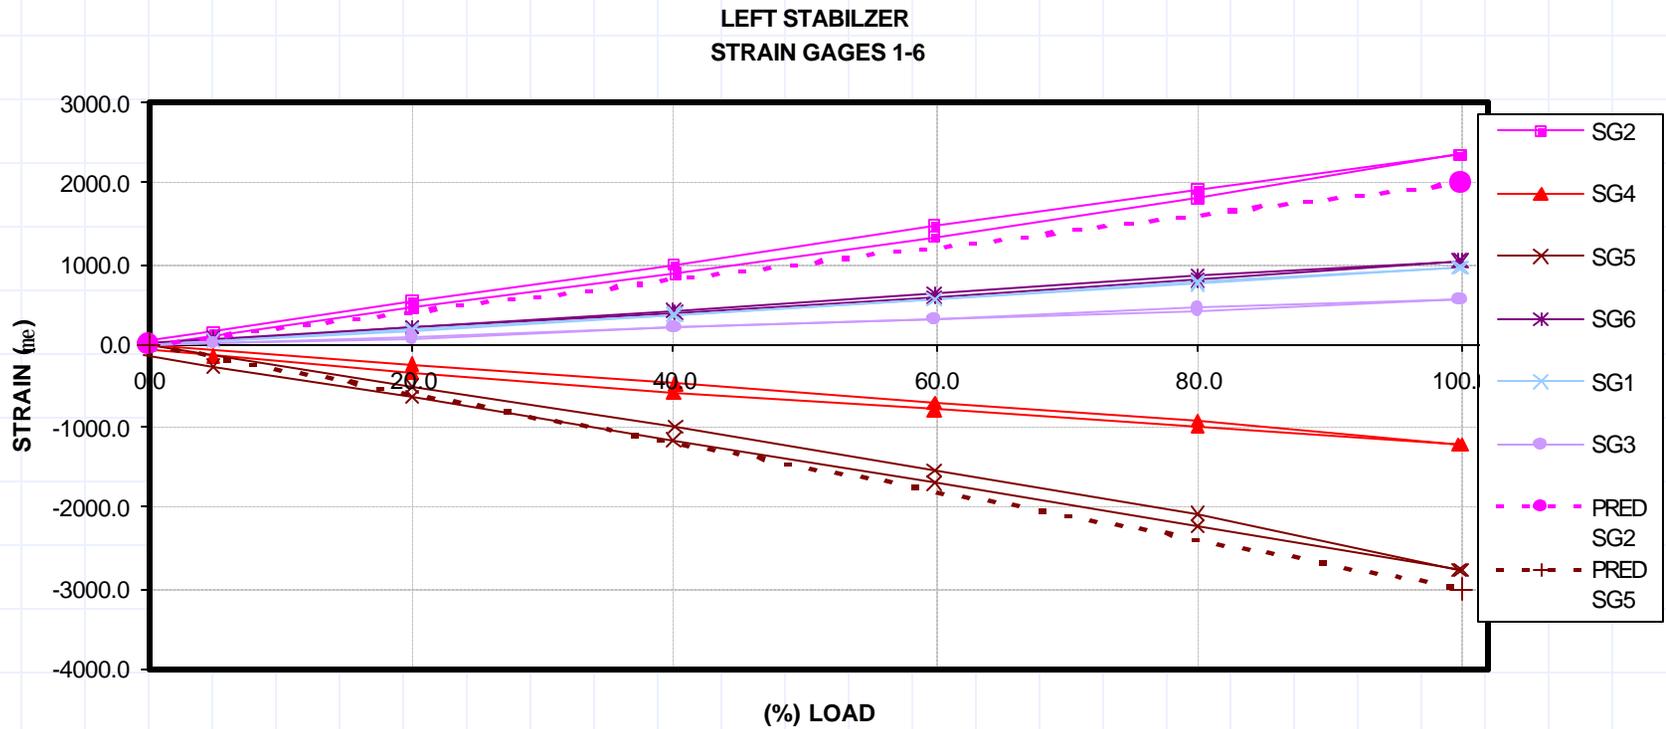
Load Case 3 Strains

- ◆ An unserviceable torque assembly was re-furbished and life cycle tested to DLL, and subsequently to DUL.
- ◆ Strain and displacement measurements show that during the life cycle testing, the torque tube exhibited linear, elastic characteristics.
- ◆ Corrosion on a torque tube, if found, is a Maintenance issue. These tests show conclusively that a corroded torque tube is not an Airworthiness issue.

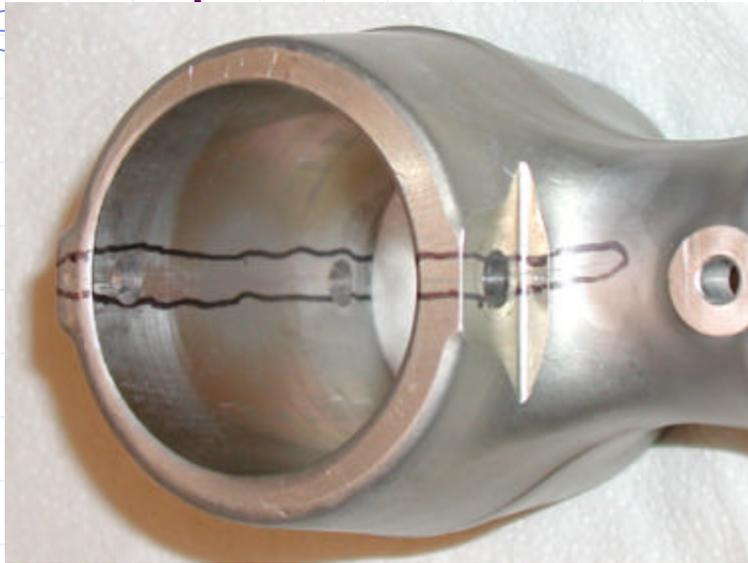
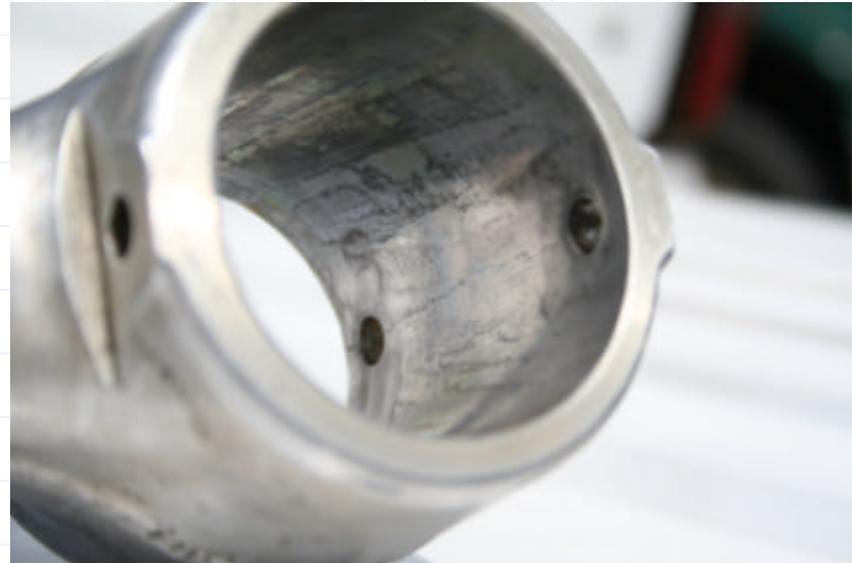
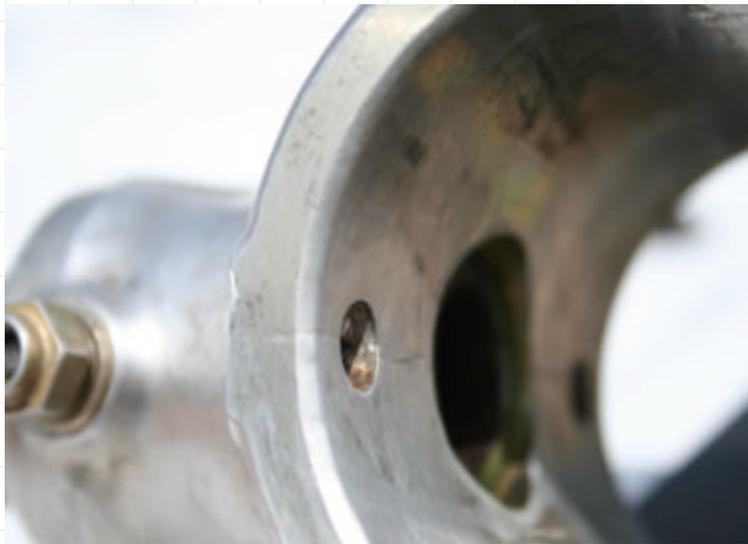
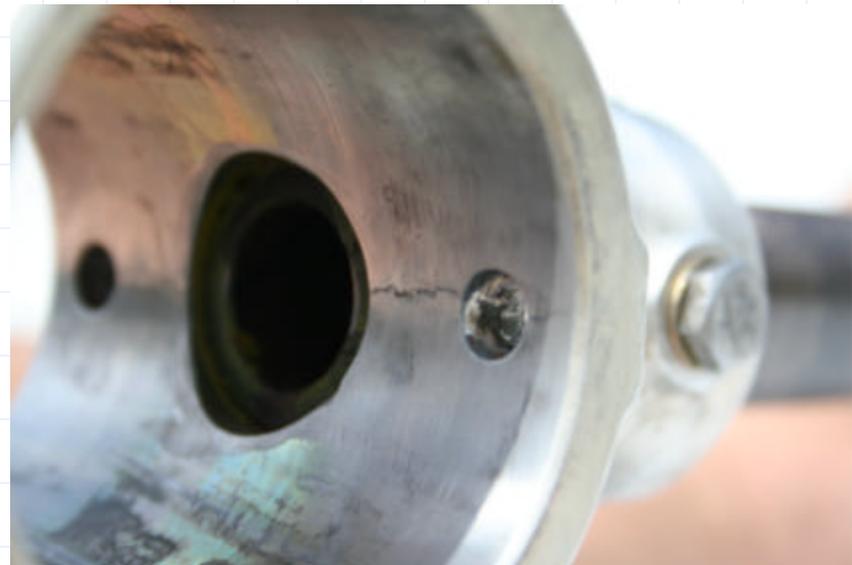
Samples of Cracked Horns

- ◆ First reported by Denny Haskins in Mar 07 Flyer
- ◆ Internal cracking initiating at intersection edge of Primary and Secondary bores
- ◆ Average TIS when cracking is observed – 3500 hours
- ◆ Expected TIS when failure is expected – 5000 hours
- ◆ Observed to occur on Singles only (180/250/260)
- ◆ NOT ALL SINGLES HAVE SHOWN SIGNS OF HORN CRACKING

- ◆ Believed to be due to Maintenance Neglect caused by:
 - ◆ A. Excessive Trim Tab Movement:
 - Trim Drum vertical play
 - Rod End ball/socket play
 - Trim Tab bushings/bolt play
 - ◆ B. Control Cable tension incorrectly adjusted
- ◆ Maximum Tab Movement = .076 inches (.050" recommended)
- ◆ Control Cable Pre-Tension = 22 pounds (24 # recommended)

- ◆ Sharp edge between primary & secondary bores gives a 5.6 stress concentration factor
- ◆ Play in trim tab causes stabilator to respond to high frequency impulses from propeller
- ◆ Looseness of control cables allows counterbalance tube and weight to oscillate
- ◆ High frequency oscillations create bending stress in horn, amplified 5.6 x at the bore intersections
- ◆ Cracking migrates to aft side of horn after forward portion cracks and loses circumferential stiffness

- ◆ **SINGLES WITH LESS THAN 3500 HOURS**
 - Disassemble torque tube assembly at next annual
 - Do not remove counterbalance tube
 - Inspect horn for cracks, if none found, then
 - Create .03" radius at bore intersections
 - Polish radius and bore with 600 grit paper
 - Repack bearings
 - Re-assemble and make log book entry of inspection
- ◆ Repeat at next SL 1160 Compliance inspection period

- ◆ **SINGLES WITH MORE THAN 3500 HOURS**
 - Disassemble torque tube assembly within 50 hours
 - Do not remove counterbalance tube unless horn is cracked
 - Inspect horn for cracks at bore intersections
 - If Cracks found, locate serviceable horn/Piper part/PMA part, then
 - Create .03" radius at bore intersections
 - Polish radius and bore with 600 grit paper
 - Repack bearings
 - Re-assemble and make log book entry of inspection & replacement
- ◆ Repeat at next SL 1160 Compliance inspection period

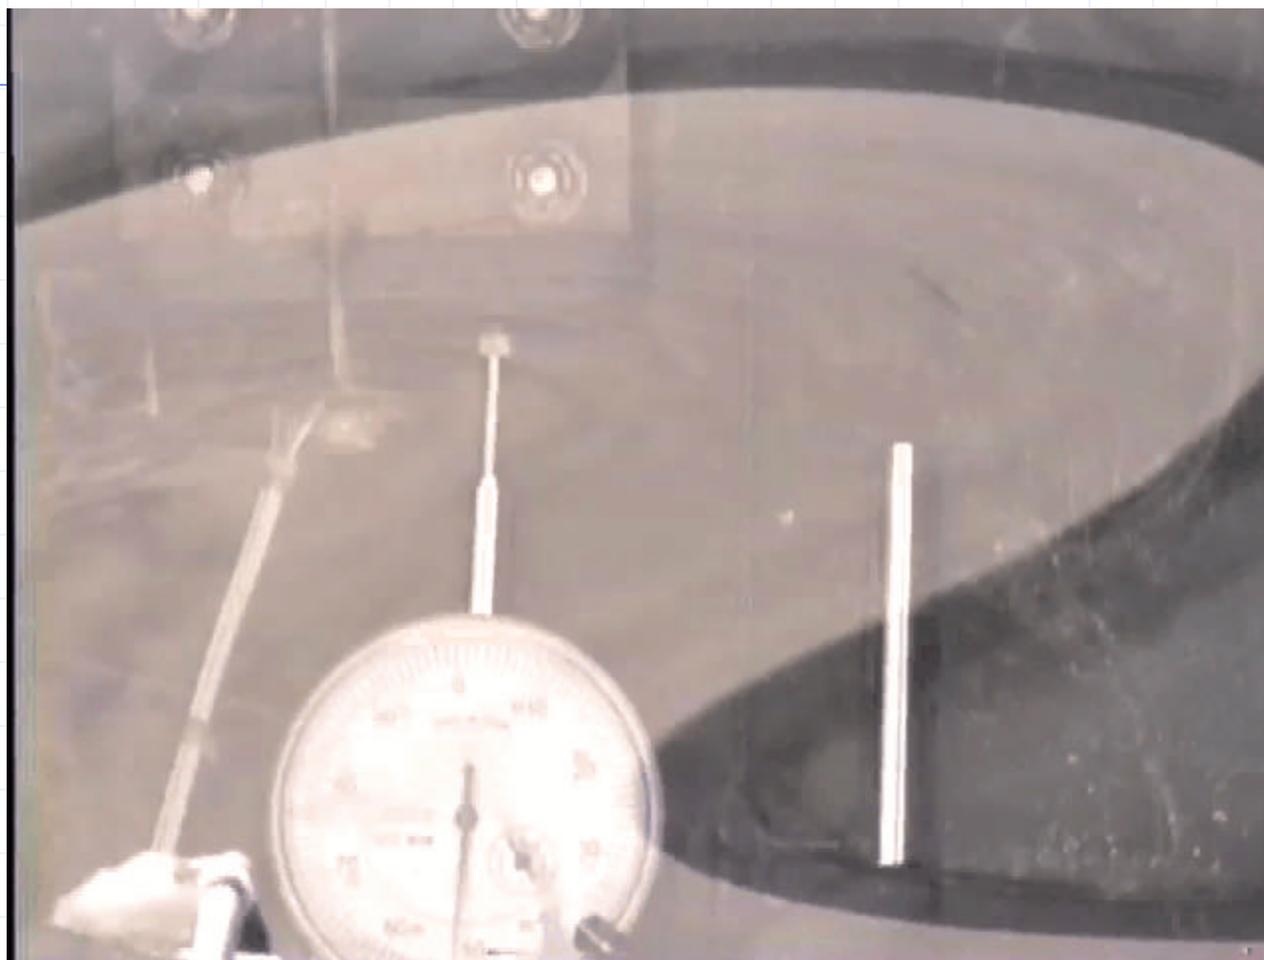
Preliminary Vibration Data

- ◆ Counterbalance weight oscillation using dial indicator
 - Plus/minus .010 inches – all rpm's
 - Data from 7/7/07
- ◆ Response from accelerometer/pitot tube setup
 - No data collected
 - Check-out electronics and retry
- ◆ When operational, perform flight data collection
 - Dial indicator data from mini-cam
