### Modifications for the Kenwood TS-930

## TS-930S PLL Unlock

Service Bulletin no. 869 (29-3-1983)

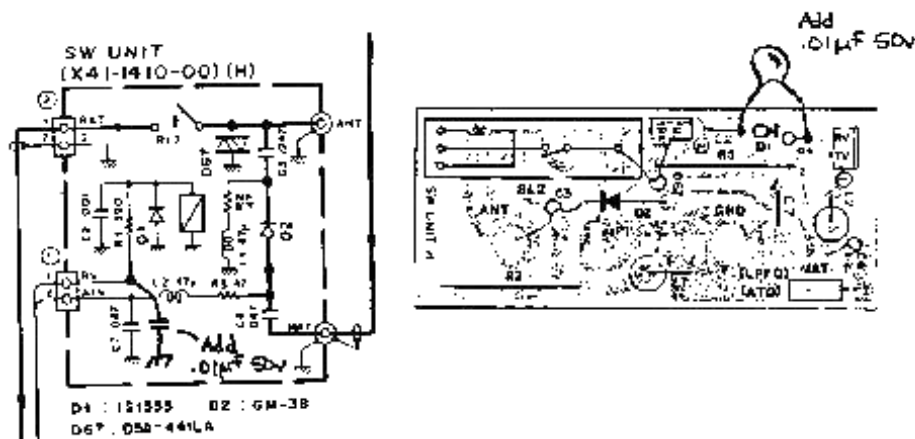
Some users have reported an internal beat tone that appears every 10 KHz, when operating in the range of 20-21.5 MHz. Apparently the RV terminal switch unit H is being affected by the 1st loop of the PLL unit. The cure is relatively simple. Add a .01 μF 50V disc ceramic capacitor on the RV line of switch unit H as shown below.

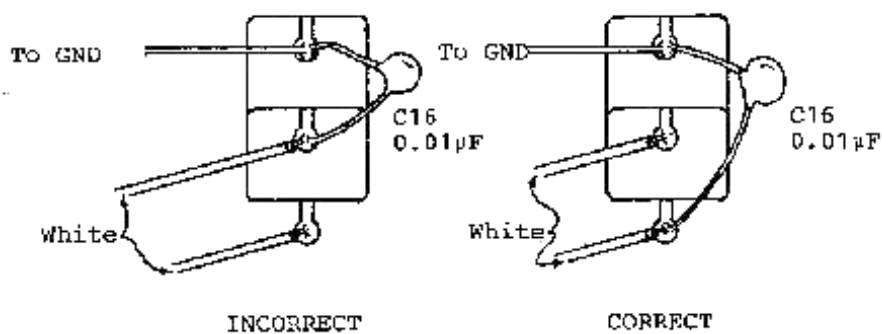
For reports of RF feedback from the external speaker, especially when using a vertical antenna, or a linear amplifier, check for correct installation of capacitor C16 on the EXT SPKR jack.

C16 should go from ground to the white wire on the opposite side of the jack. Some units have the capacitor soldered to the middle terminal in error!

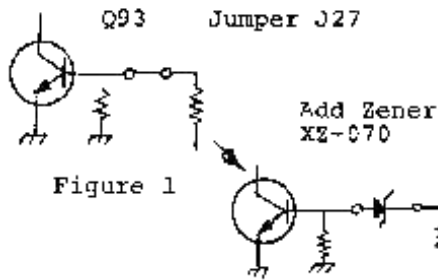
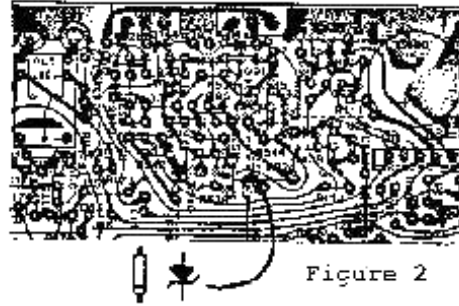
A loss of receiver sensitivity (6-30dB) may be caused by shorted switching diodes in the Signal unit (X57-1000-xx). The following procedure will increase the capability of the unit to withstand high RF voltage levels.

Replace Signal unit jumper J27 with an XZ-070 Zener diode.

(PCB coordinate C-1, see figure 2.)

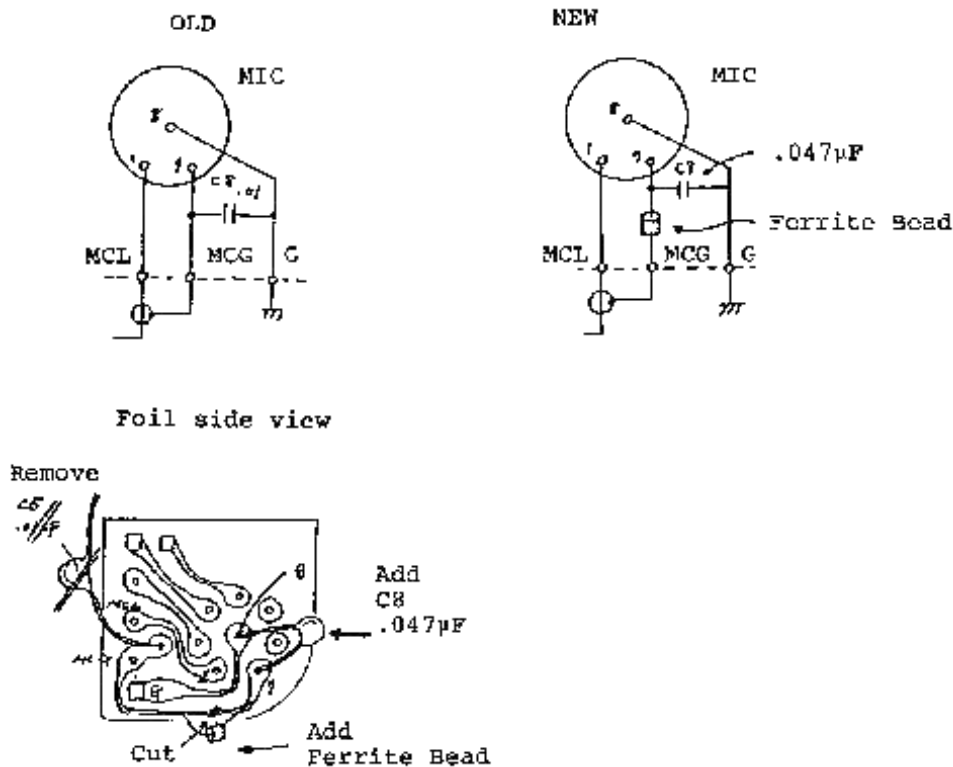
Some users may report RF feedback to the MIC at low frequencies, for example: 3.5 MHz.

Make the following changes to SW unit (J) (X41-1410-00):

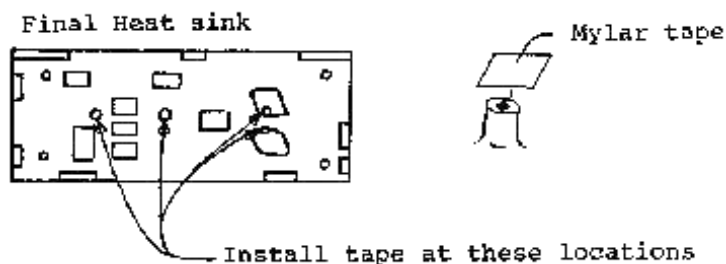
Some users have reported that the ALC meter indication occasionally jumps during long key down periods on the 28 MHz portion of the bands. The symptom may be caused by the ground foil of the Final unit (X56-1430-00) coming in contact with one or more of the projections on the final heat sink, due to expansion when the temperature rises.

Apply Mylar insulating tape to the projections on the heat sink, to prevent reoccurrence of this symptom. See figure below.

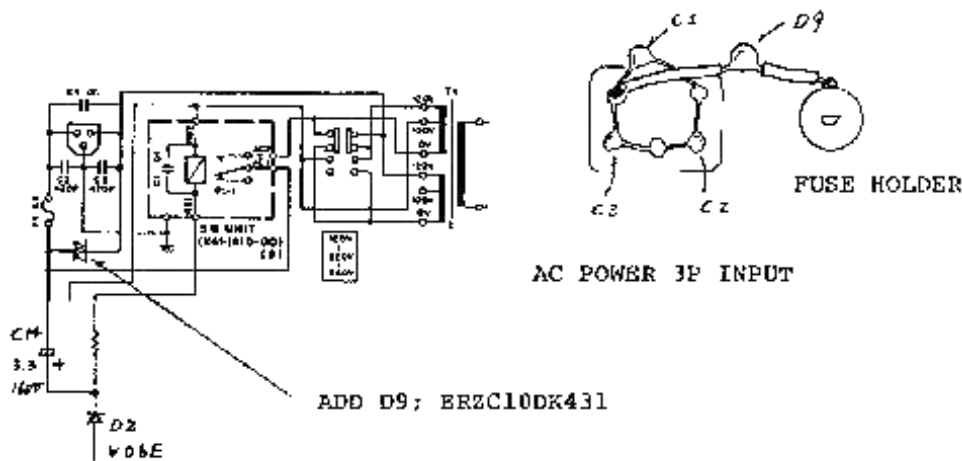
A line surge (exceeding approximately 4.5 kV) due to static electricity or nearby lighting discharge may short power relay diode, D2 (V06E), and cause electrolytic capacitor C14 (3.3  $\mu$ F) to break down. This results in relay chatter and the relay contacts may finally weld.

Addition of the surge absorber to the primary power supply input circuit, as shown below, should help avoid this type of failure.

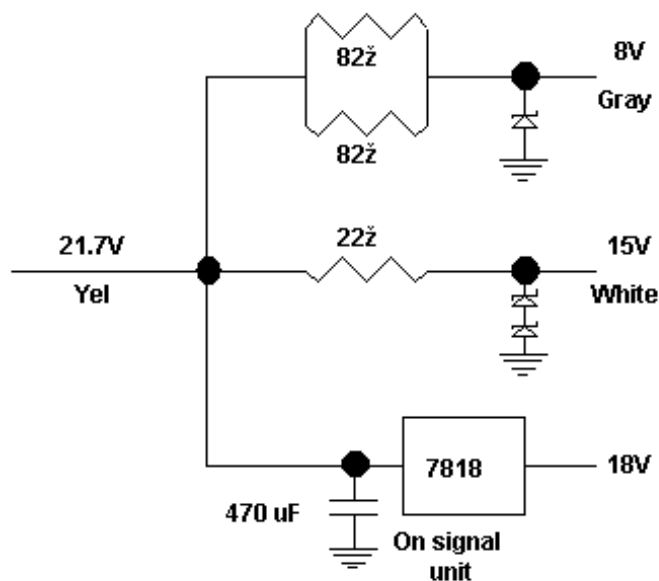
The power supply uses high-wattage resistors and zener diodes in the power supply fan case to reduce the 21.7V secondary supply voltage 7.5V and 15V for the digital board (which has 5V and 12V regulators) and for the signal unit, which has an 18V regulator. The 21.7V is distributed by the yellow wires via a black terminal block between the antenna tuner and the filter unit; this block also has the switched +28.5V orange wires. The original circuit looks like this:

The main schematic diagram of the radio is wrong, it shows the 33Ω resistor that is the third supply voltage for the digital board connected to the 21.7V instead of the 28.5V line.

The dissipation in the resistors and diodes is above their ratings, and this could be a reliability problem. This new circuit replaces the resistors and diodes with 78xx 1 A. TO220 regulators mounted on the power supply heat sink. In addition to

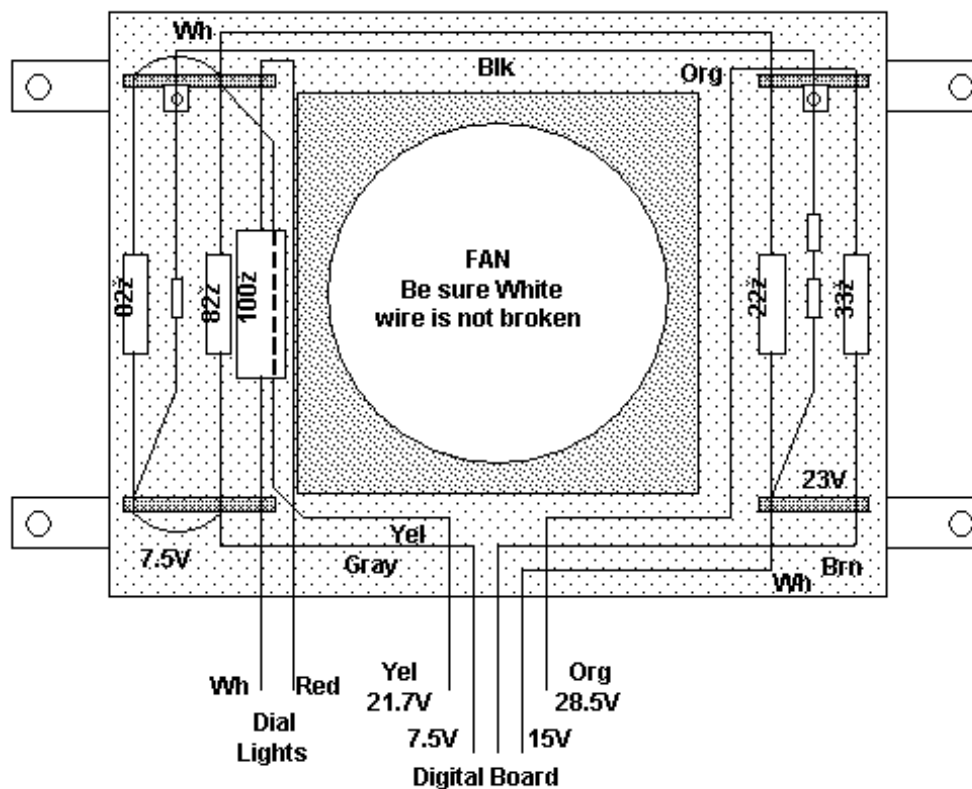
The resistors to be replaced are inside the power supply fan case. You will notice that the resistors will have lost their color coding from overheating, and the terminal strips may be somewhat charred, from overheating. Cut out the two 82 $\Omega$  resistors and their zener diode, and cut out the 22 $\Omega$  resistor and its two zener diodes. You can save these in case of trouble, but the new circuit should be more reliable.

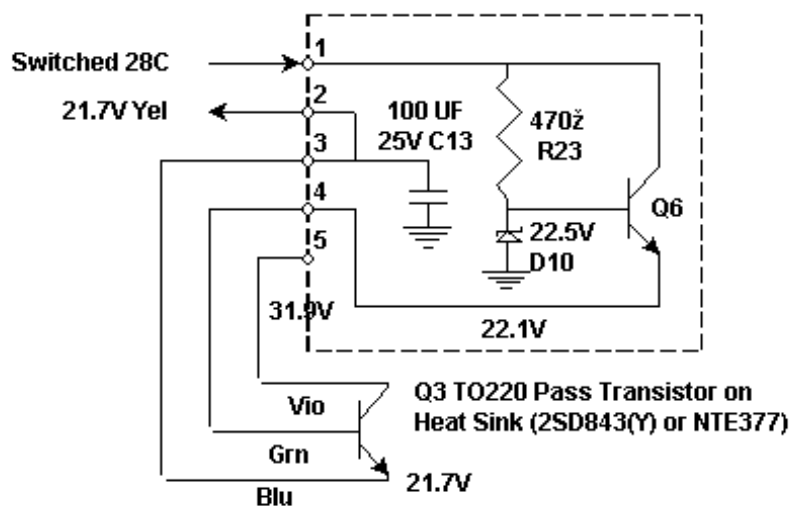
Despite the attention in the literature to the 28.5V TO3 regulators that supply the power amplifier, almost all of our power supply failures have been traced to the 21.7V regulator circuit. As the pass transistor is failing the radio will typically exhibit unusual operation, such as chirpy signal or intermittent display.

The 21.7V regulator is a pair of cascaded emitter followers driven by a 22.5V zener diode fed from the 28.5V supply switched through the power switch. The zener diode D10 and the first transistor Q6 are on the power supply board, and the second transistor Q3 is the TO220 transistor on the heat sink. The schematic incorrectly shows C13 to be 25 uF 100V (it is 100 uF 25V).
