# A-BOOM<sup>TM</sup>

BOOM ARM MOWER

# BULLETINS

Manual P/N 02980499  
(01/04)

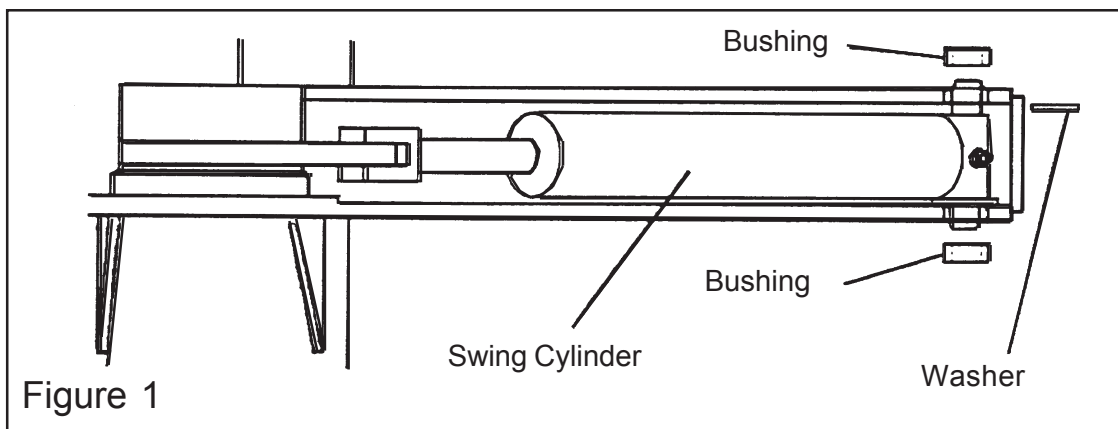
The problem is caused by a slightly oversize bore for the bushing, allowing the bushing to work out of its bore during operation. Reports have been few and far between.

1. Replace the Teflon bushing (P/N 02965214) with the steel spring bushing (P/N 02959890).
2. Install a steel washer (P/N 00749946) between the top of the cylinder and the upper plate to limit pin movement if the clearance exceeds 1/4".
3. These changes will prevent loss of bushing and resultant boom sway during operation. Due to the short distance of travel and the low load these bushings will require lubrication.
4. Run and test repairs for operation.

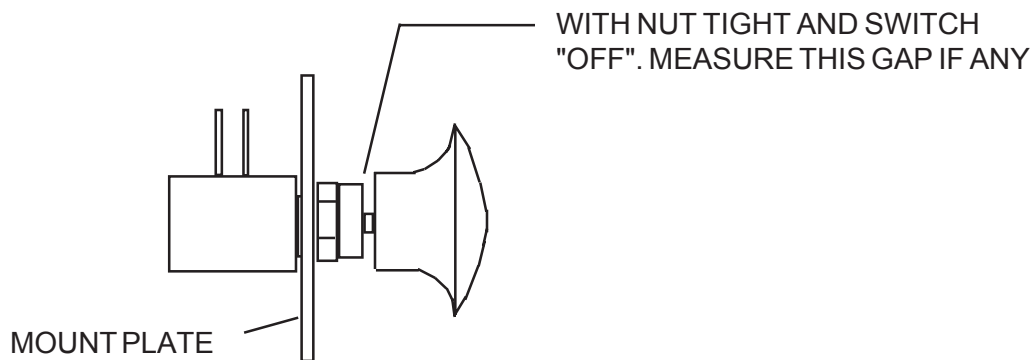
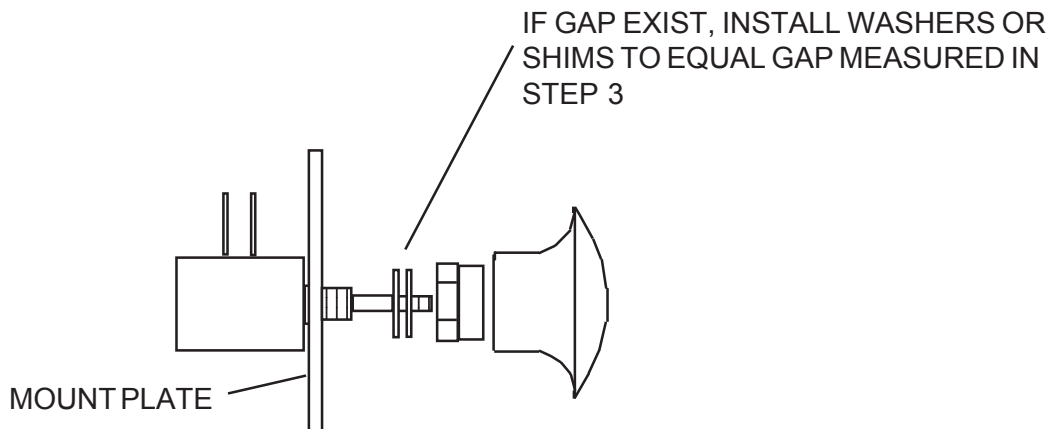
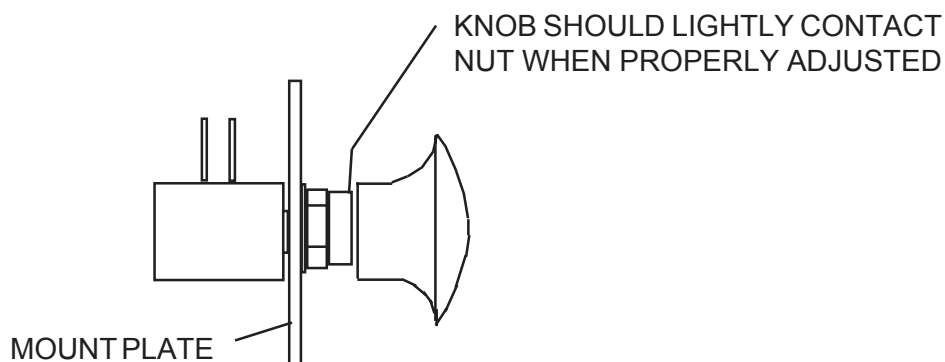
Test performed on numerous switches indicates that the (b) failures are due to excessive force being applied to the knob when shutting off the mower. Specifically, the knobs are usually roughly slapped to turn the mower off. After internal parts of the switch are damaged, the rod can then be pulled out easily. The (a) failures are due to the knobs not being securely tightened.

To prevent these failures from occurring, or to replace a damaged switch, use the following procedure to adjust the travel of the switch. (See attached diagram).

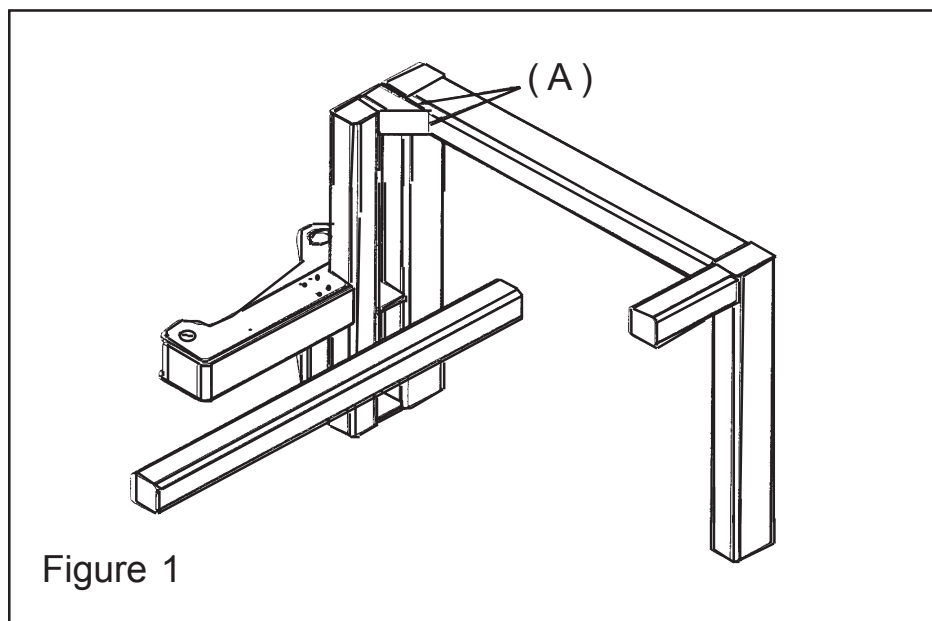
Figure 1

If cracks occur at points ( A ) Figure 1, use the following procedure to effect a satisfactory repair on the frame crossover tube.

2. Prepare the cracks for welding. Grind a groove at the site of the crack(s) and clean the area to be welded.
3. Weld the cracks making 100% welds on the cracks.

4. After repairing the cracked areas, prepare the areas for the installation of the gusset P/N 02966825. the welds may have to ground so gusset will sit flat and square in area ( A ) figure 1.

5. Position the P/N 02966825 formed gusset as shown in Figure 2. Weld all around with 1/4" fillet weld.
6. Clean and paint all repair areas to prevent rust.

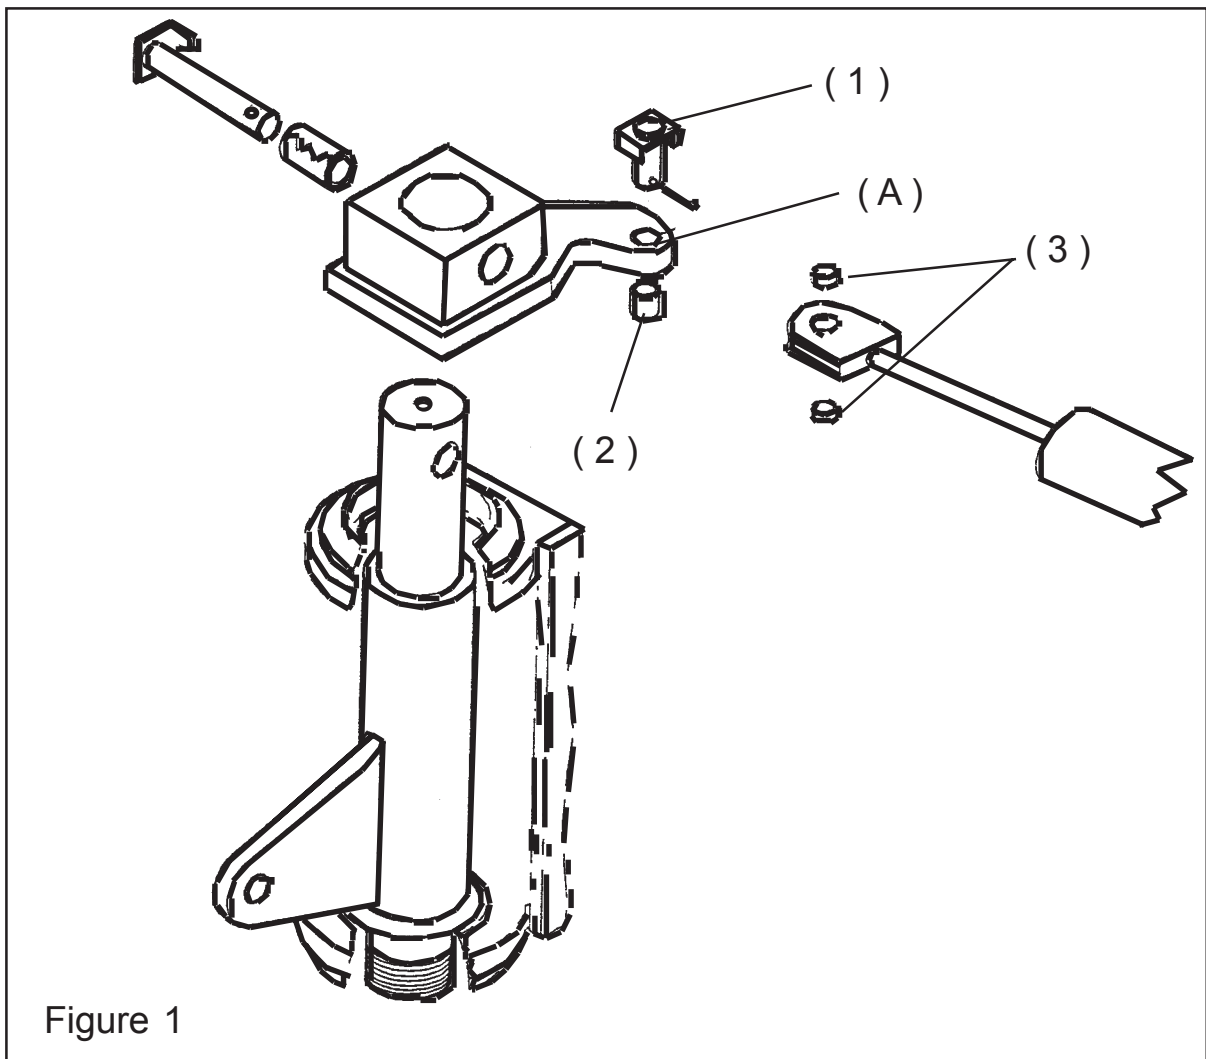
There are three procedure types (methods) of repair that can be used. The method used depends on the condition of the bushing bore ( A ) on the turning arm. All procedures start with the mowing Head at rest on the floor (Ground) and all Hydraulic pressure relieved from system.

1. Remove center pin and turning arm Pin ( 1 ). Move the swing cylinder out of the way.
2. Using a suitable driver, remove the old bushing ( 2 ) and install a new bushing P/N 02969987.
3. Replace two bushings in the cylinder clevis ( 3 ) with P/N 02959890 bushing, use suitable driver.
4. Align cyl. clevis with turning arm bore and install new P/N 02960458 Pin and cotter pin.
5. Lubricate pin, and test for proper operation.

1. Remove center pin and turning arm Pin (1). Move the swing cylinder out of the way.
2. If Bushing bore cannot be drilled in place, the turning arm will have to be removed. If so remove the turning arm from the king post. See the Operators / Service Manual for Turning arm removal.
3. Bore or drill the hole for the bushing to 1-3/8"
4. Install the P/N 02957501 (1-3/8" OD Bushing), using a suitable driver.
5. Reinstall the turning arm on the king post. It may be advisable to replace the main pin bushing and/or main pin at the same time.
6. Replace two bushings in the cylinder clevis ( 3 ) with P/N 02959890 bushing, use suitable driver.
7. Align cyl. clevis with turning arm bore and install new P/N 02960458 Pin and cotter pin.
8. Lubricate pin, and test for proper operation.

1. Remove center pin and turning arm Pin (1). Move the swing cylinder out of the way.
2. remove turning arm from king post.
3. Replace Turning Arm with new turning arm with steel bushing (use rear turning arm P/N 02956830 or front turning arm P/N 02956831, one or the other but not both).
4. Replace two bushings in the cylinder clevis ( 3 ) with P/N 02959890 bushing, use suitable driver.
5. Align cyl. clevis with turning arm bore and install new P/N 02960458 Pin and cotter pin.
6. Lubricate pin, and test for proper operation.

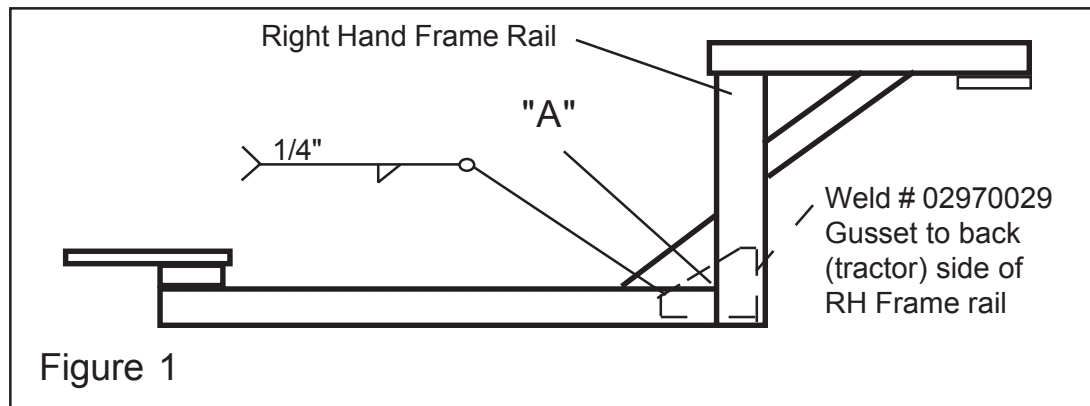
Repair Procedures for A-Boom RH Frame Rails cracking at Juncture of rear Horizontal Rail and Vertical Tube. If Cracks appear in the weld at Point "A" in Figure 1 use the following procedure to repair the rail.

1. Check the portion of the rail to be repaired. Insure that there is adequate clearance between it, the tractor and mower frame to enable you to grind and weld the crack. If clearance is a problem it may be required to remove the frame rail. If it is required to remove the frame rail see Operators Assembly manual for procedures.
2. Grind a groove at the site of the crack and clean the area to be welded.
3. Weld the crack making 100% welds.
4. After repairing the crack. Prepare the area for installation of the Gusset (P/N 02970029).
5. Position the Gusset on the inside of the Right Hand frame rail as shown in figure 1. Weld all around with 1/4" fillet weld.
6. Clean and paint the are where repaired. Reassemble any parts removed, Run & Test.

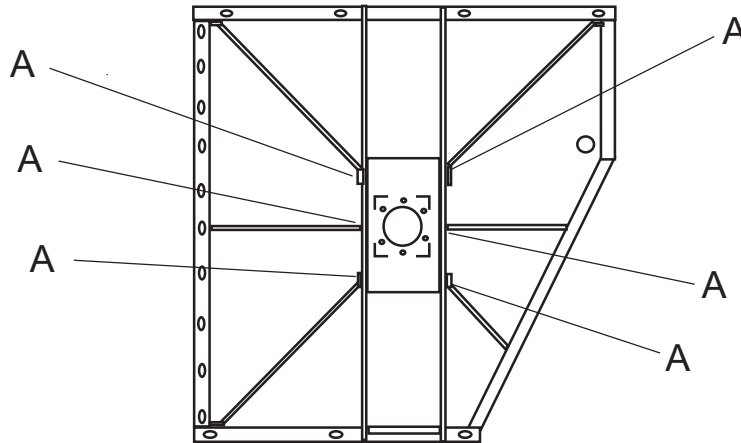
If cracks appear in the welds at points "A" as shown above, use the following procedures to repair head.

1. Grind a groove at the site of the crack and clean the area to be welded.
2. Weld the crack making a 100% weld.
3. After repairing the cracks, prepare the sites for installation of the gussets.
4. Position the reinforcing bar gusset part no. 02970111 if 90° or part no. 02970112 if 48° over the X-Bar as shown in drawing next page. Weld with a 1/4" fillet weld on the bottom and an edge weld on top. DO NOT weld the ends.
5. Clean and paint the area.
6. Reassemble any parts that were removed.
