# SERVICE LETTER

No. 842

Piper Aircraft Corporation

Subject: Main Landing Gear Torque Link Greaser Bolt Inspection and Replacement

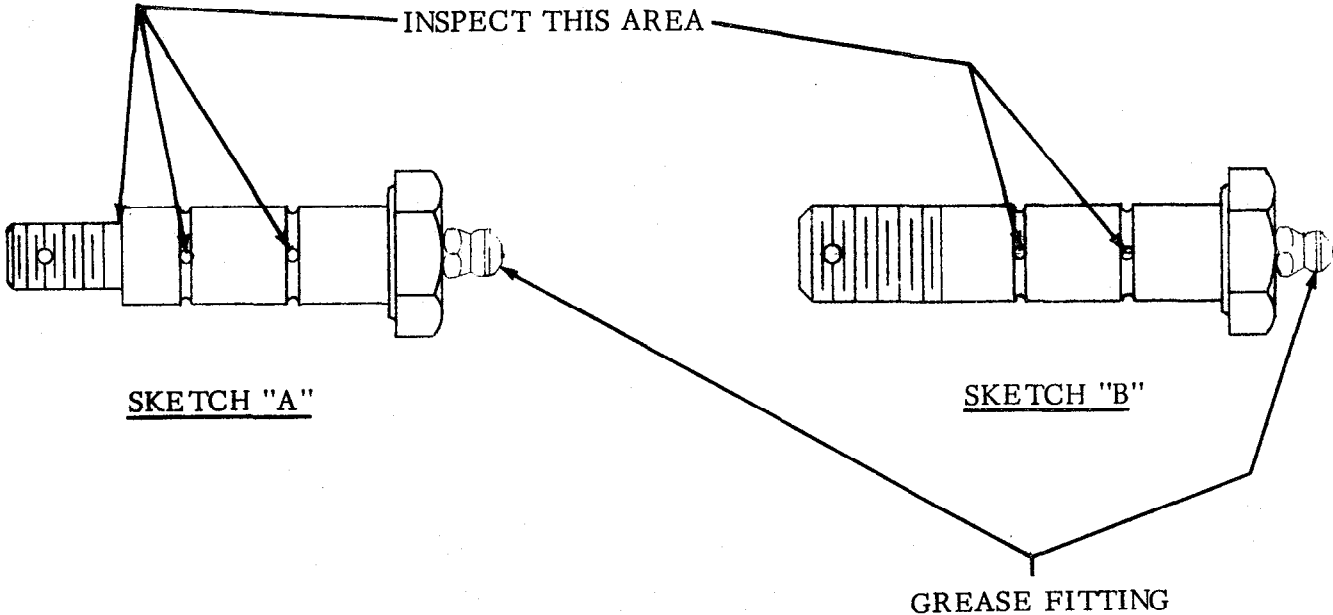
Aircraft equipped with greaser bolts per Sketch "A", may install Kit 760 910V to alleviate the 100 hour inspection until a total of 500 hours of operation have been accumulated and then the bolts can be inspected at each 500 hours thereafter.

Aircraft equipped with greaser bolts per Sketch "B", may install new Bolt 79543-02 and alleviate the 100 hour inspection until a total of 500 hours of operation have been accumulated, then can be inspected at each 500 hours thereafter.

Purpose: There have been incidents where greaser bolts have been found with cracks radiating from the greaser hole in the groove. Production aircraft with serial numbers subsequent to those listed above have had the greaser bolt replaced with a standard AN8 Bolt and new torque links. In the field the greaser bolt with grooves can be replaced with a greaser bolt which incorporates grease holes only and no grooves.

1. If the aircraft is on jacks, the main gear struts must be deflated (see appropriate Service Manual) and the piston axle assembly supported before proceeding. Otherwise, proceed with Instruction 2.
2. Remove the greaser bolt holding the main landing gear torque links together.
3. Thoroughly inspect each bolt using a 10X magnifying glass, or dye check, or magnetic partical inspection for cracks as shown in Sketches "A" and "B".
4. If any cracks are found, the bolt should be replaced. See Material Required, No. 1.
5. On aircraft using the bolt shown in Sketch "A" we recommend this bolt be replaced with Piper Kit Number 760 910V, even if no cracks are found. See Material Required, No. 2.
6. If the struts were deflated as required by Instruction No. 1, re-inflate the struts. Refer to the appropriate Service Manual for proper inflation.
7. Make appropriate log book entry.

1. For Instruction No. 4; one (1) or two (2) non-grooved greaser bolts Piper Part Number 79543-02.
2. For Instruction No. 5; one (1) Kit, Bolt-Main Gear Modification Piper Part Number 760 910V, for each main landing gear two (2) required per aircraft.
