# MISCELLANEOUS MODELS INFORMATION & SERVICE BULLETINS

Manual P/N 0298  
(05/04)

**Alamo Industrial**  
P. O. Drawer 549  
Seguin, Texas 78155  
830-372-3551

**2004 Edition**

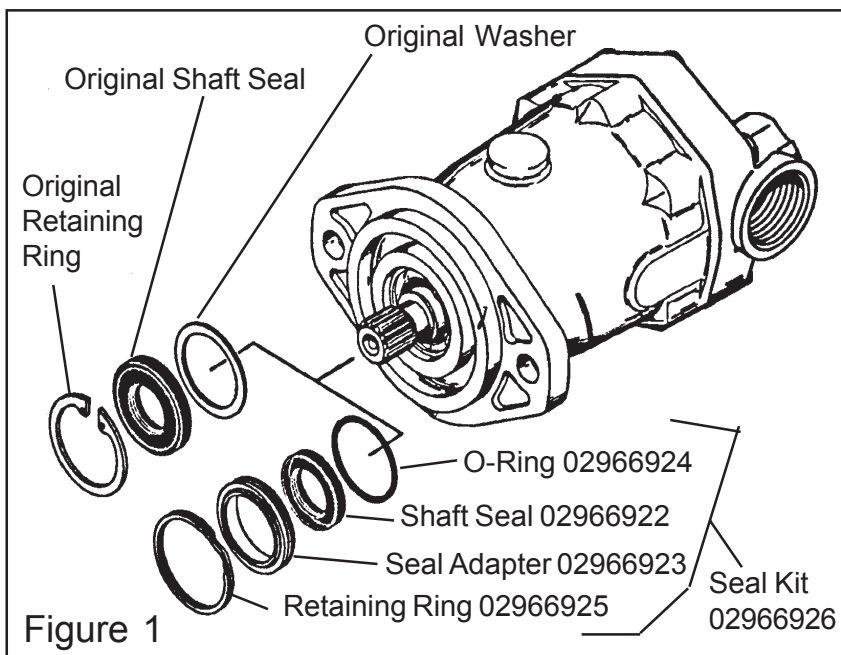
There is a high pressure shaft seal kit available for the piston motors used on above products, kit P/N 02966926. If the shaft seal has been blowing out, replace with this kit. Note: the new motors shipped in the future will have this high pressure seal already installed.

**Lubricate** new seal adapter, O-ring and fill the snap ring groove in motor housing with lithium based # 2 grease. **Install O-Ring and shaft seal** into the adapter. (Seal lip should face shoulder of adapter). **Install adapter** in motor housing, with shaft seal side into housing first, by pressing it into place with finger pressure. Light tapping may be used, however, be careful not to cock the adapter as it is pressed by the snap ring groove, as this would cause O-Ring damage. **Install the new retaining ring. Reinstall motor on machine.** Run and test for operation.

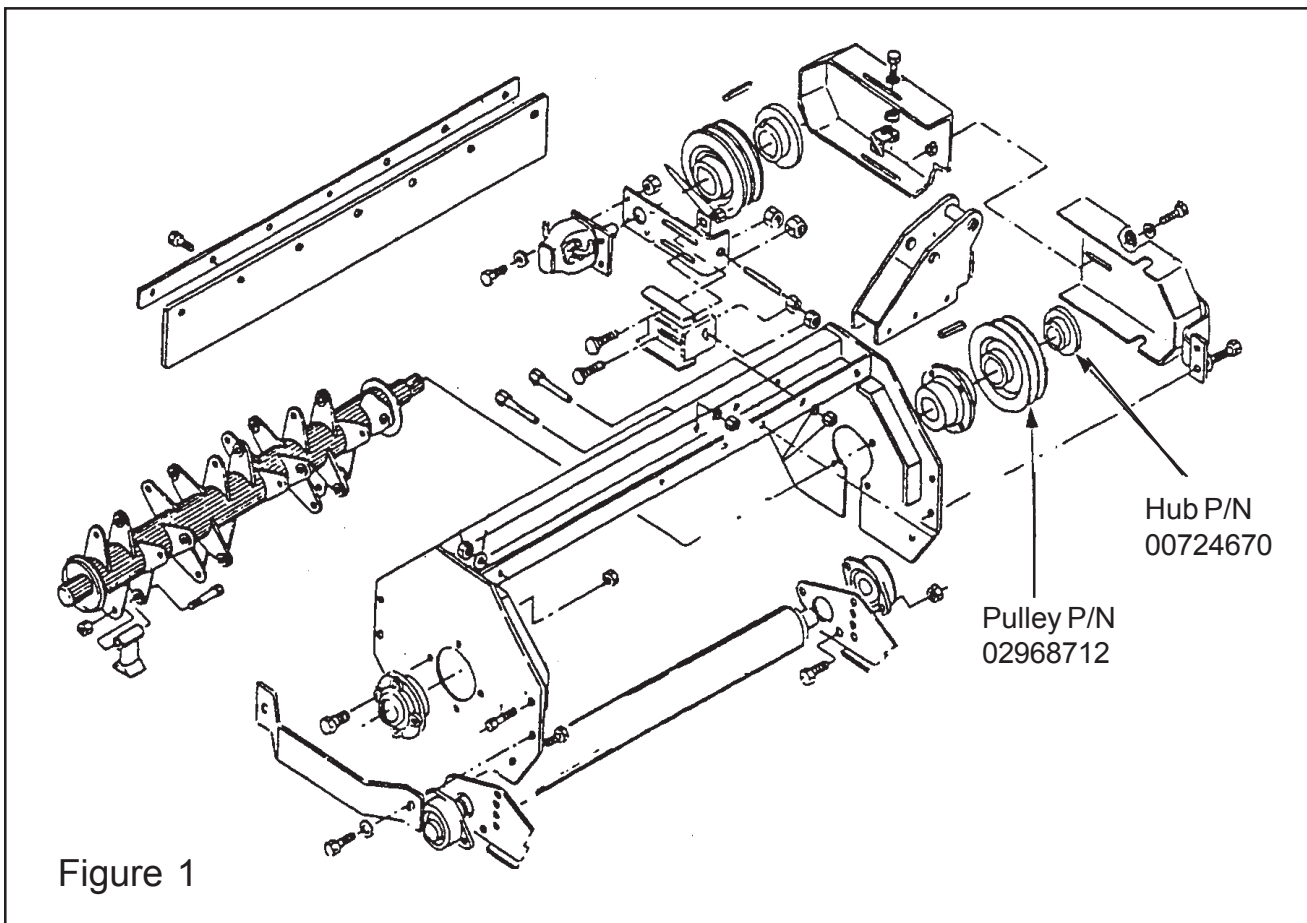
Figure 1

A new method has been devised to secure the pulley to the cuttershaft. A new pulley, P/N 02968712 and a QD Pulley Hub P/N 00724670 has replaced the old pulley with setscrew, washer, lockwasher and bolt. The new pulley and hub are a keyed, taper lock design which will provide a better fit and longer service life for the shaft.

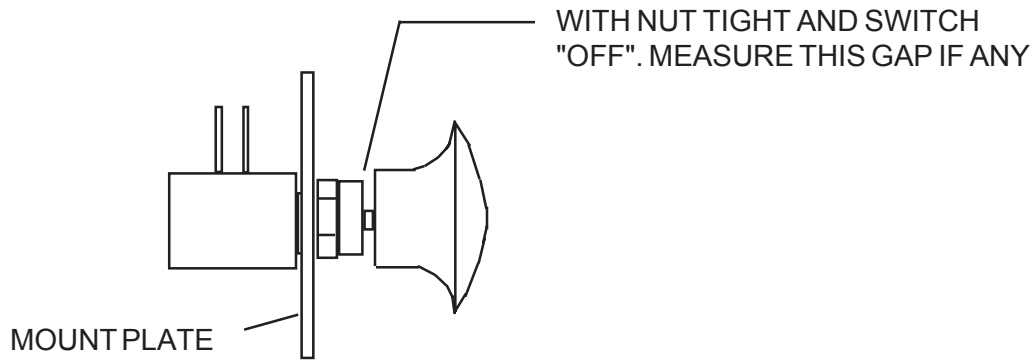
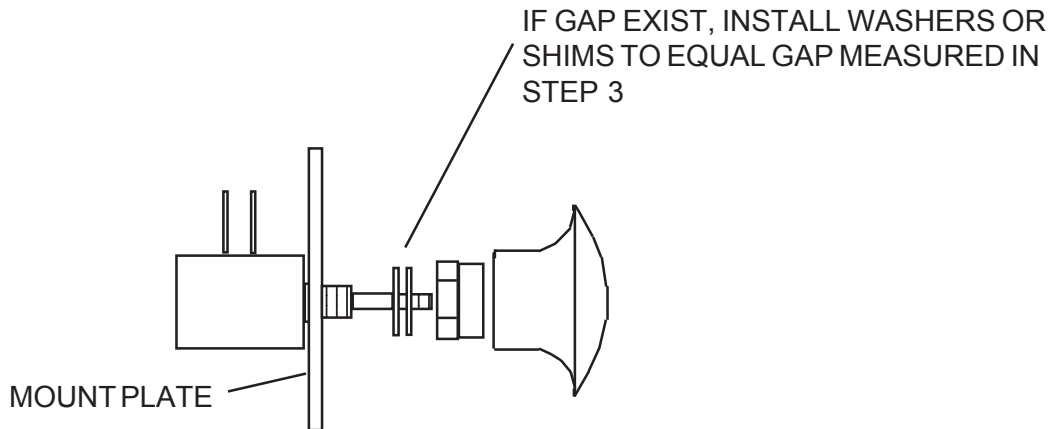
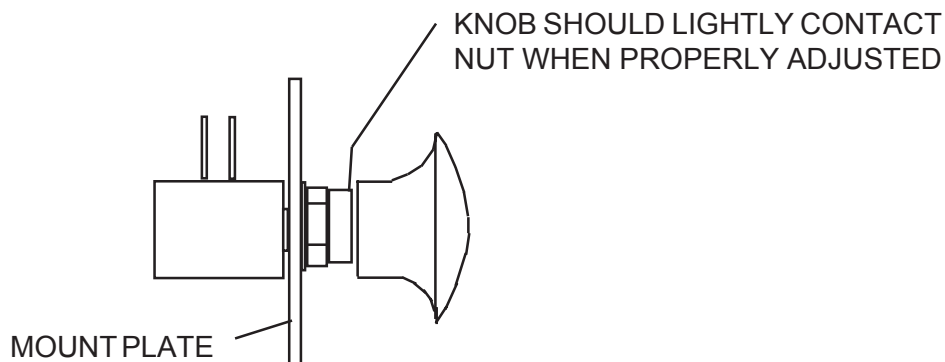
Alamo has recently received reports of failures of the referenced switch. The failures modes are:

Test performed on numerous switches indicates that the (b) failures are due to excessive force being applied to the knob when shutting off the mower. Specifically, the knobs are usually roughly slapped to turn the mower off. After internal parts of the switch are damaged, the rod can then be pulled out easily. The (a) failures are due to the knobs not being securely tightened.

To prevent these failures from occurring, or to replace a damaged switch, use the following procedure to adjust the travel of the switch. (See attached diagram).

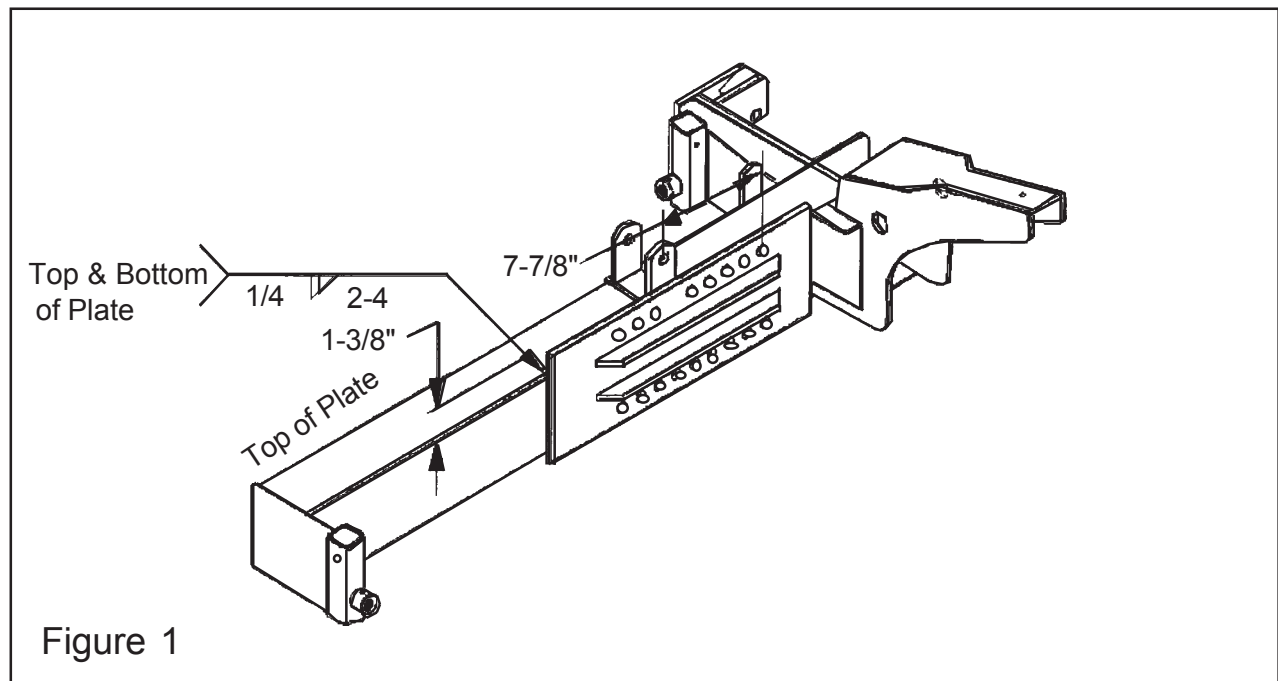
Figure 1

A kit is now available to repair or reinforce the main frame of the Grass King mowers. The kit is designed to be installed on undamaged frames, but can be used on damaged frame if the frame can be straightened and is structurally sound. Instructions and decals are included in the kit as well as the plate weldment that is to be installed

The repair procedure is shown in instruction sheet P/N 02969709

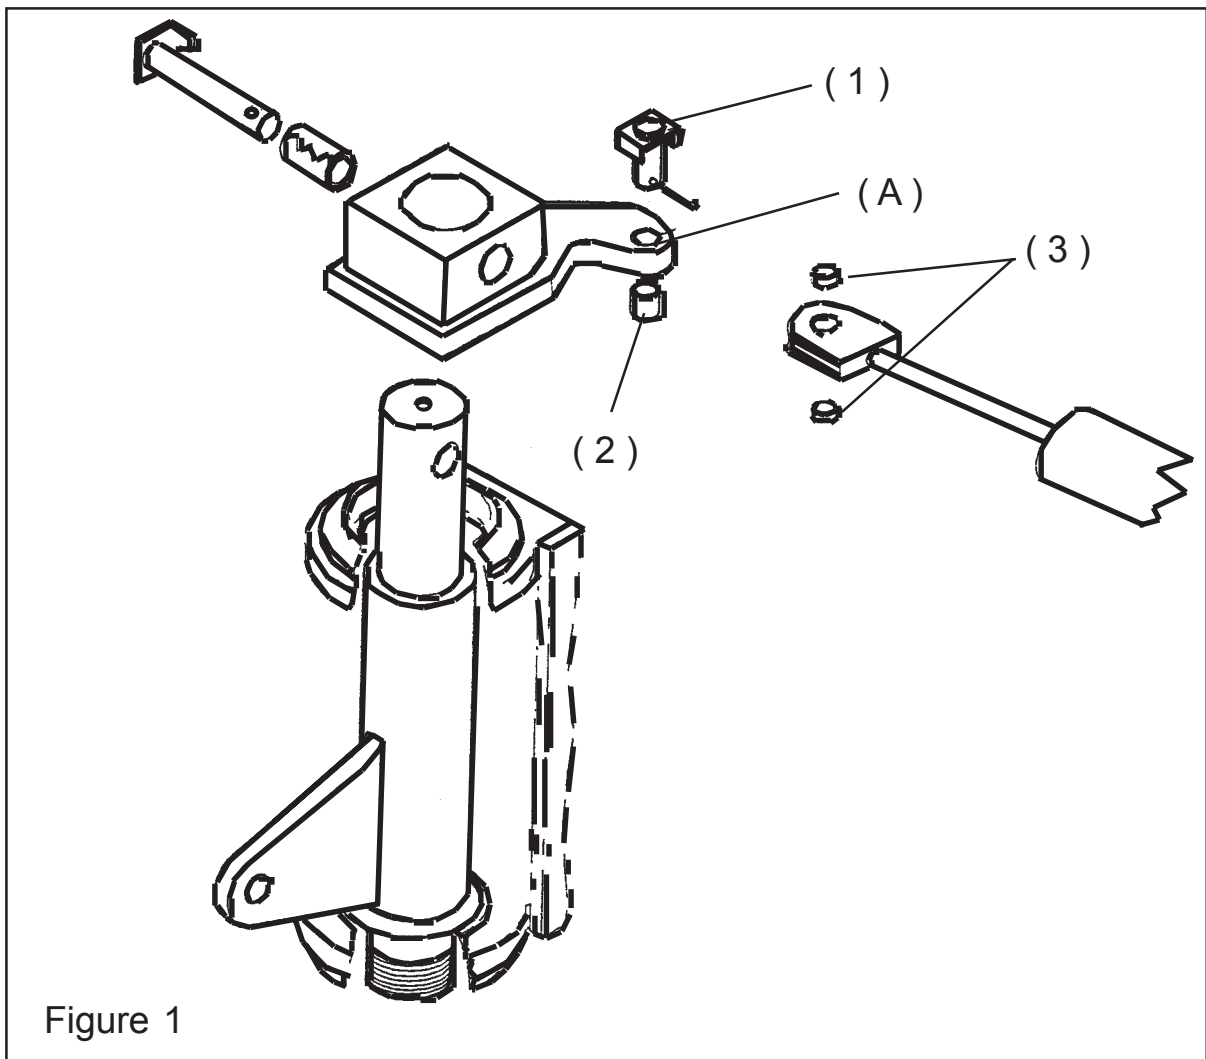
There are three procedure types (methods) of repair that can be used. The method used depends on the condition of the bushing bore ( A ) on the turning arm. All procedures start with the mowing Head at rest on the floor (Ground) and all Hydraulic pressure relieved from system.

1. Remove center pin and turning arm Pin ( 1 ). Move the swing cylinder out of the way.
2. Using a suitable driver, remove the old bushing ( 2 ) and install a new bushing P/N 02969987.
3. Replace two bushings in the cylinder clevis ( 3 ) with P/N 02959890 bushing, use suitable driver.
4. Align cyl. clevis with turning arm bore and install new P/N 02960458 Pin and cotter pin.
5. Lubricate pin, and test for proper operation.

1. Remove center pin and turning arm Pin (1). Move the swing cylinder out of the way.
2. If Bushing bore cannot be drilled in place, the turning arm will have to be removed. If so remove the turning arm from the king post. See the Operators / Service Manual for Turning arm removal.
3. Bore or drill the hole for the bushing to 1-3/8"
4. Install the P/N 02957501 (1-3/8" OD Bushing), using a suitable driver.
5. Reinstall the turning arm on the king post. It may be advisable to replace the main pin bushing and/or main pin at the same time.
6. Replace two bushings in the cylinder clevis ( 3 ) with P/N 02959890 bushing, use suitable driver.
7. Align cyl. clevis with turning arm bore and install new P/N 02960458 Pin and cotter pin.
8. Lubricate pin, and test for proper operation.

1. Remove center pin and turning arm Pin (1). Move the swing cylinder out of the way.
2. remove turning arm from king post.
3. Replace Turning Arm with new turning arm with steel bushing (use rear turning arm P/N 02956830 or front turning arm P/N 02956831, one or the other but not both).
4. Replace two bushings in the cylinder clevis ( 3 ) with P/N 02959890 bushing, use suitable driver.
5. Align cyl. clevis with turning arm bore and install new P/N 02960458 Pin and cotter pin.
6. Lubricate pin, and test for proper operation.

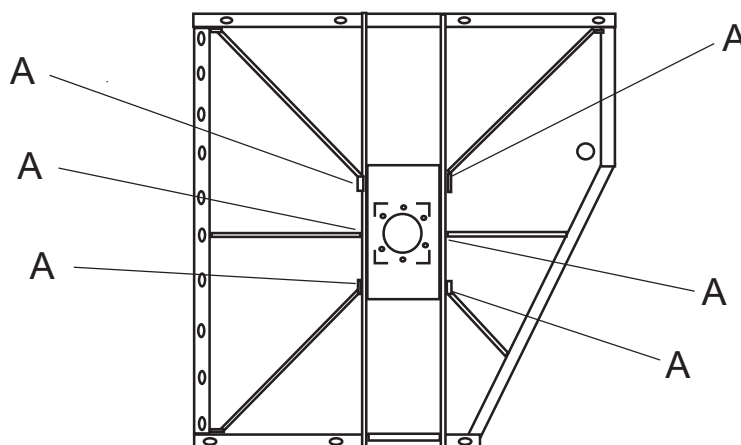
If cracks appear in the welds at points "A" as shown above, use the following procedures to repair head.

1. Grind a groove at the site of the crack and clean the area to be welded.
2. Weld the crack making a 100% weld.
3. After repairing the cracks, prepare the sites for installation of the gussets.
4. Position the reinforcing bar gusset part no. 02970111 if 90° or part no. 02970112 if 48° over the X-Bar as shown in drawing next page. Weld with a 1/4" fillet weld on the bottom and an edge weld on top. DO NOT weld the ends.
5. Clean and paint the area.
6. Reassemble any parts that were removed.

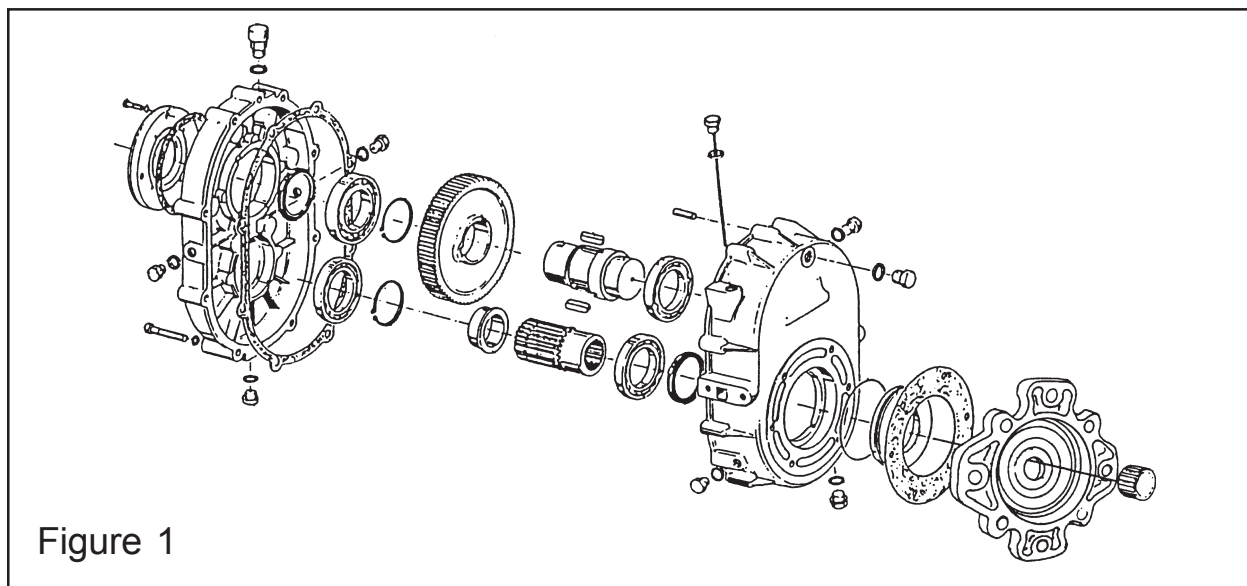
Figure 1

Speed Increaser Assembly P/N 00768991: Plug Seal Update, There have been some isolated reports of the case plugs backing out on the above mentioned Speed Increasers, causing loss of oil and cataastrophic failures of the gearbox.

All units operating in warm temperature of 100° F. or higher should be changed right away to prevent plugs from backing out.

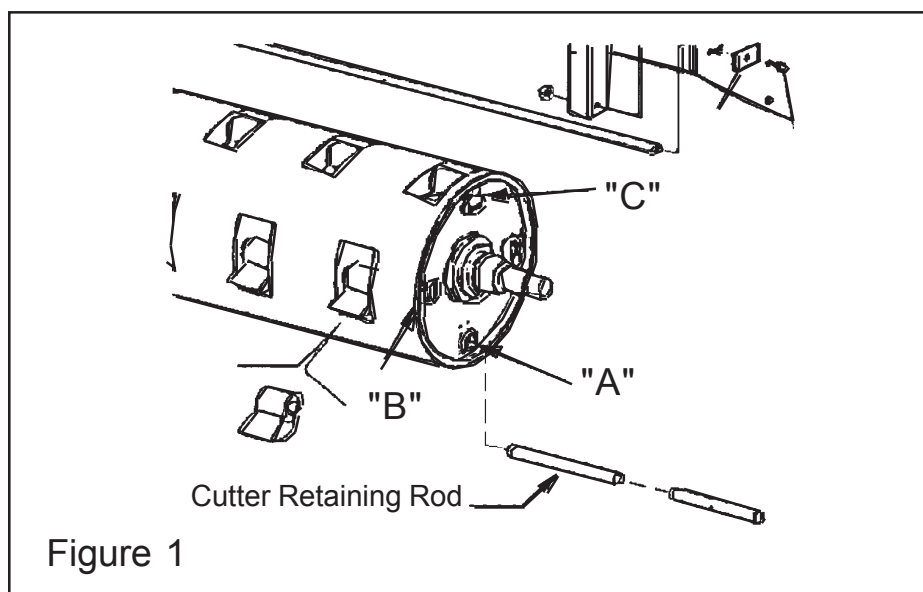
Figure 1

The Cutter retaining Rod is a normal wear item and should be replaced when they show signs of excessive wear. Under normal cutting conditions they can be reused through three to five cutter flail changes. Use the following procedure when changing flail knives and retaining rod.

Reinstall each rod one position clockwise from the position it was originally installed. For example, if the rod was removed from position "A" (see figure 1), then replace it into position "B", removed from position "B" is moved to position "C" and etc. around the cutter shaft. This will position the cutter flails over an unworn area on rods.

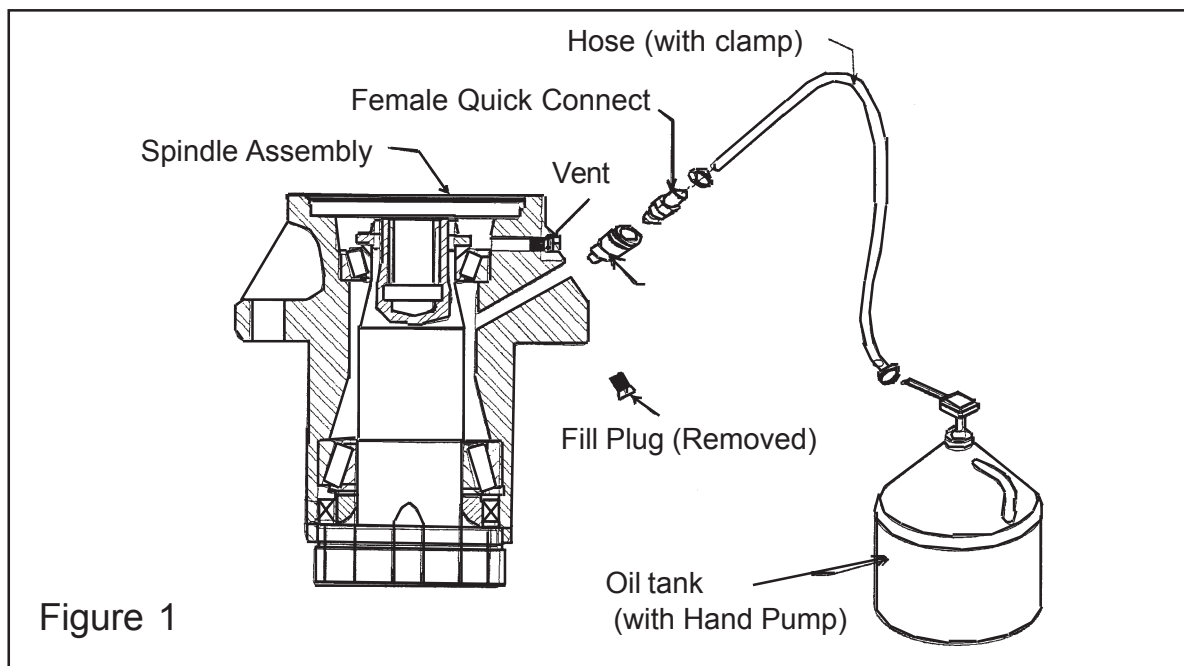
Utilization of this spindle fill kit should decrease maintance time and failures by providing accurate oil fill of the spindle assembly.

Installation requires the replacement of the fill plug with the female quick connect fitting. To fill the spindle, attach the hose and oil bottle to the spindle by utilizing the quick connect fittings. remove the vent plug and pump in the oil untill oil is seen at the vent plug opening. reinstall the vent plug and remove the bottle at the quick connect fitting. The female quick disconnect is designed to be left on the spindle in place of the fill plug.

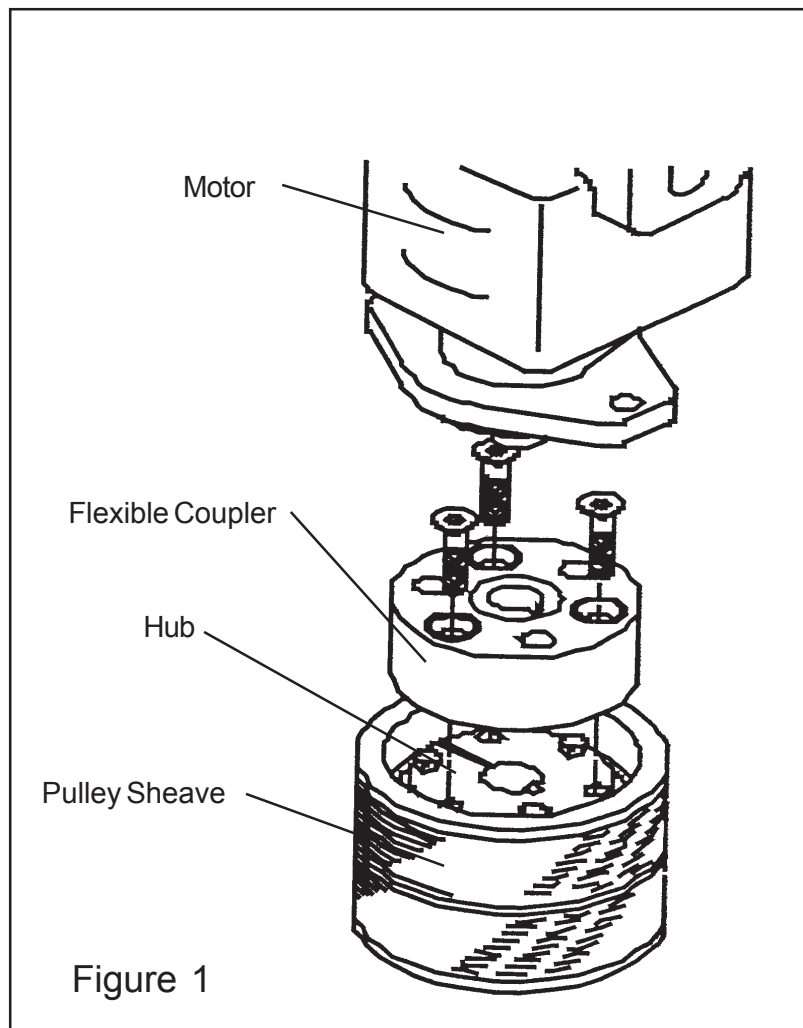
There has been a design change to the drive coupler assembly for the Buzz bar Cutting Head. If a flexible coupler, Alamo Industrial P/N 02974245 (for Machete) or P/N 02974246 (for A-Boom & Slopemower), are ordered they will be a different design. The new flexible coupler design will be molded rubber with metal inserts. The new molded rubber version will directly replace the machined design using the same part number. An installation drawing, that describes the assembly in detail, will be shipped if a new coupler is ordered. this bulletin is to inform you of the design change (see Figure 1) If there are further questions please contact Alamo Industrial's Technical Service Department.

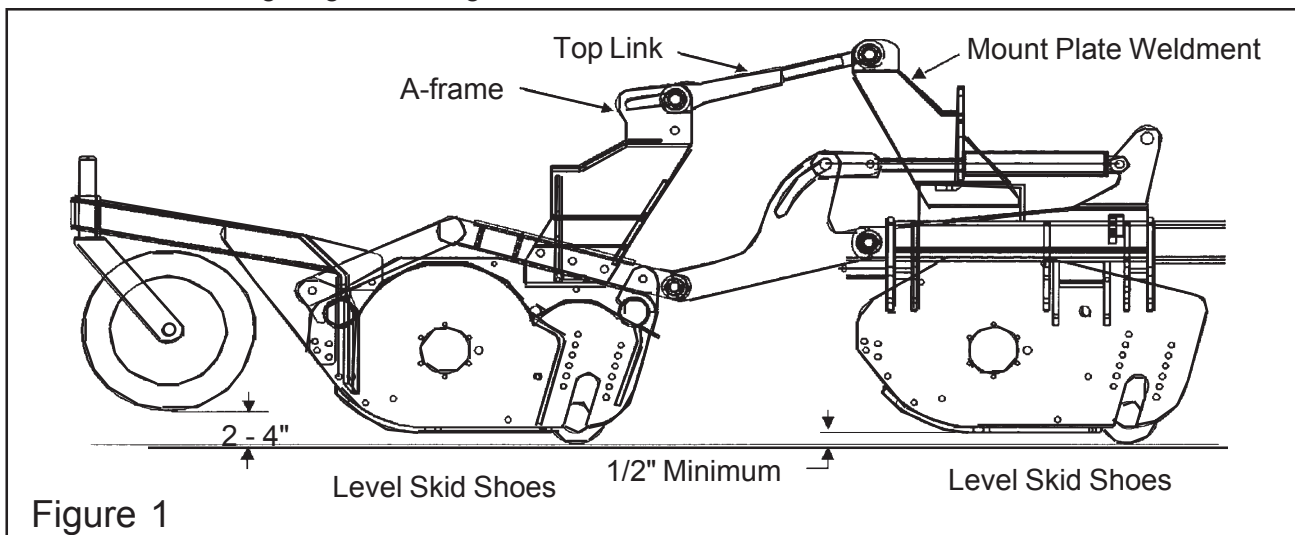
Figure 1

If the front mower is not leveled as described above, the amount of vertical movement available for the front mower, when higher terrain is encountered is severely restricted resulting in binding and bending or breakage of the a-frame and mount plate weldments. The front mower must be re-levelled each time the cutting height is changed.
