## Technical Tips - INSERT HEAD Module

### MaxiMailer – Service Engineers’ Technical Tips Documentation – Jan 2007

The following documentation describes all MaxiMailer field issues and corrective actions. Please refer to these documents before any service or maintenance is conducted. Items **highlighted thus** are Jan 2007 additions.

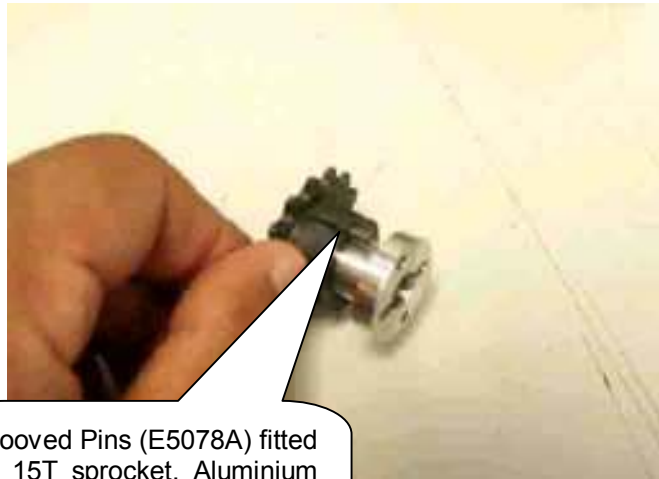
Grooved Pins (E5078A) fitted on 15T sprocket. Aluminium hub pushed on after. Use loctite to secure the pins in place.

~~Please Note~~ that the pins should be fitted into the sprocket first then the aluminium hub pushed on after.

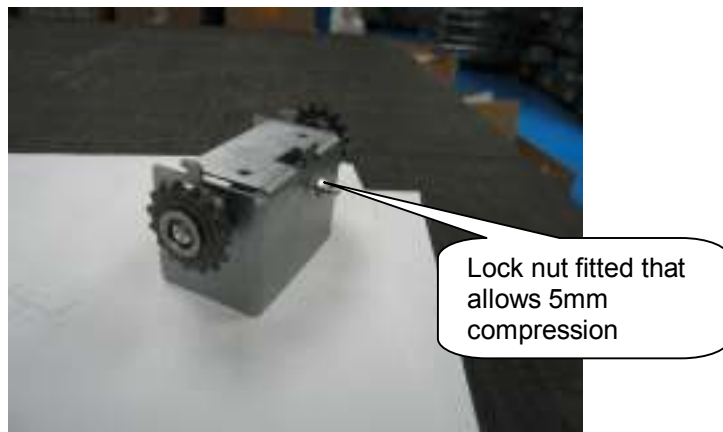
Note if a M4 lock nut is fitted onto the Sprocket Bracket Assembly (A7059A) as shown below – ensure this is slackened off.

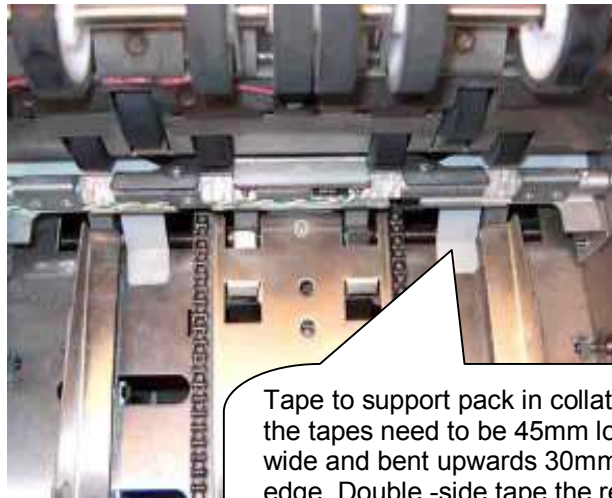
Tape to support pack in collate pocket - the tapes need to be 45mm long x 20mm wide and bent upwards 30mm from one edge. Double -side tape the remainder and fix inboard of the collate pocket side guides, making sure that they do not interfere with the fingers and collate pocket side guides.

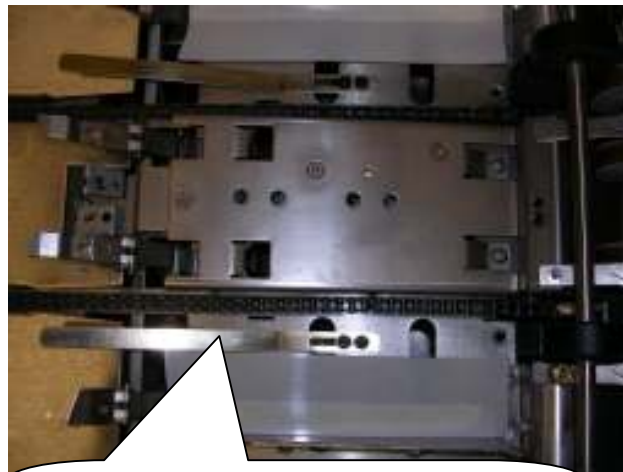
Alternative field fix: spring steel can be secured to bed of collate pocket.

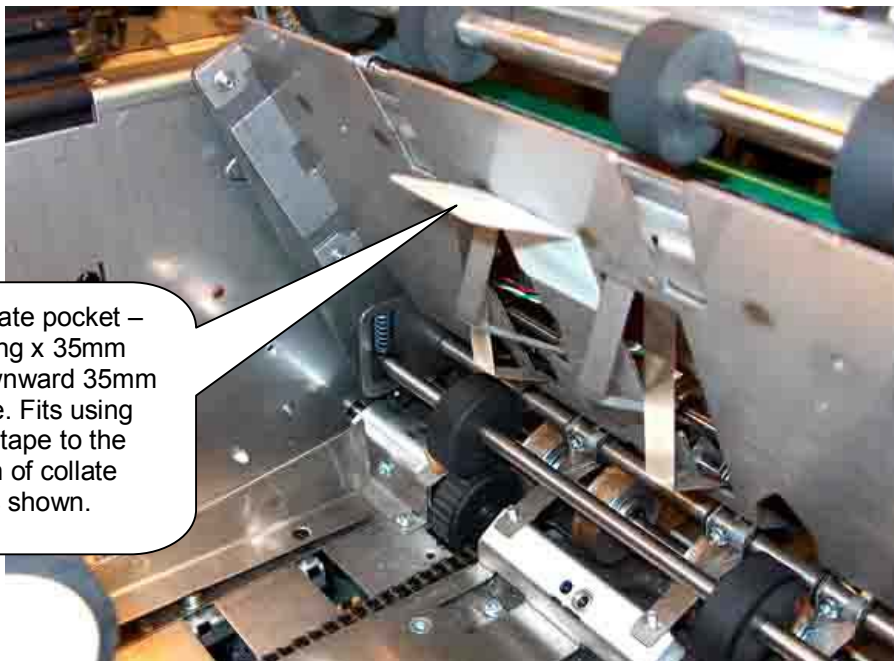
There have been instances where added support of collated documents is required in the Head unit collate pocket before inserting into the envelope as shown below:-

Fit tape in collate pocket – tape 70mm long x 35mm wide bent downward 35mm from one edge. Fits using double -sided tape to the middle section of collate pocket roof as shown.

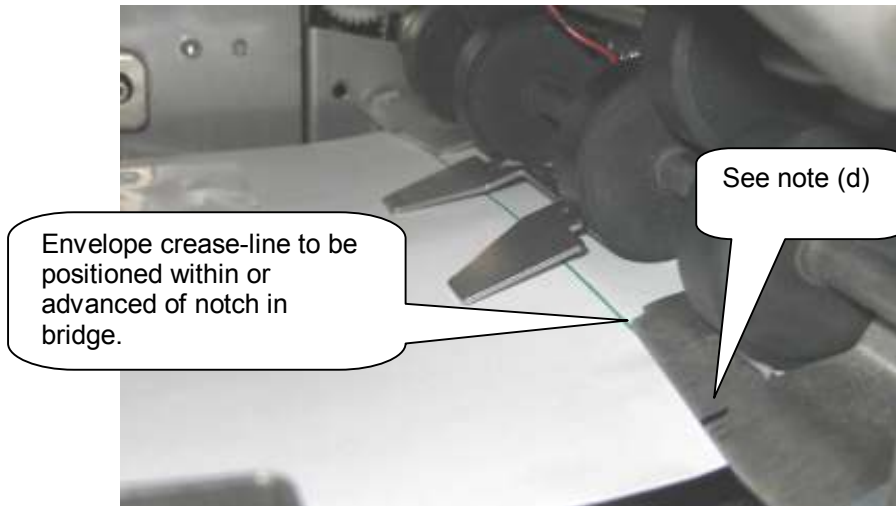
e) Check envelope stop posn is correct for the envelope (see Photo below). The stop posn can be moved forward (e.g. +ve takes the envelope towards the wetter area). Note that if this is too far back it can restrict the envelope from opening.

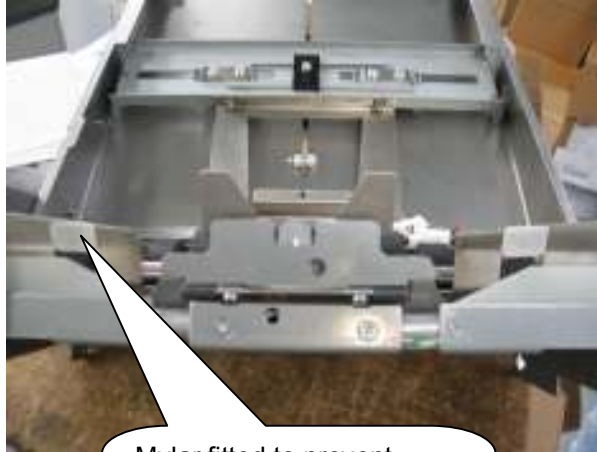
Mylar fitted to prevent fingers catching on cut-outs (2 posn G6210A and G6211A) – see below.

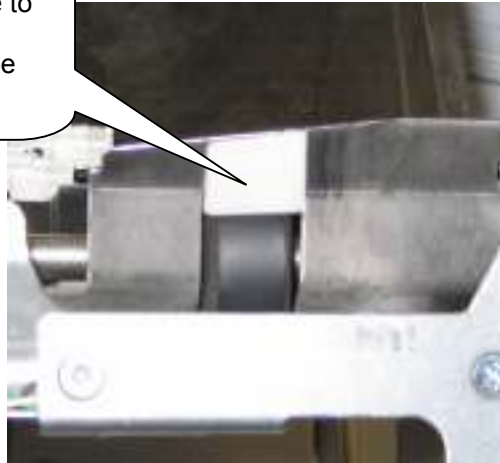
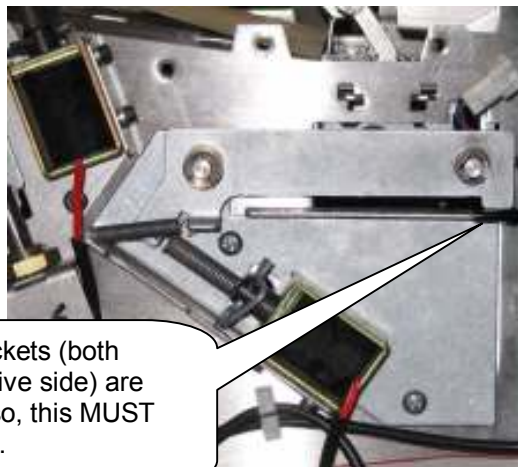
Check that brackets (both operator and drive side) are not bent-up. If so, this **MUST** be straightened.

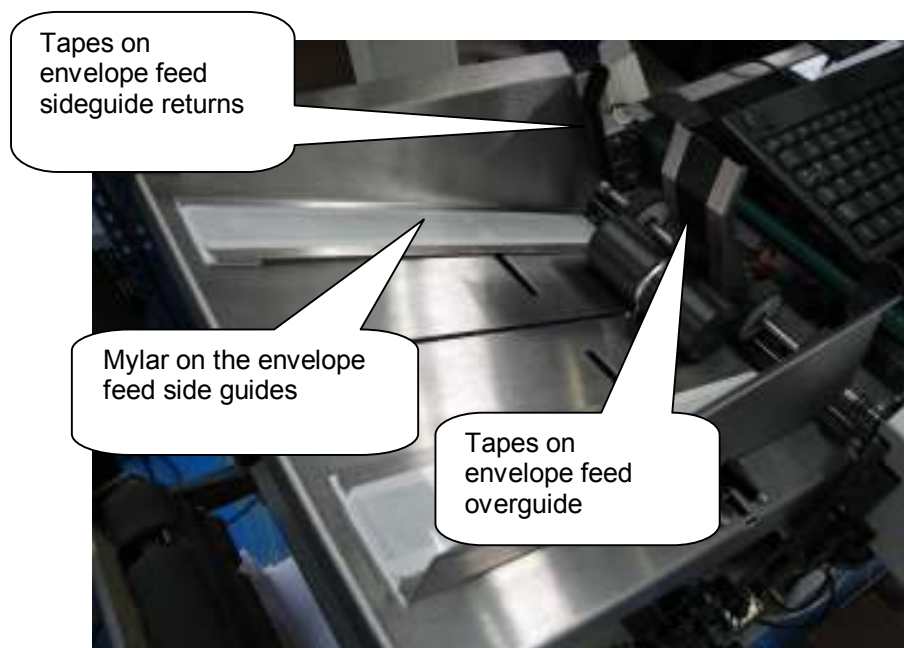
iii) To assist feeding - Mylar tapes can be fitted onto the side-guide as shown below and also onto the returns and overguide.

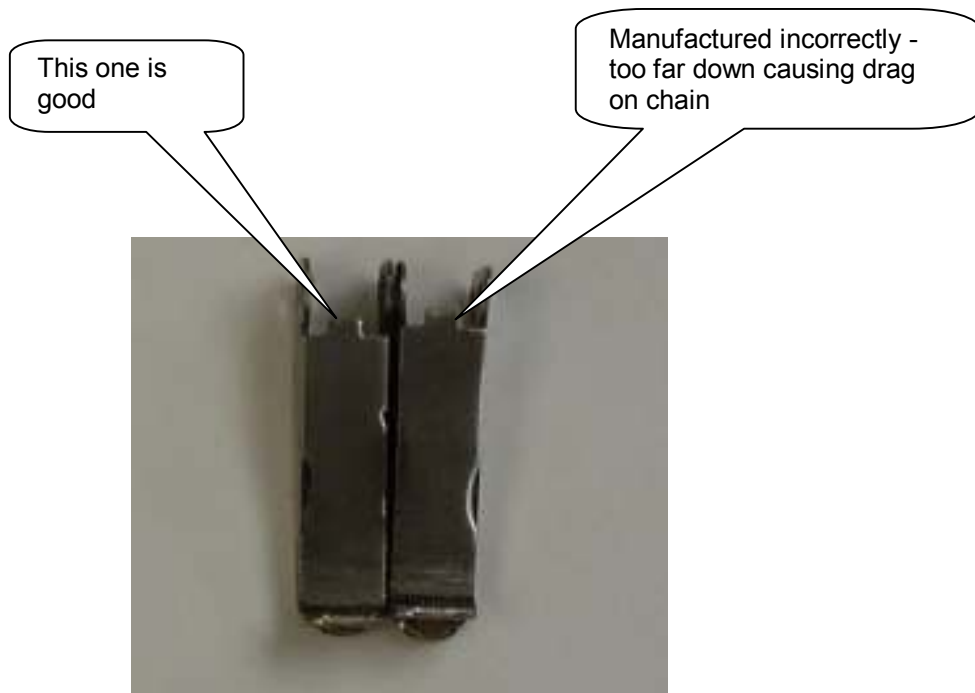
If experiencing sporadic insert crashes - check insert pawls are aligned with each other and that there is no resistance when manually moved (to check this turn by hand one complete cycle). Check that the pawls are manufactured incorrectly - if not they could drag on the insert chain, see below.

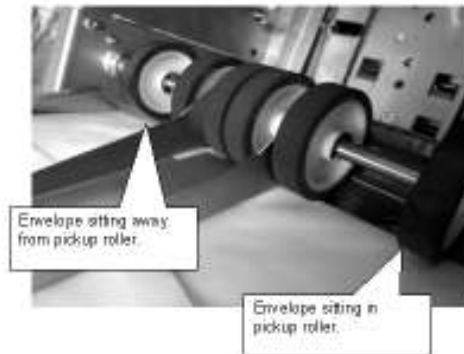
**Figure 1: Envelope lead edge curled/twisted and does not sit parallel to the separator/pickup roller (resulting in skewed feeding)**

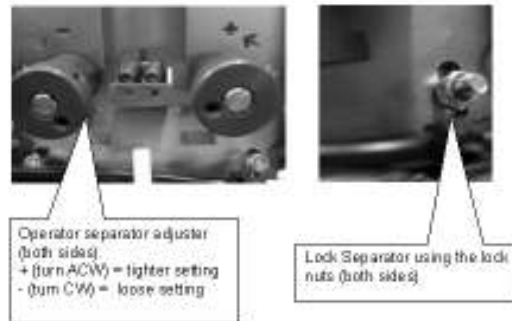
**Figure 2: Separator spring action locked to prevent any separator movement downwards. This is carried out by adjusting the 2 locknuts (either side)**

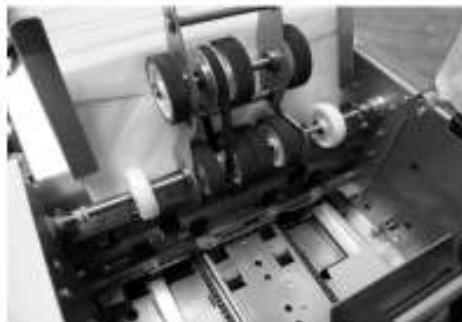
**Figure 3: Outer lower tyres removed from the pre-feed assembly**

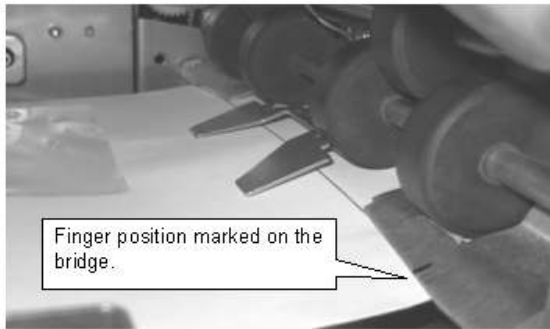
**Figure 5: Outer finger setting set correctly for the envelope width.**

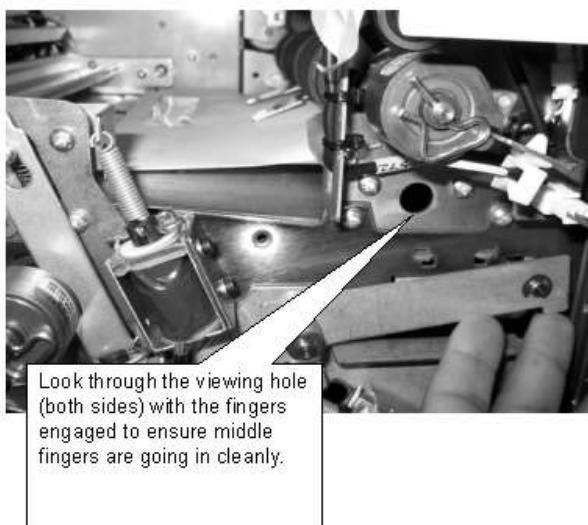
**Figure 6: Middle fingers opening the throat of the envelope**

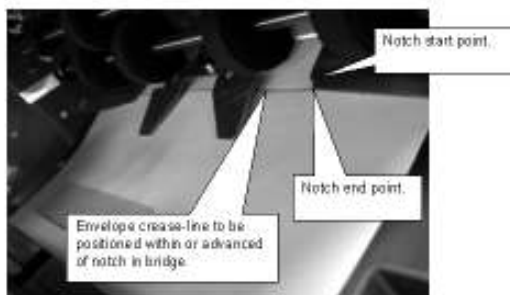
**Figure 7 and 8: Envelope Stop Position and Skew limits.**

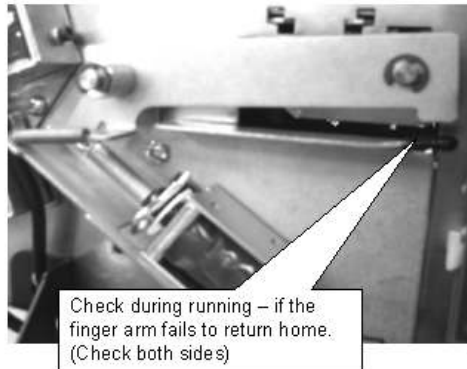
**Figure 10: Finger not returning into home position**

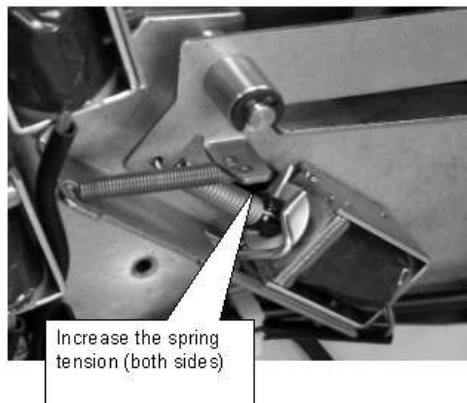
**Figure 11: Finger return spring tension**

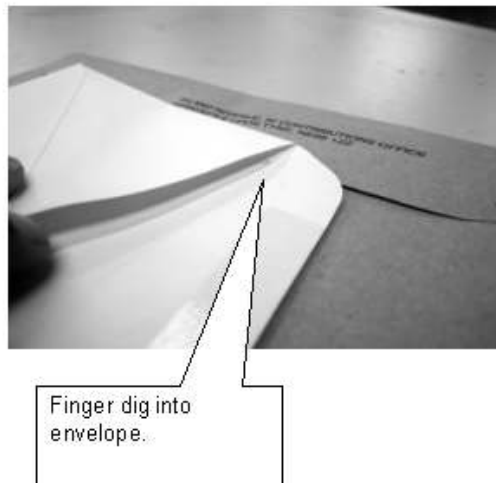
**Figure 12: Insertion crashes due to fingers digging into envelope.**

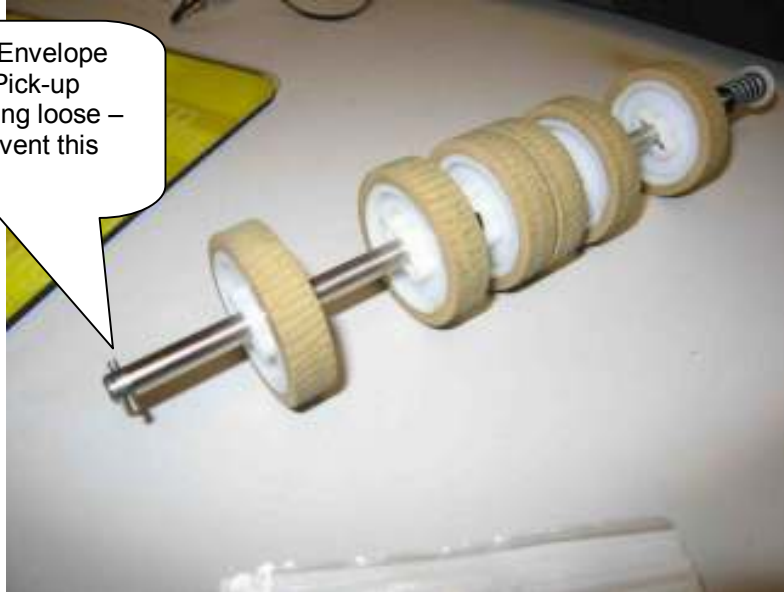
Pin (E5078A) in Envelope or Insert feeder Pick-up shaft is not working loose – Loctite pin to prevent this from occurring.

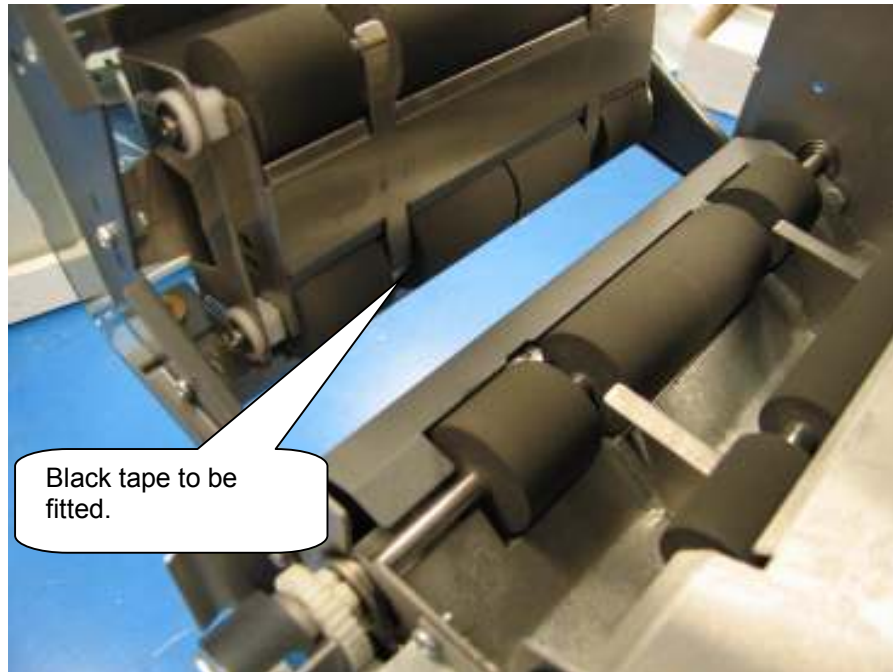
There has been one instance of envelopes exiting the machine without closing the flap resulting in error 47 (jam at output sensor). Initially check by blocking/ clearing the closer output sensor (analogue reflective sensor). If the sensor stays blocked - at the first instance try moving the machine away from light. If this is not appropriate BLACK insulation tape can be fitted onto the closer overguide B7731A as shown below.

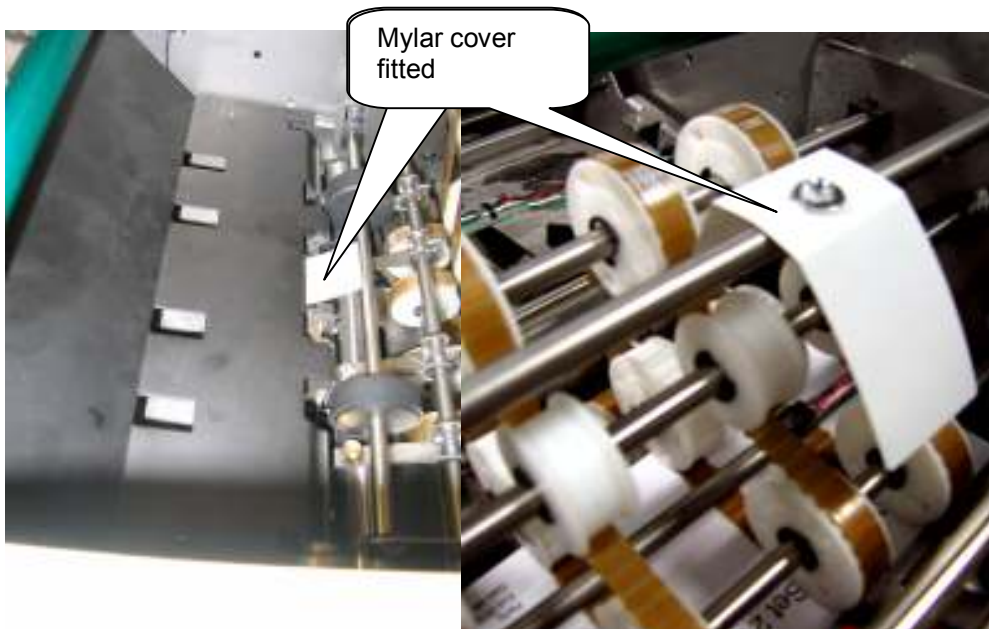
This is caused by direct sunlight or lighting above / over the head unit which effects the above sensors at switch ON. At the first instance move the machine to prevent this from occurring (ref installation instructions). If this is not possible then a shield can be fitted as shown below. The cover ([B7502F](#), Issue 2) has been redesigned and can be fitted if required (optional). With regards to the input conveyor again **Mylar tape can be fitted as shown below:-**

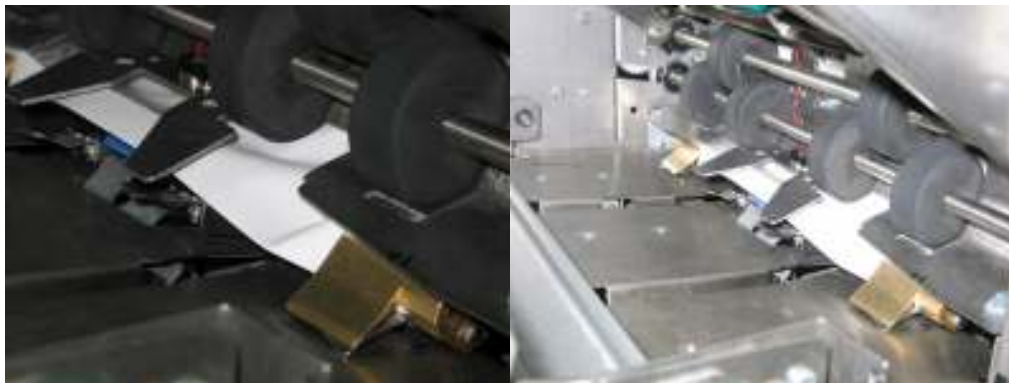
In some cases (for example, if an envelope is stream-fed) then the envelope can be pushed between the fingers and overguides (as shown in the picture below). In this case the customer must be told to remove the envelope with care. The envelope must be removed from the collate pocket clam area of the machine and not from the insertion area. If the customer does this they may bend the overguides.
