Kodak DryView

8300/8600/8610 LASER IMAGING SYSTEMS

Service Bulletins

New Solution for EC 27 or EC 28 Caused by FILM Stalling in the PROCESSOR

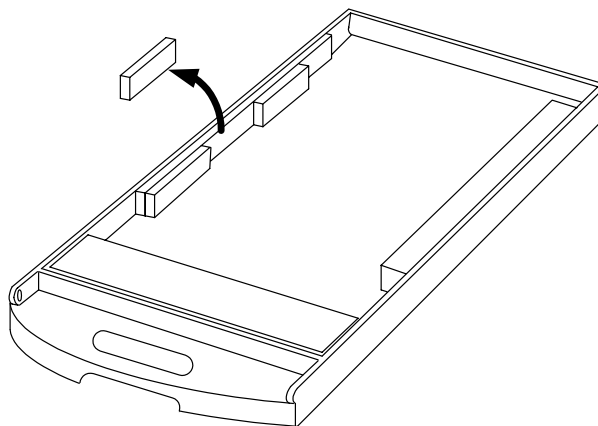
Removing Middle Two-Inch Section of Registration Foam

Excessive pressure applied to the film by the registration foam, on the left side of the FILM TRAY, can cause film-feed retries and failures. The easiest way to reduce this pressure is to remove the middle third of the six-inch foam that holds the film in place.

With a ruler and a sharp knife, measure, cut and remove the middle two inches of the registration foam as shown in the illustration. Be sure to remove only the middle two inches of foam. Clear the FILM TRAY of all foam debris resulting from the cuts.

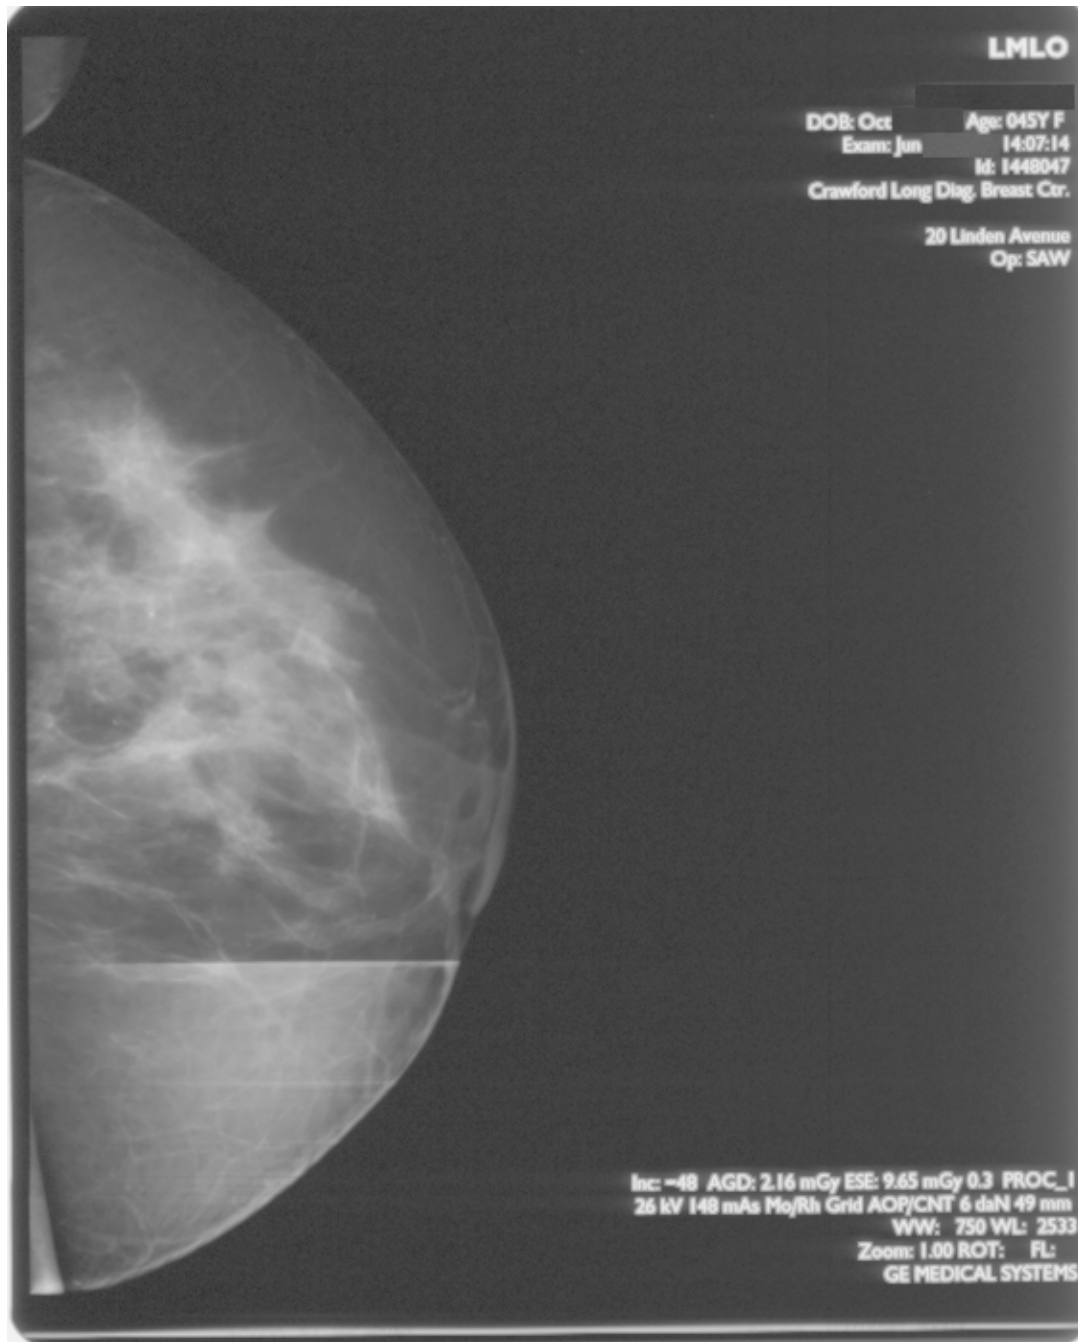
However, a defective MOTOR CONTROL BOARD may also cause a faded image artifact. The following images show examples of the types of artifacts that can be caused by a defective MOTOR CONTROL BOARD.

Abrupt Density Change in Image - MOTOR CONTROL BOARD

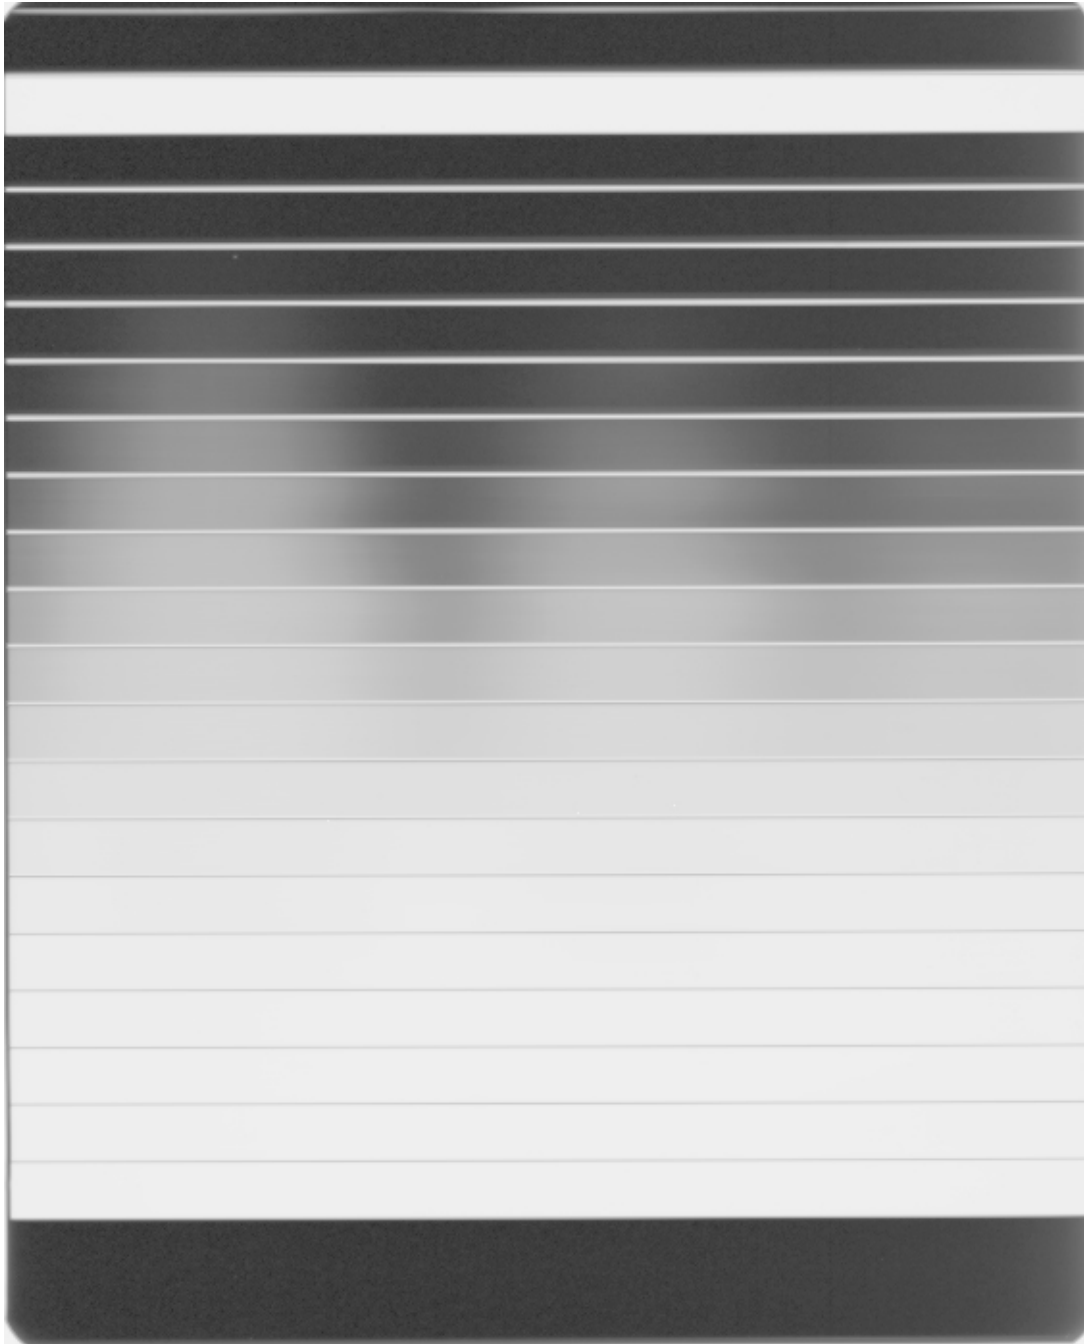
Faded Areas, May Fail Film Calibration - MOTOR CONTROL BOARD

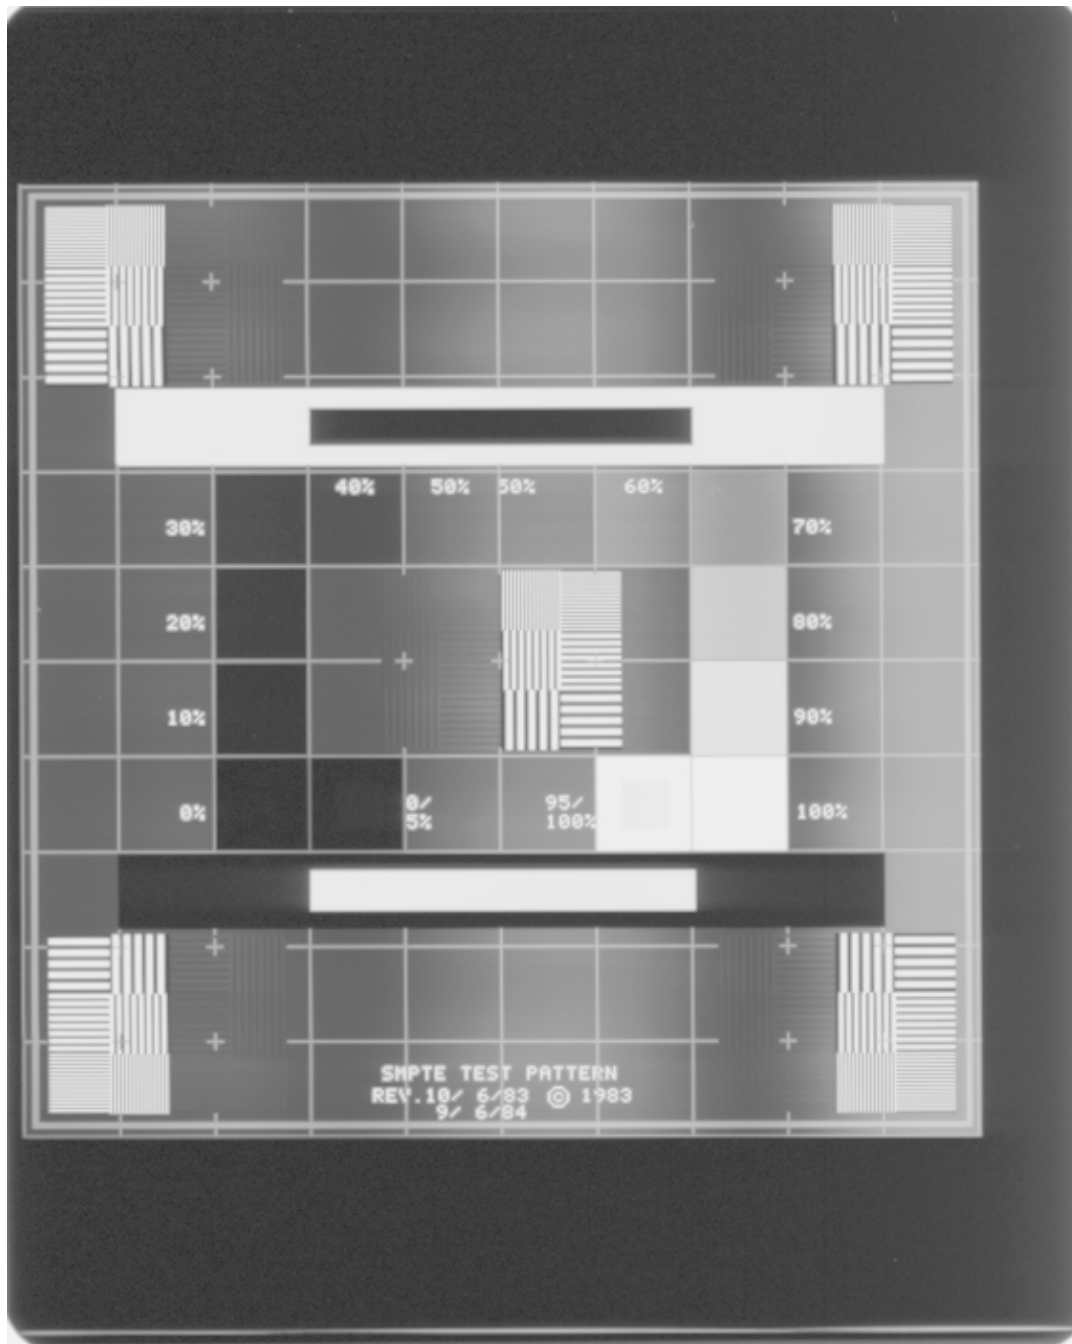
Faded Mid Tone Areas of Image Only - MOTOR CONTROL BOARD

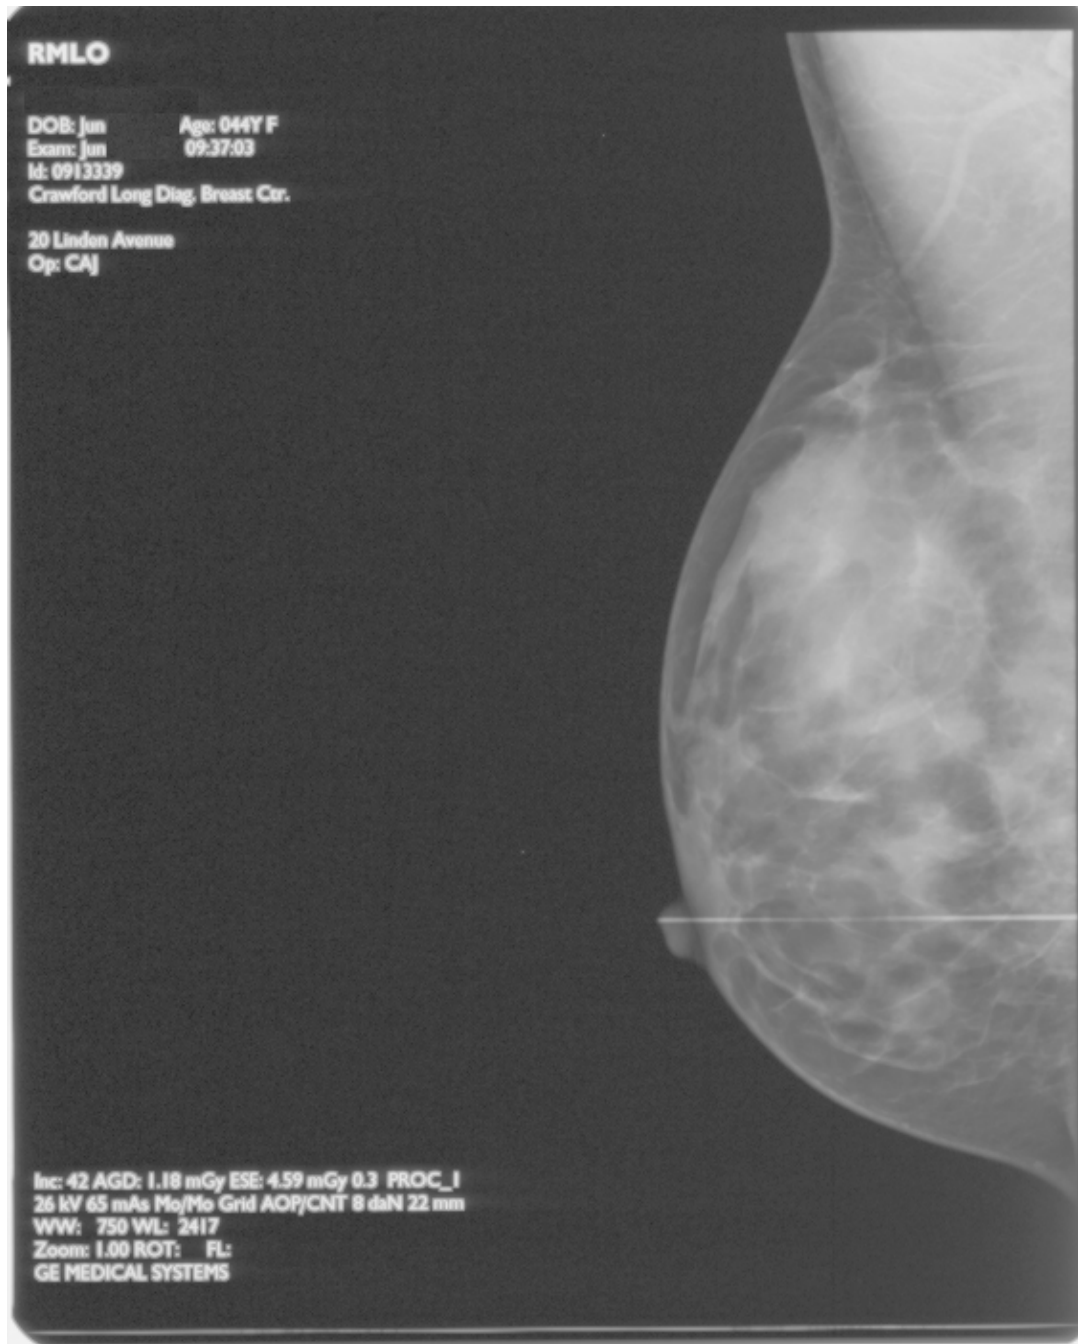
Horizontal Line in Image Area Only - MOTOR CONTROL BOARD

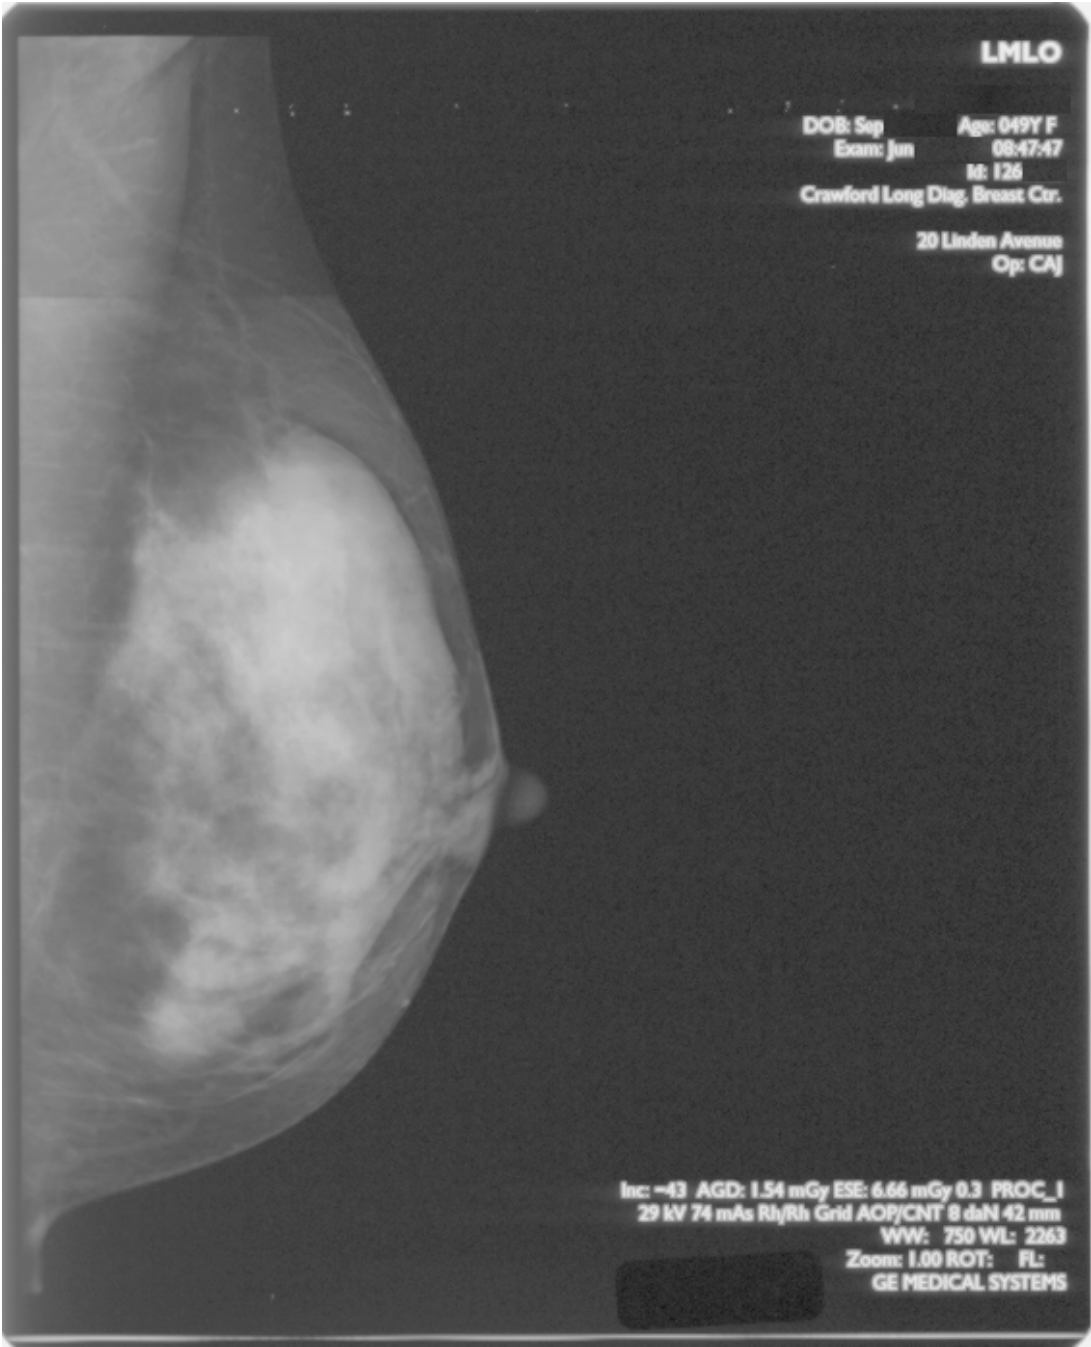
Horizontal Line in Image With Density Change - MOTOR CONTROL BOARD

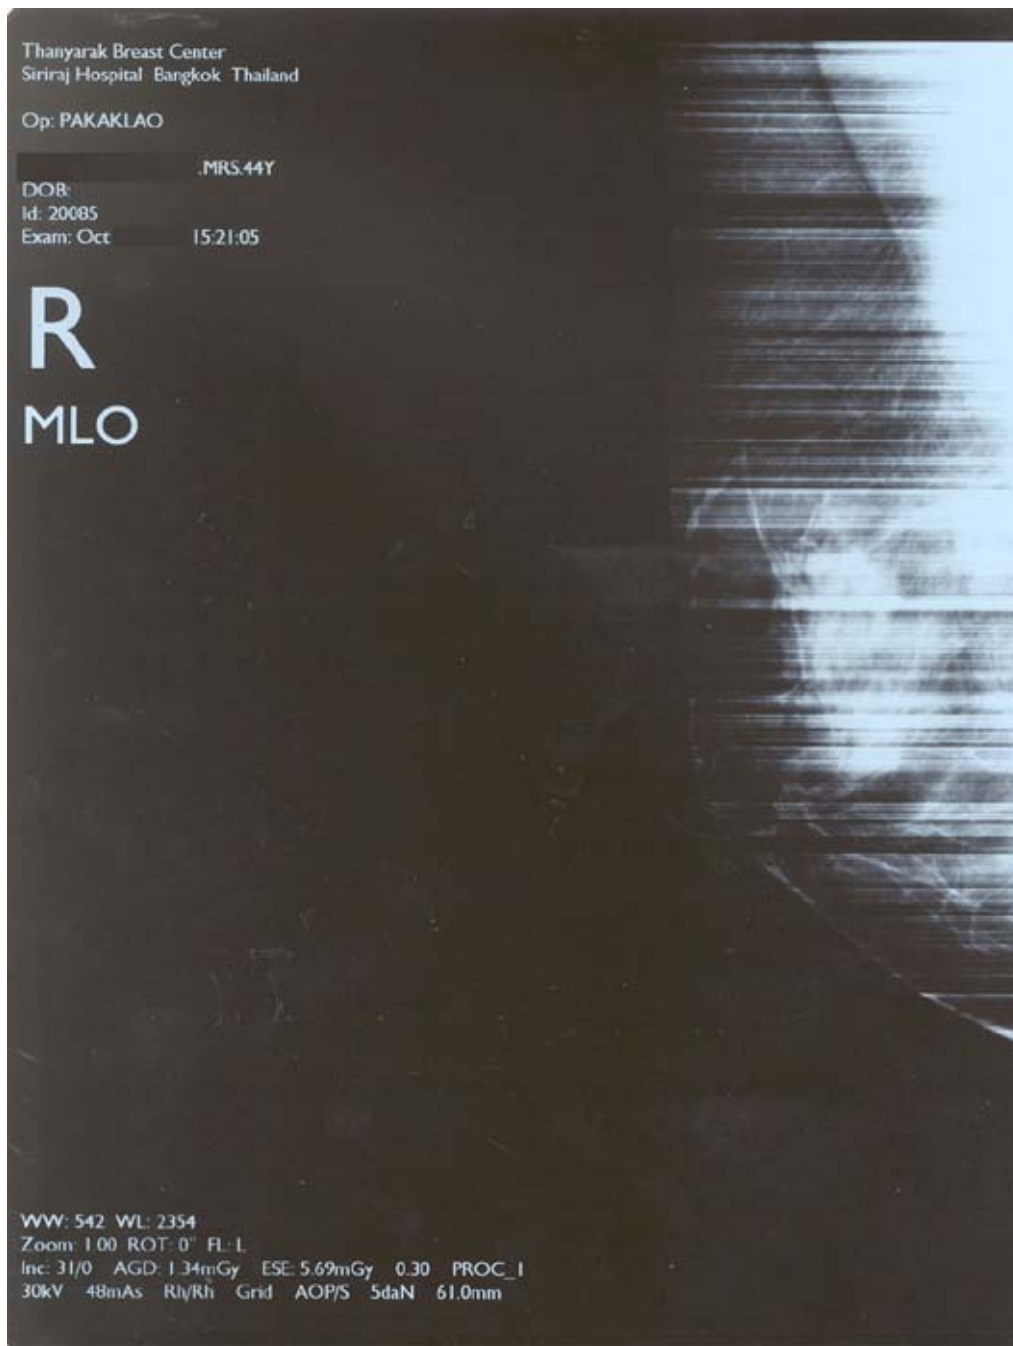
Horizontal Streaks in All of Image - MOTOR CONTROL BOARD

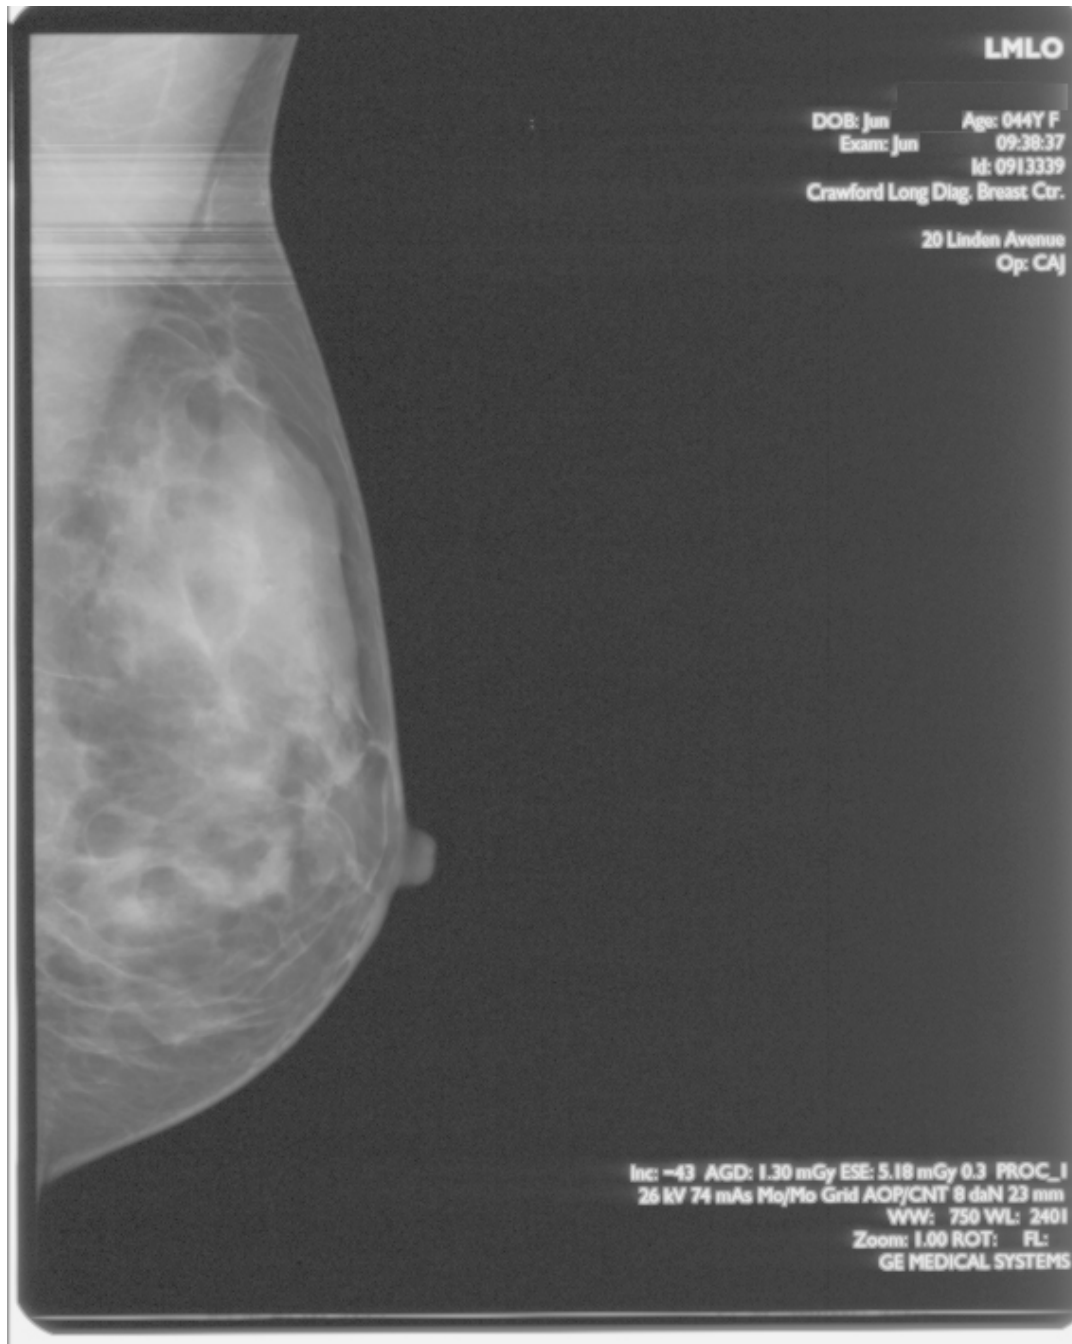
Missing Scan Lines in Image Only - MOTOR CONTROL BOARD

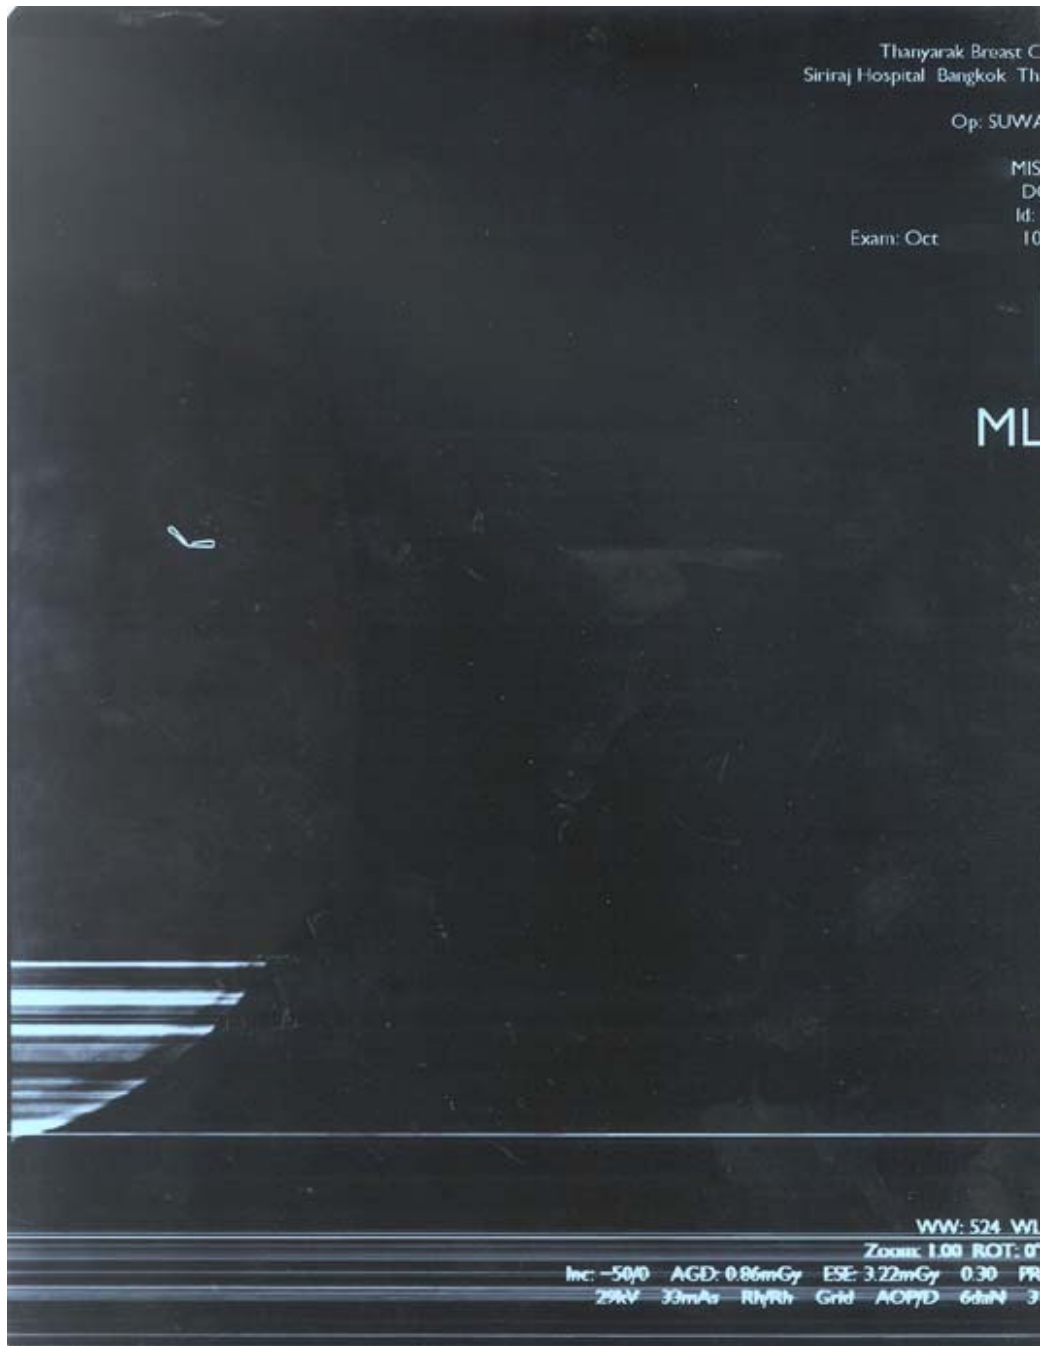
Torn Streaks in Part of Image Data - MOTOR CONTROL BOARD
