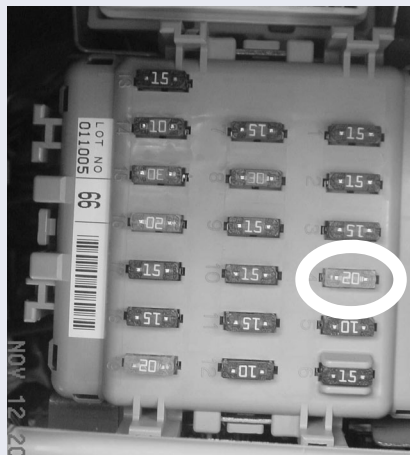
harness for the power mirrors may have been routed incorrectly within the mirror housing. This routing may cause the harness to rub, and eventually pinch against the door gusset mounting screw. Once the harness is pinched the insulation is cut and eventually blows the fuse.

Currently only the RH mirror is causing the problem but, it can be assumed that the LH mirror may cause the same concern.

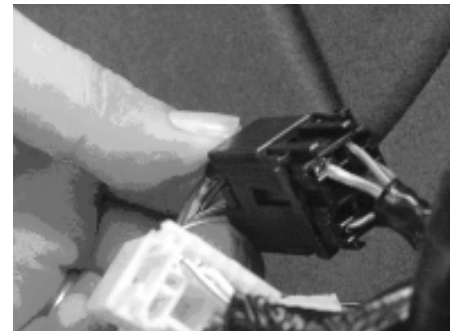
The symptom is the rear wiper will not complete its cycle when the switch is turned to the "OFF" position. The wiper stops immediately, regardless of its position on the glass. The cause, as you can see in the attached photo, is either a pulled wire from the connector, or in one other case the pin was pushed out of the connector. This connector is located in the lower RH "D" pillar, and can be accessed at the same location as the rear combination light.

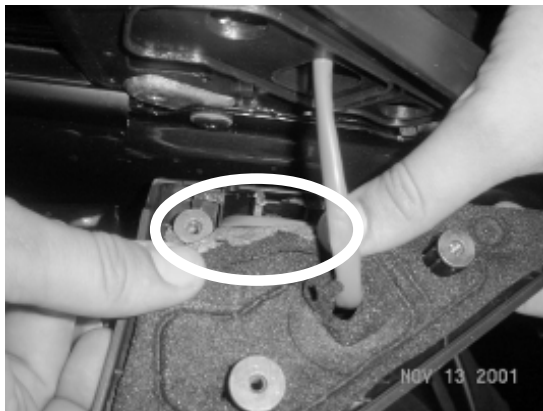
*Left: Area where the mirror harness becomes unseated.*

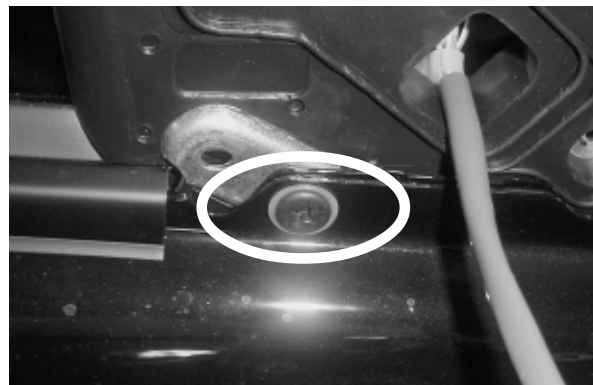
*Below: The Gusset screw that causes the circuit to short out.*
