Service Bulletin

SAFETY RECALL

2001-2002 GL1800/A

Frame Weld Inspection

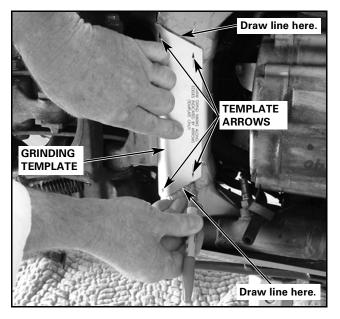
- Clean the frame crossmember with acetone and place the **grinding template** (S0512) on the crossmember as shown below.
- 10. Using a suitable felt marker, draw a 30 mm line on both crossmember welds. Use the edge of the template as a rule and draw the lines between the two sets of arrows as shown in the illustration. Remove the grinding template.

11. Inspect both Left and Right welds for any cracks. If you do not find any cracks, proceed to step 12 below. If you find a crack, make a new mark on the weld that has the crack, drawing the line along the entire edge of the the template (this new line will be 89 mm long).

If the crack falls within the length (89 mm) of this line, prepare the motorcycle for welding per the Dealer Procedures and advise the welder to use the Cracked Weld Repair Manual (S0515). After the bike has returned from the welder, prepare the frame and re-assemble the motorcycle per the Dealer Procedures. Then, proceed to the IDENTIFICATION section of this Service Bulletin.

If the crack exceeds the length (89 mm) of this line, call TechLine at (800) 421-1900 for further instructions.

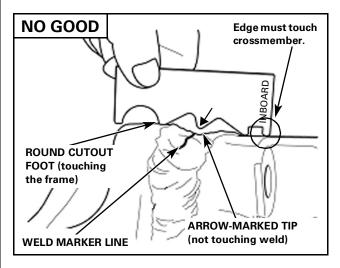
If the arrow-marked tip touches the weld bead peaks along the entire length of the marker line, the welds are GOOD. Raise the motorcycle and reinstall all removed parts in the reverse order of removal. Proceed to the IDENTIFICATION section of this Service Bulletin.

If the arrow-marked tip DOES NOT touch the weld bead peaks along the entire length of the marker line, the welds are NO GOOD (see the NO GOOD illustration).

If your inspection indicates a NO GOOD weld on either side, you must weld **both** sides. Proceed to the REPAIR PROCEDURE section of this Service Bulletin.
