1(4) SB1204

TOPIC: OVER TENSIONING OF INLET MANIFOLD FASTENERS

LEADING TO GASKET FAILURE

APPLICABLE TO: ALL SANDVIK CAT C7 ACERT EXPLOSION PROTECTED

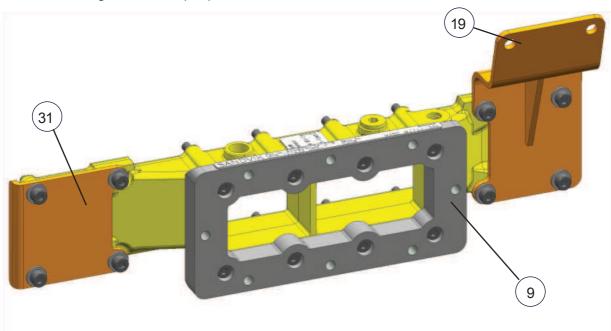
1. Please note the installation of the additional support bracket (31) on the HUEI pump end of the inlet manifold (see image). When installing, make sure the fuel filter bracket (19), inlet manifold adaptor plate (9) and the new longer 40mm SHCS for the ends are in place before commencing the bolt torque procedure.
