**HONDA ServiceNews**

ASN 19750 (9807)

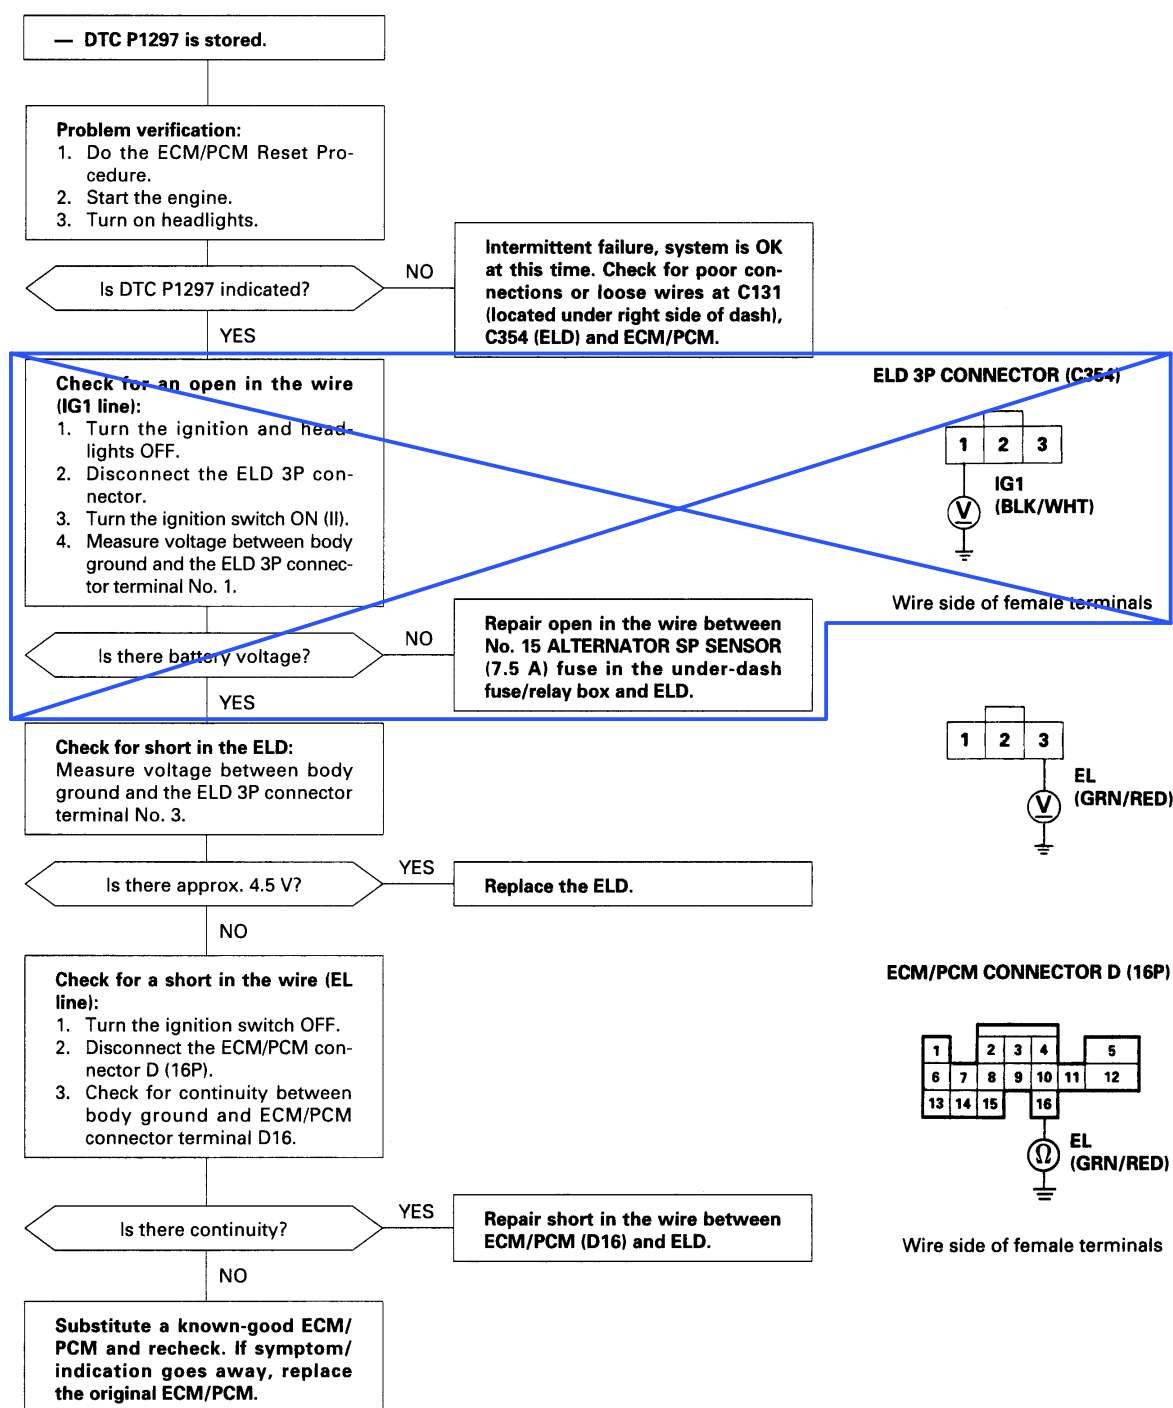
Page 11-115, DTC P1297:

Until the '96-99 Civic S/M is available, here are two corrections you need to make if you're using the '96-98 Civic S/M to diagnose DTC P1297, electrical load detector circuit low input, or DTC P1298, electrical load detector circuit high input (low or high voltage problems in the ELD circuit).

**P1297** The scan tool indicates Diagnostic Trouble Code (DTC) P1297: A low voltage problem in the Electrical Load Detector (ELD) circuit.

*Delete the info in the middle of the troubleshooting chart.*

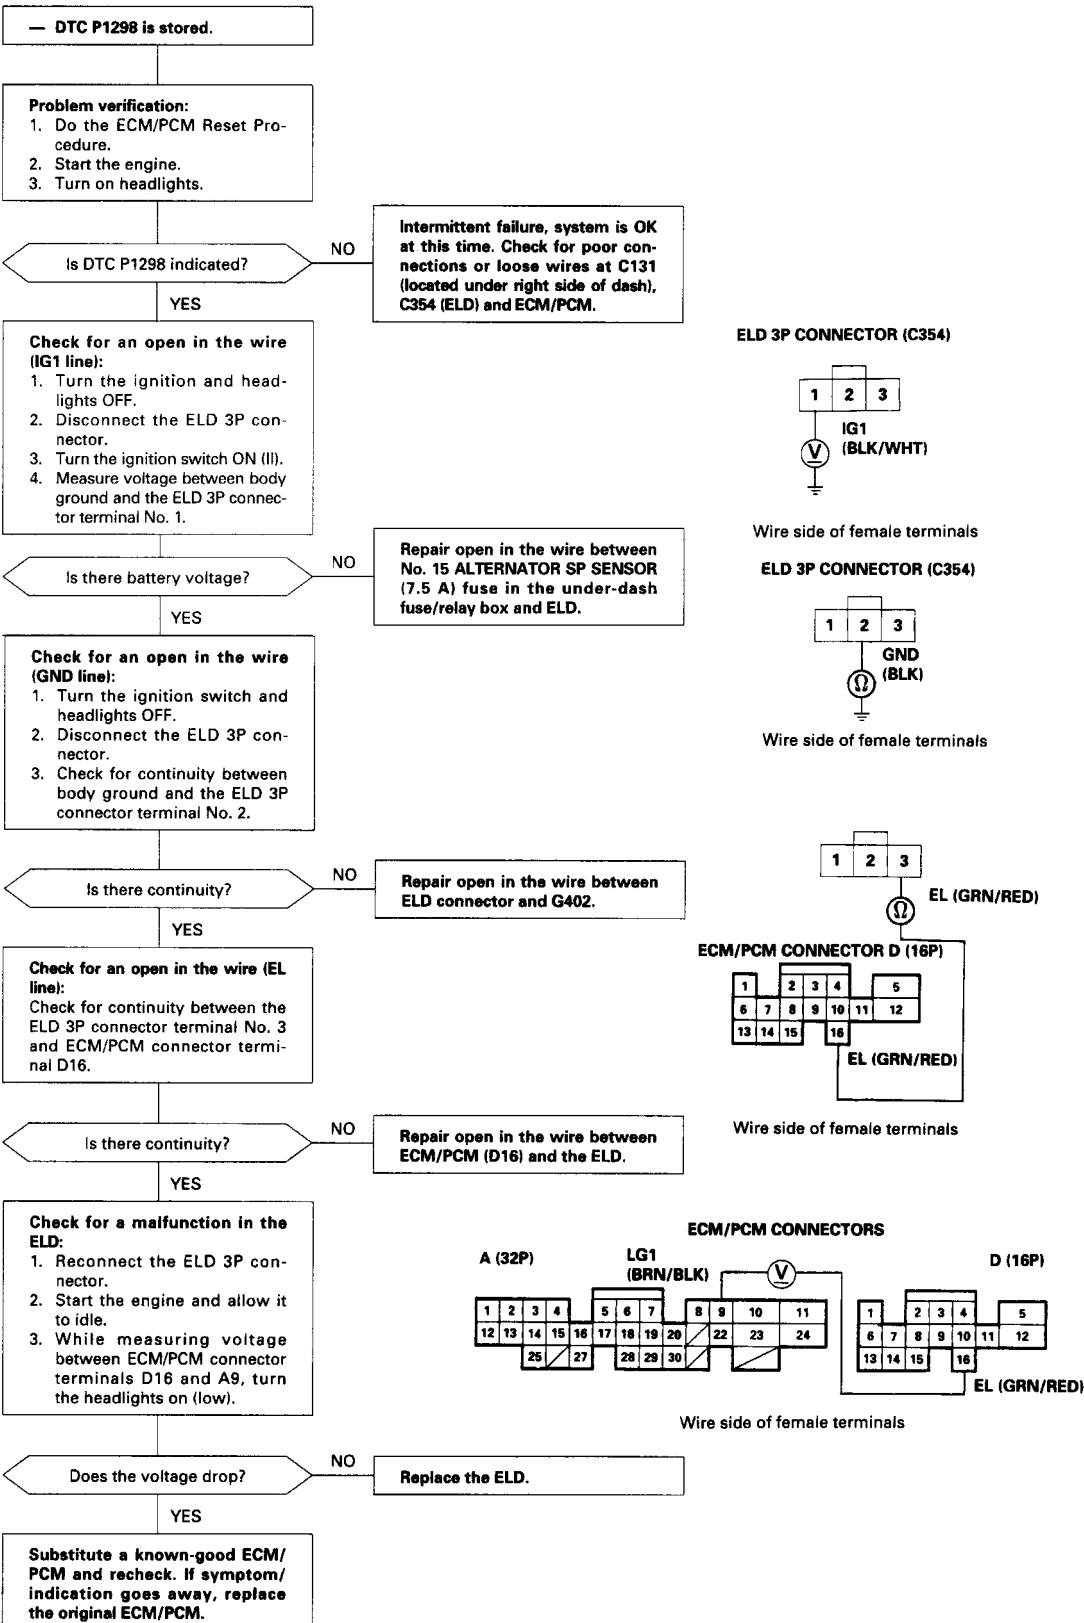
## Page 11-116, DTC P1298:

**P1298** The scan tool indicates Diagnostic Trouble Code (DTC) P1298: A high voltage problem in the Electrical Load Detector (ELD) circuit.

*Cross out the info on the entire page, and insert this correction page in front of it.*

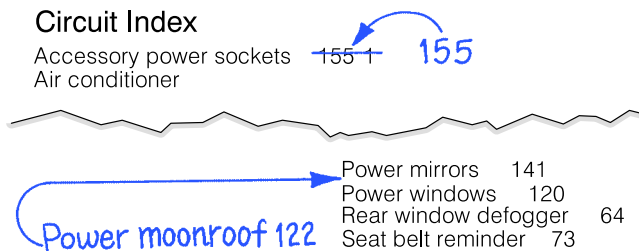
Here are two corrections for the '98 Passport ETM index. Make them on the indexes in front of the book, and on the back cover.

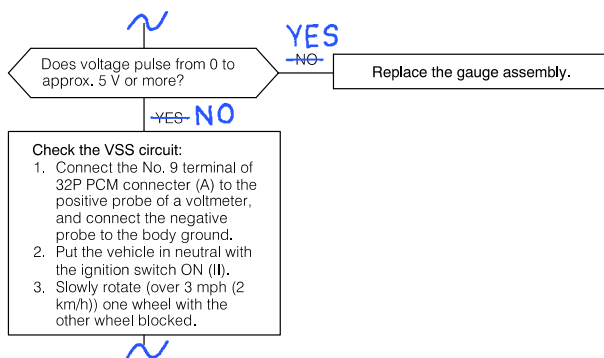
On page 23-118 of the '98 Odyssey S/M, one of the "Yes" "No" responses in the VSS troubleshooting chart is reversed. Correct your S/M like this:

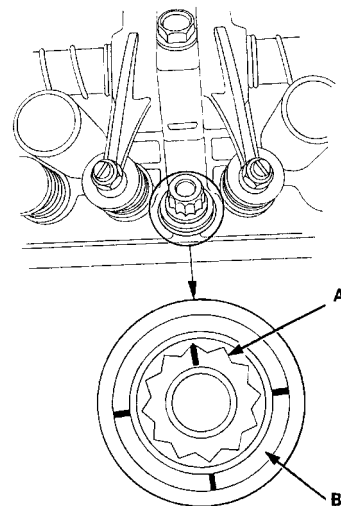
If you've ever torqued cylinder head bolts on a '98 Accord, you may have found the procedure on page 6-53 of the S/M to be a little confusing. Until we revise the procedure in the '98-99 Accord S/M, cross out steps 2, 3, and 4, and use these revised steps instead. (Or you could copy this page of S/N, cut out the steps, and tape them onto page 6-53.)

1. Make one mark on each bolt head (A) and three more at 90° intervals on the cylinder head boss (B) as shown.

2. Tighten each cylinder head bolt 90° (a quarter turn) in numbered sequence, then tighten them another 90° in sequence.
3. If you're using new bolts, tighten them an additional 90° in sequence.
