ALERT SERVICE BULLETIN

ASB221E

INSPECTION OF MODEL 1A103/TCM PROPELLER HUB FOR CRACKING AND REWORK PROCEDURES

1A103/TCM (All Serial Numbers)

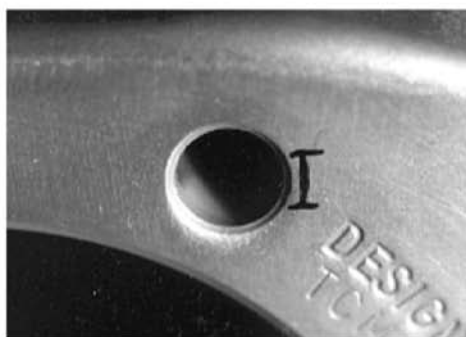
Figure 1. Crack Identification

McCauley has received reports of cracks in the 1A103/TCM model propeller hub. Cracks have been found on the camber side of the propeller hub near the mounting bolt holes. These crack(s) have been observed primarily in areas where fretting is present around propeller mounting bolt holes.

- (3) If you find a small crack(s) on the camber (forward) side of the hub (near the bolt holes) that meet the following criteria, the propeller can be reworked and the crack(s) must be removed. Refer to Figure 1 and Figure 11.

- (a) All of the following criteria must be met in order for the propeller to be eligible for rework:
 - 1 Crack(s) in the camber (forward) side of the hub are less than 0.50 inch (13 mm) long.
 - 2 Crack(s) in the camber (forward) side of the hub do not touch a bolt hole.
 - 3 No part of the camber (forward) side of the hub crack is within 0.25 inch (6.4 mm) of the outside edge of the hub.
 - 4 No part of the camber (forward) side of the hub crack is within 0.25 inch (6.4 mm) of the outside edge of the center bore.
 - 5 If the propeller has previously been reworked, the crack is located adjacent to a different bolt hole than one that has previously been reworked.

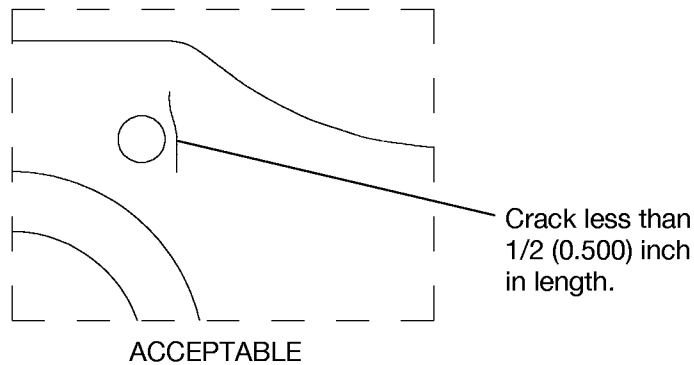
All cracks shorter than 1/2 (0.500) inch, that do not contact a bolt hole, and are more than 1/4 (0.250) inch from hub edge and hub centerbore is acceptable. **Propeller may be reworked.**

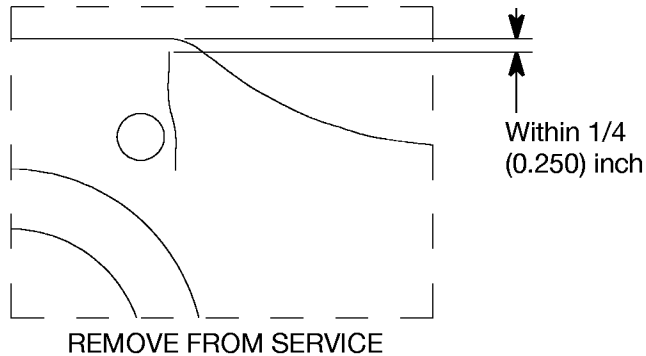
Any crack longer than 1/2 (0.500) inch, that contacts a bolt hole, is less than 1/4 (0.250) inch from hub edge, or is located in area of previous rework is unacceptable.

Remove unrepairable propeller from service.

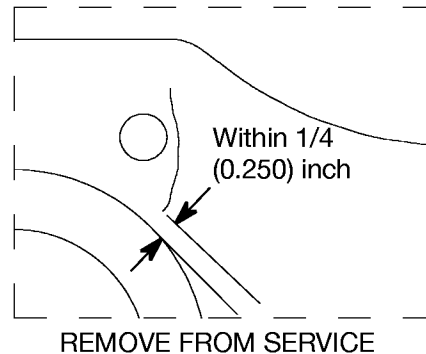
Figure 11. Reworkable and Non-Reworkable Cracks (Sheet 1)

- (a) Crack(s) in the camber (forward) side of the hub are 0.50 inch (13 mm) or longer.
- (b) Crack(s) in the camber (forward) side of the hub touch a bolt hole.
- (c) Any crack on the camber (forward) side of the hub that is within 0.25 inch (6.4 mm) of the outside edge of the hub.
- (d) Any crack on the camber (forward) side of the hub that is within 0.25 inch (6.4 mm) of the outside edge of the center bore.
- (e) A crack in any part of a propeller bolt hole (including the chamfered surfaces and any depth).

Any crack longer than 1/2 (0.500) inch, that contacts a bolt hole, is less than 1/4 (0.250) inch from hub centerbore, or is located in area of previous rework is unacceptable.

- (2) If you find any of the of the following conditions, the propeller must be removed from service (Refer to Figure 11.):

Remove unrepairable propeller from service.
