Dental-Information

Sirona Dental Systems · Fabrikstrasse 31 · D-64625 Bensheim

June 2002

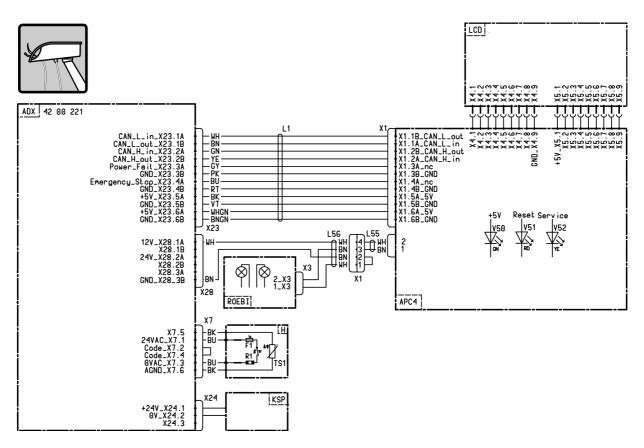
Incorrect

Sheet 2A of the **wiring diagrams for the C4⁺, REF. 59 02 981** shows an incorrect wiring layout for the X-ray viewer attached to the dentist's element. The correct layout is shown on the following page. The wiring diagrams supplied together with the treatment centres will be corrected as soon as possible.
