Technical Update

PH,TR,11033 – 6/2006

Equipment Type: Phoenix® Dialysis System

Subject: Troubleshooting Boot-Up Problems:
“Rx MGMT Key Only”

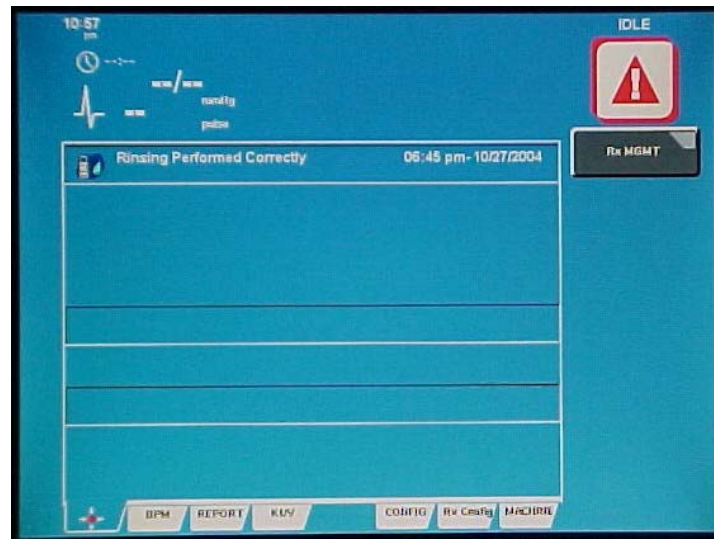
After completing boot-up, the IDLE screen has only the Rx MGMT Action Key with the red Alarm Pictogram above it. The Navigation Tabs are unresponsive to touch. Typically, there are no other visual or audible alarms. **See Fig. 1 below.**

The Phoenix has booted-up in a condition where the Carrier (Main) CCA (circuit card assembly) and program are not communicating with one or more of the Slave CCA's. In this condition, the main program halts (locks-up) and softkeys and keypads become unresponsive. Conditions that can result in these symptoms are:

1. **Poorly seated Slave or Carrier CCA** - Data bus lines are physically interrupted, preventing data from entering or leaving the Slave or Main CCA data bus.
2. **Defective Slave or Carrier CCA** - Slave or Carrier CCA is unable to communicate correctly on the data bus.
3. **Low 5 volt power supply** - Data communication is dependent on 5V pulses. If the 5V power supply voltage falls too low, data can become corrupted or lost causing the main program to generate communication alarms or to halt (lock-up) completely.
4. **Defective Power Supply** – A faulty alarm signal from the power supply can disable normal communications from the slave and Main CCA's.
5. **Defective Compact Flash** – A faulty compact flash, or one with corrupted data files, can interfere with normal communication between slave CCA's.

1. With the main power OFF, reseal all CCA's correctly in the card cage and turn the main power ON.
2. If present, check that the +5VB/+5VD Jumper (6977953) is correctly installed.

3. With the main power ON, identify the communication LED's on each card cage CCA and observe that they are flashing normally. **See Fig. 2 below.** If necessary, compare the LED's with another Phoenix machine that is in IDLE and that is functioning normally. Replace any CCA whose communication LED is not flashing correctly. **(Note: If the Protective and Carrier CCA are the only boards where the communication LEDs are flashing, measure the voltage at J2-1 (PWFAIL) on the Phoenix motherboard. Normal voltage is TTL High (2.7V-5.0V). If the voltage is TTL Low then only the Protective and Carrier CCA communication LEDs will flash, but at a rate slower than normal. Confirm the same measurement at the power supply by disconnecting power supply connector J6 and measuring pin 1. If the voltage is still TTL Low, then replace the power supply.)**

4. Measure and verify that the 5V power supply voltages are within the specifications indicated in Phoenix Service Manual: Maintenance, Section 8 – Calibrations, Power Supply Verifications (4.9V – 5.3V). **(Note: If the voltage falls much below 4.95V, random communication errors may begin to be observed.)** If the voltage is $\leq 4.95V$:

5. Replace the Compact Flash and confirm that the Rx MGMT, SETUP, and ADR keys are present after reboot. If only the SETUP key is not present, do an ADR Rinse and confirm that the SETUP key returns.
