M9040 mfp
M9050 mfp
LJ 9040 mfp
LJ 9050 mfp
LJ 9040
LJ 9050

Tray 4 Paper Jams

13.11.05 jam in input accessory
13.11.XX jam in input accessory

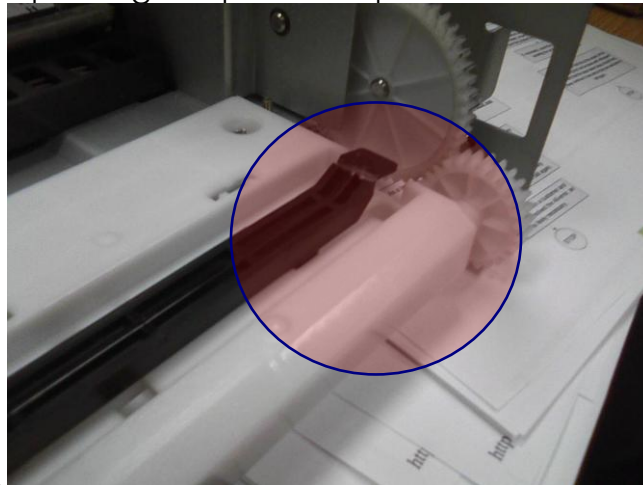
When closing tray 4, there is a black plastic tab on the paper pick roller lowering arm, if this tab is broken off, the pickup rollers will not lower onto the paper stack. 13.11.05 Jam in input accessory will appear in the control panel. It can also be associated with Jam errors 13.11.XX

If the tab is broken or bent backwards, replace the paper pick up assembly only, the Part number is RG5-6208-180CN. The part can be seen by removing tray 4 and visually inspecting the part. The picture below shows the tab, it is

cracked and bent.

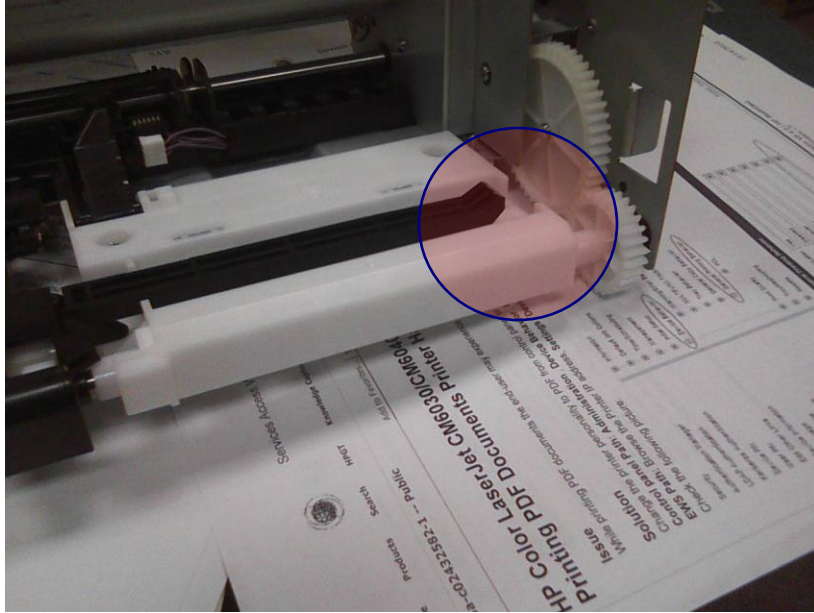
The tab is broken on this paper pick assembly above.

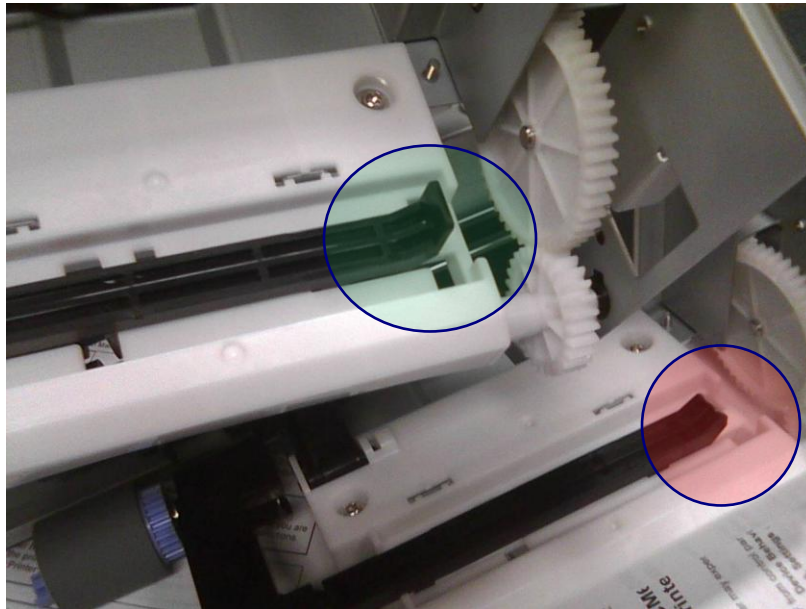
The above picture shows a good and bad Paper pick assembly. The tab is not broken off on the top unit (Green shade), and is broken off in the bottom unit (red shaded).

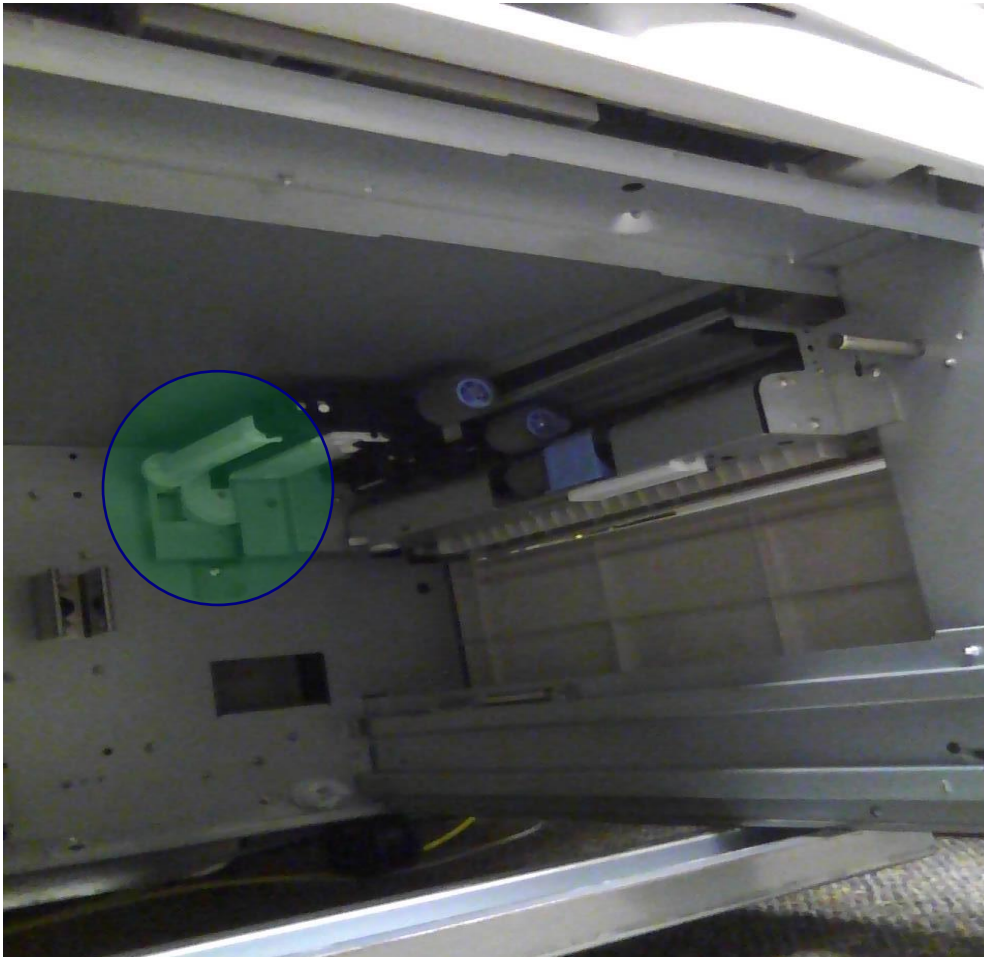
approximately 5 ½ inches from the back of the tray and 1 inch from the bottom. The right switch is not viewable if there is paper in the tray. The Assembly is in the upper right corner of the tray 4 cavity. Below is a picture of a good (tab not broken) assembly. If the tab is bent or broken you will be able to see more of the white round gear behind it. It is easier to see with a flash light.

To remove tray 4, take all of the paper out of the tray, then remove the tray by holding open both of the blue switches on each side of the tray and pulling the tray out. The switches are located on the inside of each metal support wall
