Reprogramming File Availability for Oil Level Detection

2013-2014 Legacy and Outback 2.5L Models

11-145-14R

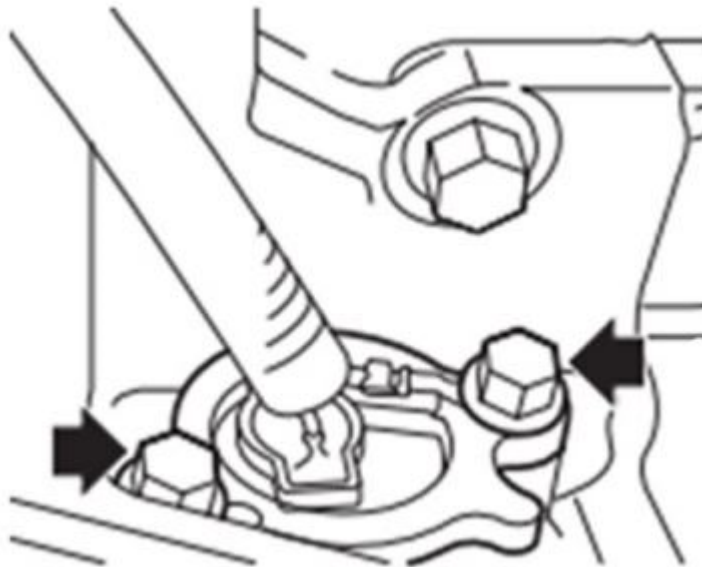
Oil Level Switch

Availability of reprogramming files and a revised oil level switch to optimize the ECM logic for engine oil level detection in the event of false or premature low engine oil level warning lamp illumination.

Step 3 – Once the ECM reprogramming has been completed and the oil level switch wiring has been confirmed to be OK, proceed with replacing the oil level switch assembly shown in the illustration below following the procedure outlined in the applicable Service Manual.

Torque the 2 retaining bolts to 6.4 Nm (56 inch-pounds).Torque the 2 retaining bolts to 6.4 Nm (56 inch-pounds).
