SERVICE BULLETIN

APPLICABILITY: 2013MY Legacy and Outback 2.5L Models
 2012-13MY Impreza 2.0L Models
 2013MY XV Crosstrek
 2011-2014MY Forester NA Models Only
 2013MY BRZ

NUMBER: 11-130-13
DATE: 04/05/13

SUBJECT: Difficulty Starting, Rough Idle, Cam Position or Misfire DTCs
 P0340, P0341, P0345, P0346, P0365, P0366, P0390, P0391,
 P0301, P0302, P0303 or P0304

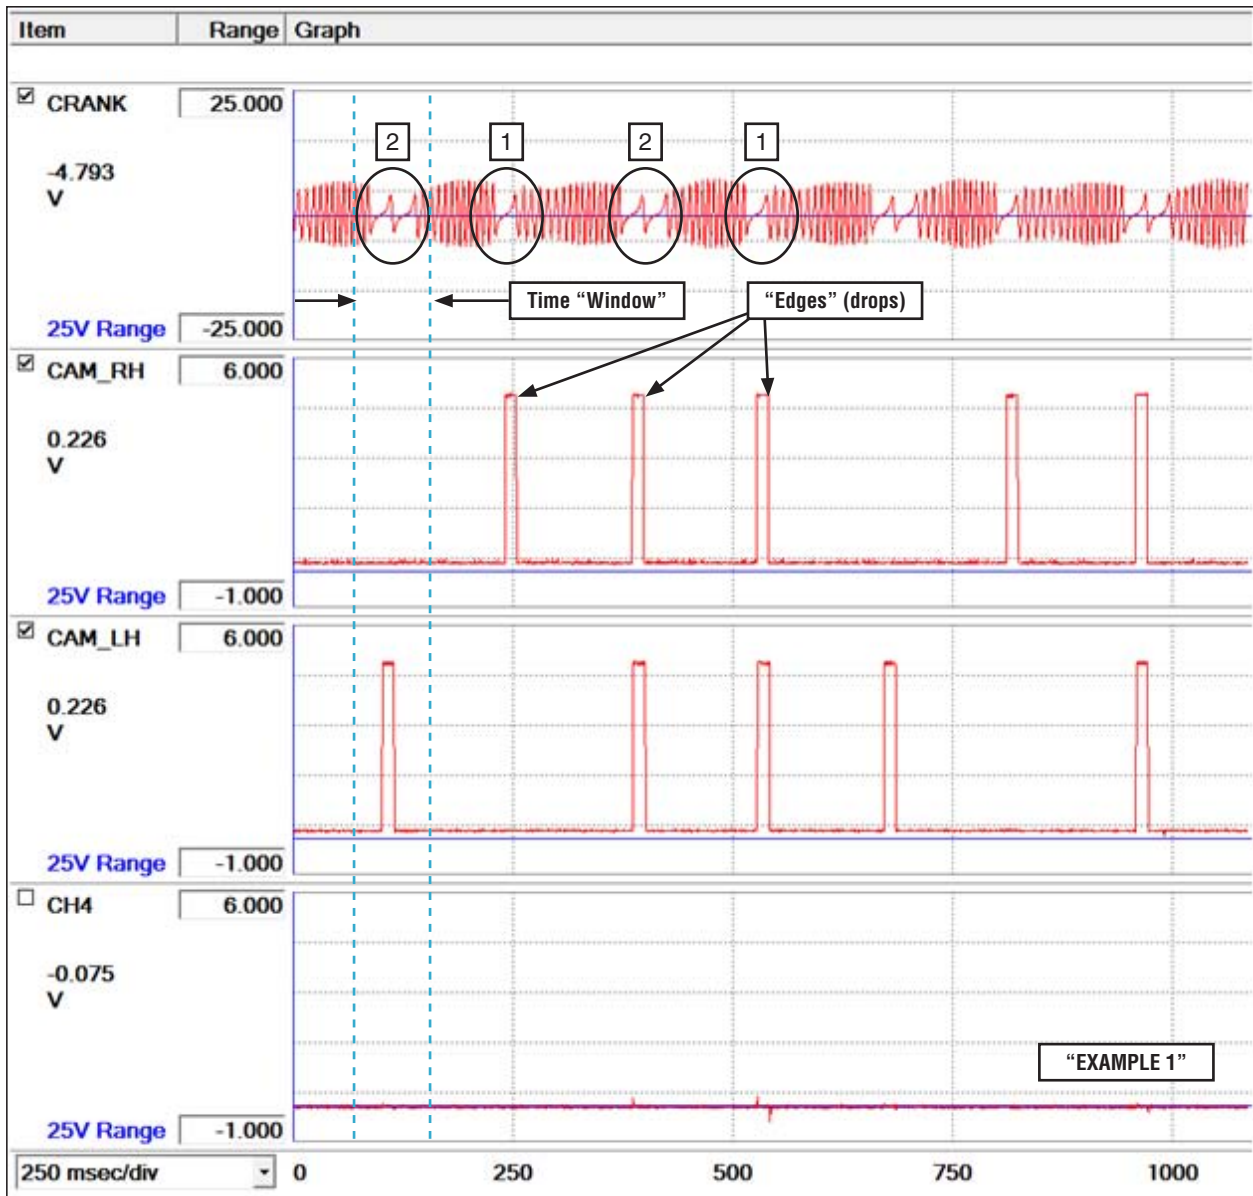
Using the chart above and comparing it to **Example 1**, it can be determined the first cylinder shown in the screen shot is #3 because the crank signal is a "2" and there is an edge signal within the window on the LH but not the RH cam sensor. Next cylinder in the firing order would be #2 as the crank position signal is a "1" and there is an edge signal in the window for the RH but not for the LH, and so on...

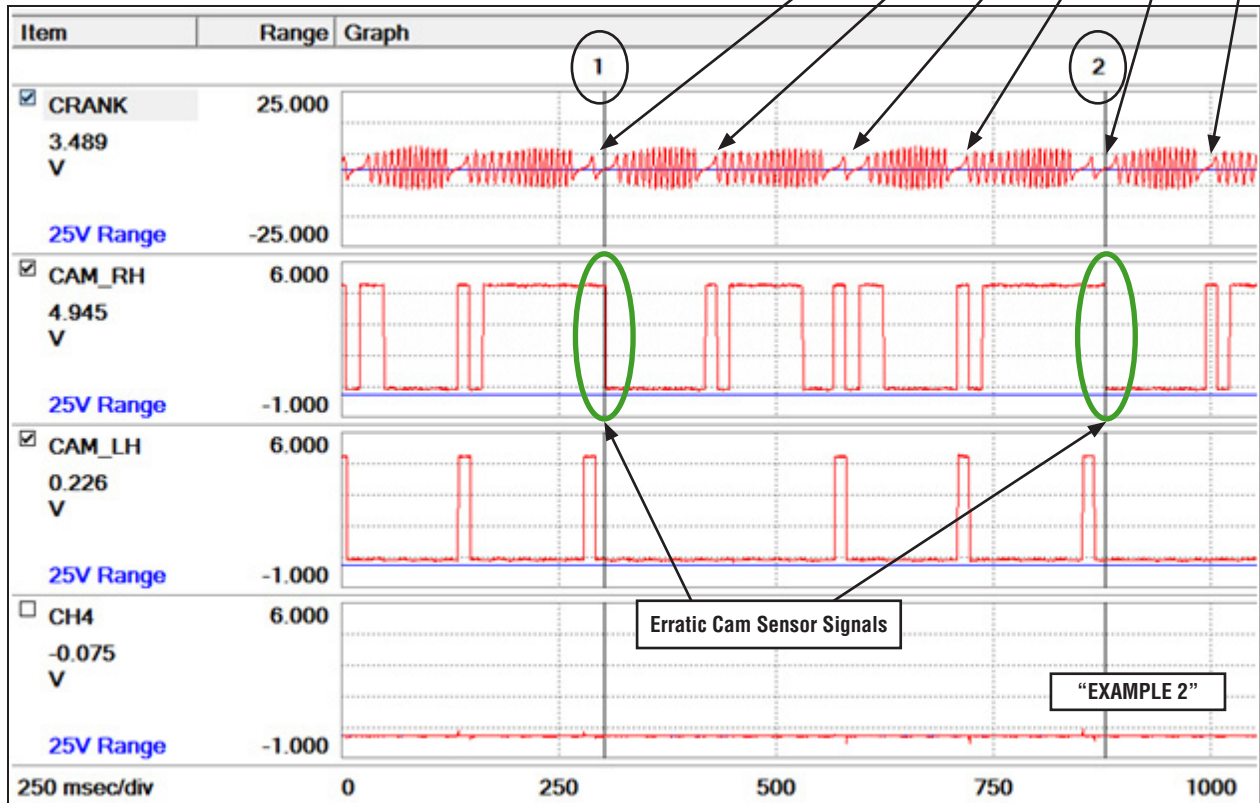
Example 2 below shows a “Bad” pattern for the RH cam sensor. Marks #1 and #2 show what appears to be #4 cylinder firing but, the next cylinder to fire according to the screen shot is #2 followed by #4 then #1. The pattern for the RH sensor never shows the proper sequence to fire #3 cylinder. In this case, recheck the data again after installing a .2mm shim under the RH cam sensor.

Firing Order shown in screen shot: #4 #2 #4 #1 #4 #2

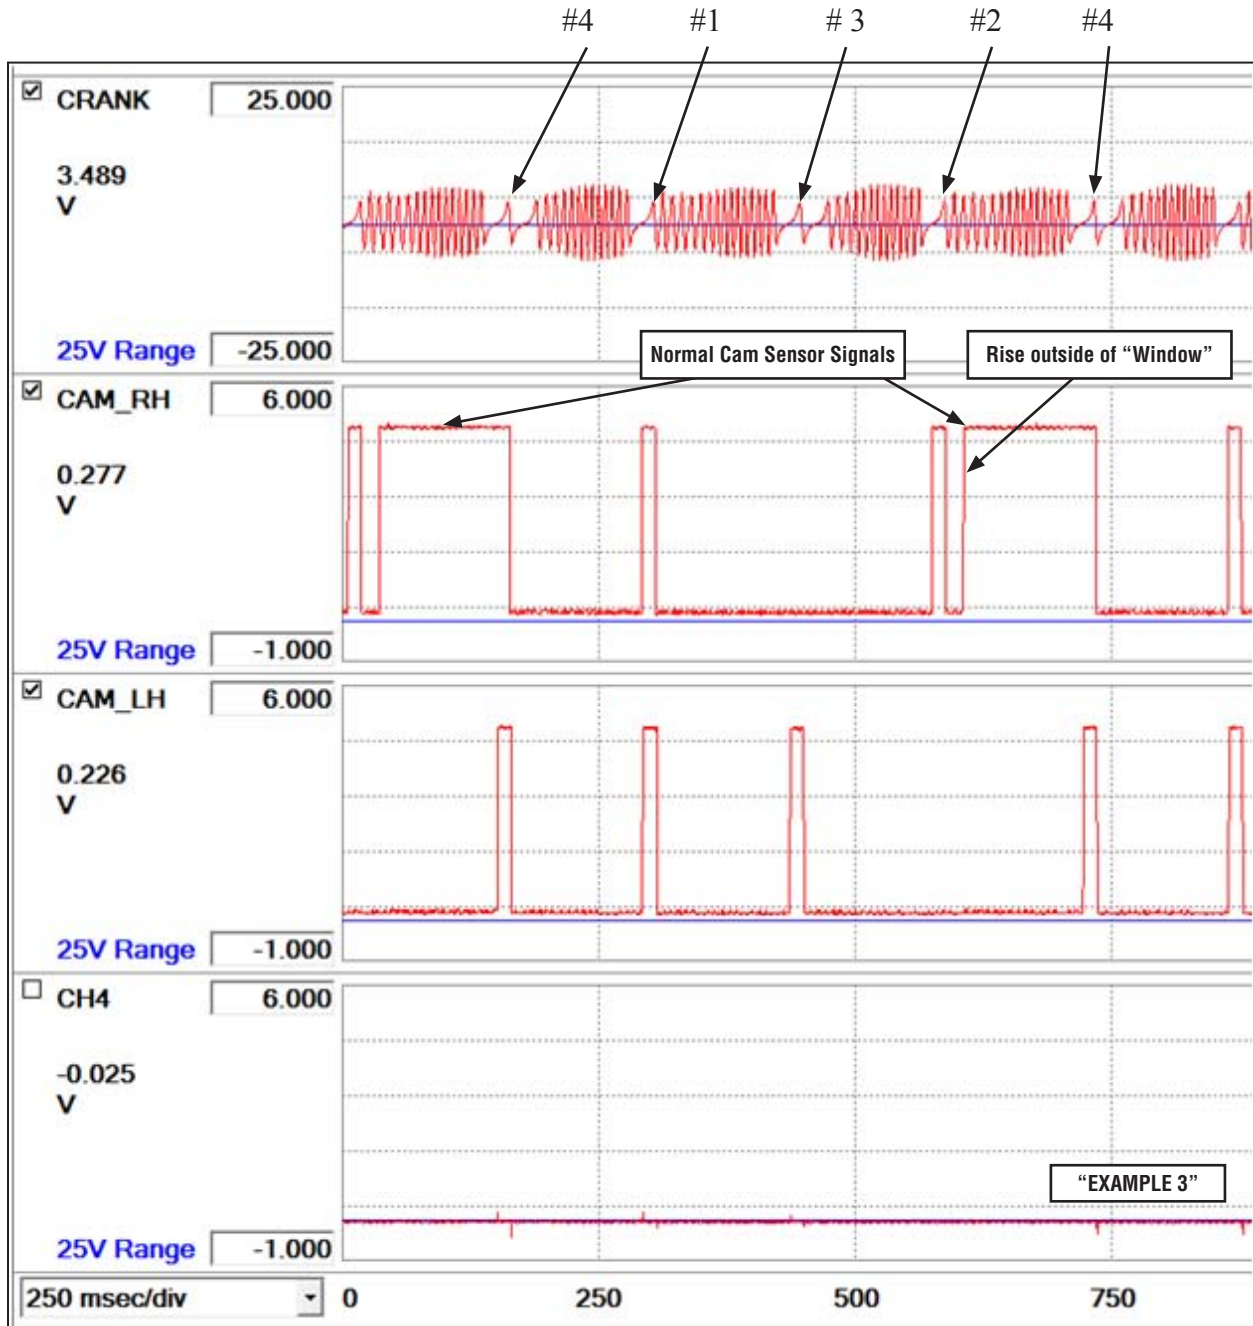
Example 3 shows what *appears* to be an erratic signal from the RH cam sensor but, you can see all the cam sensor data signal edges (drops) follow the chart and firing order as they are supposed to. Other signal edges (rises or drops) outside the “window” or a longer time line as shown here prior to the #4 signal edges seen on the RH cam sensor pattern are examples of signals which will be “ignored” by the ECM and are not a cause for concern.

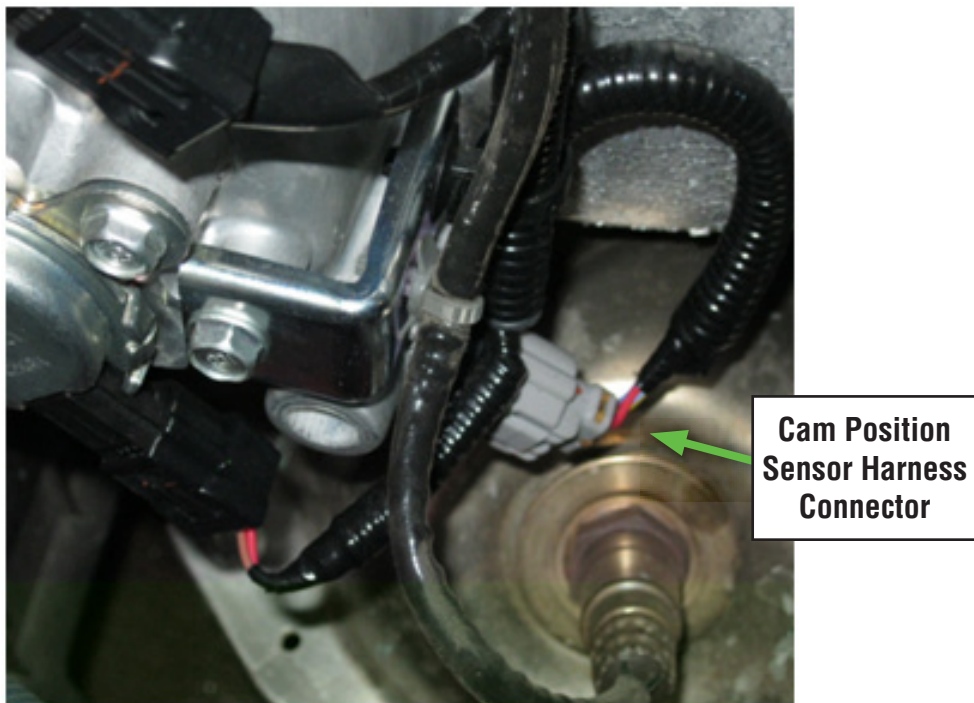
In the event you have a DTC stored for an exhaust camshaft position sensor, the repair procedure has been revised. Due to the position of the right-hand (Bank 1) sensor, measurement of the gap without removing the front catalyst is extremely difficult as shown in the photo below.

1. Confirm the irregular oscilloscope pattern for the corresponding DTC stored.
2. Remove the sensor from the timing cover and install a .2mm thick shim from the applicable kit.
3. Reinstall the sensor, torque the sensor retaining bolt to 6.4 Nm (4.7 ft. lbs. or 56.4 inch-pounds) then recheck the oscilloscope pattern.

If the pattern is normal, the repair is complete. If the irregular pattern persists, repeat Steps 2 and 3 after removing the .2mm shim and installing a .3 mm thick shim. **ONE SHIM ONLY, NO STACKING.** Repeat as necessary increasing the shim thickness .1 mm at a time until a normal scope pattern can be verified.
