ARTICLES CONTAINED IN THIS ISSUE

01 QMR OF THE MONTH

08 2015 MY LEGACY AND OUTBACK: JOURNEY TIME ALERT ON COMBINATION METER TELLTALE DISPLAY

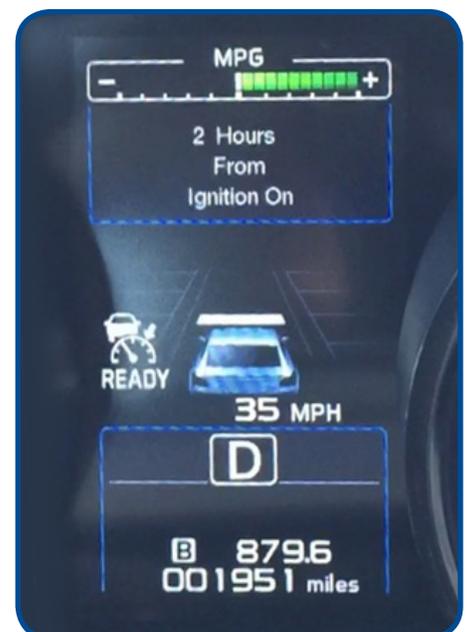
An added feature of the Combination Meter is an alert message (accompanied by a single “beep” sound) which will be displayed in the Telltale section above the odometer after 2 hours of driving have elapsed from ignition ON. The “beep” is the same sound heard when the low fuel lamp is first illuminated. This message is provided simply as a notification to make the driver aware they have been driving for 2 hours and it may be a good time to consider taking a break, checking fuel level, etc. Like other alerts shown on the Telltale display, it cannot be turned off or adjusted. This feature has been included on Subaru vehicles for several years, but unless the vehicle is driven for approximately 2 hours or more, many customers may have never experienced it.

Until the Owner's Manual is revised, information will be limited regarding this message.

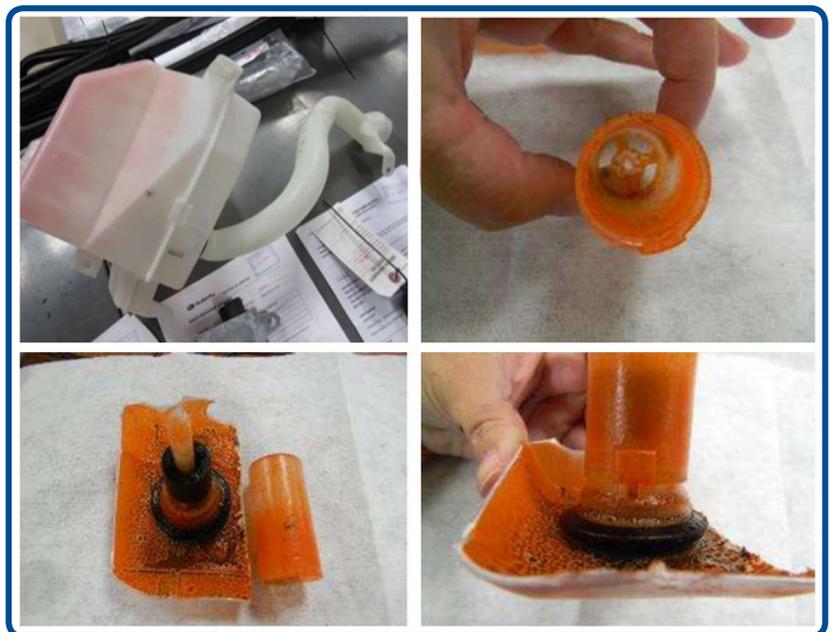
The Techline has received a limited number of inquiries regarding erratic illumination of the washer fluid level warning indicator lamp. An investigation involving parts collection along with a review of the corresponding repair order documentation was performed. The results concluded the root cause to be customer use of a popular, readily available water-dispersant windshield washer fluid / de-icer / bug remover which is orange in color. Fluid level sensors removed from the collected assemblies all showed an accumulation of an oily, orange-colored residue along with staining on the inside of the tanks. This residue was determined to be impeding proper operation of the sending unit float and switch components. Some photos of the collected parts with the residue are shown on the right. This type of damage is to be considered resultant from an outside influence and therefore not a matter for warranty.

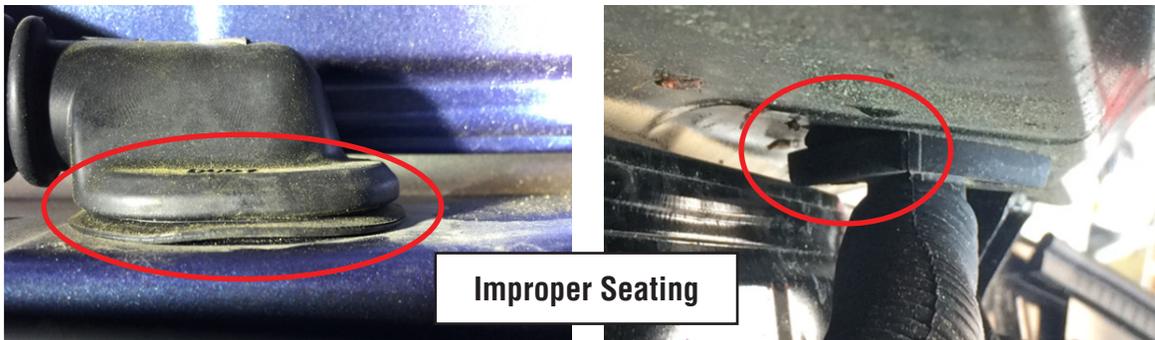
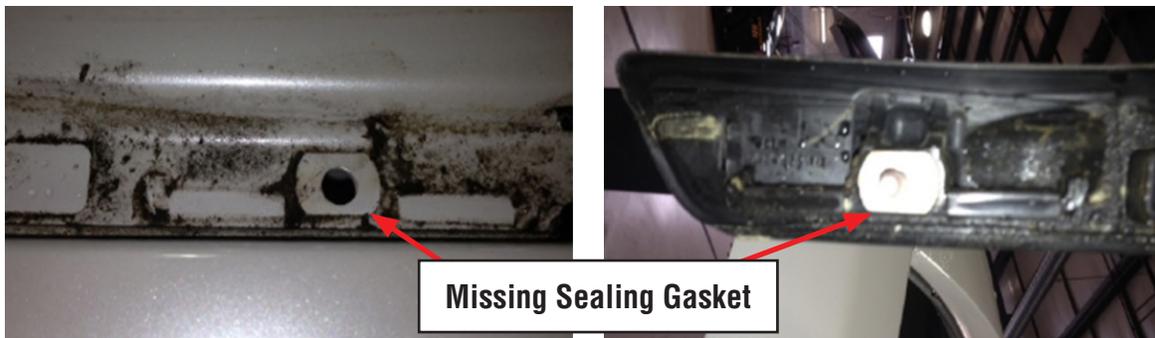
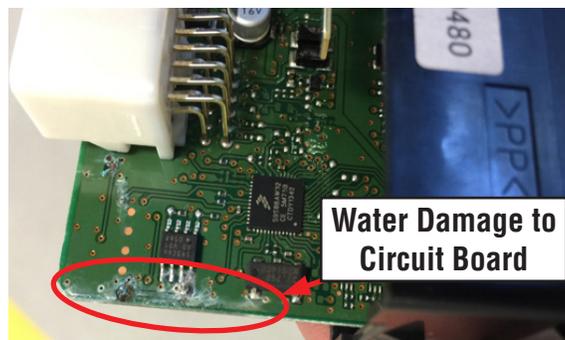
The Techline has received a number of calls regarding flashing TPMS warning lights. After initial diagnosis, if you are even able to communicate with the TPMS system, sometimes codes are stored, but most of the time there are none. If you encounter this condition, and for example, only 3 of 4 TPMS sensors are able to be registered, always check the TPMS control module for signs of water intrusion before replacing any parts. Also, always inspect the connectors and pins at the module carefully for corrosion if this condition is verified. Most cases have been traced back to the pass-through rubber harness cover / bellows between the body and the rear gate not being fully seated as shown in the photos below. The improper seating area has been primarily on the front side which can make it hard to see if not inspected carefully. There have also been isolated cases of a missing sealing gasket on the rear roof rail mounting stud. When either of these conditions occur, water can enter the vehicle, follow down the rear gate harness and drip directly onto the TPMS control module, eventually causing internal damage as seen in the bottom photo of a damaged circuit board. If you verify this concern, make sure to thoroughly clean and fully re-seat the pass through harness cover and re-check to verify any water leak has been repaired. To complete the repair, it will be necessary to replace the TPMS control module and re-register all the transmitters.

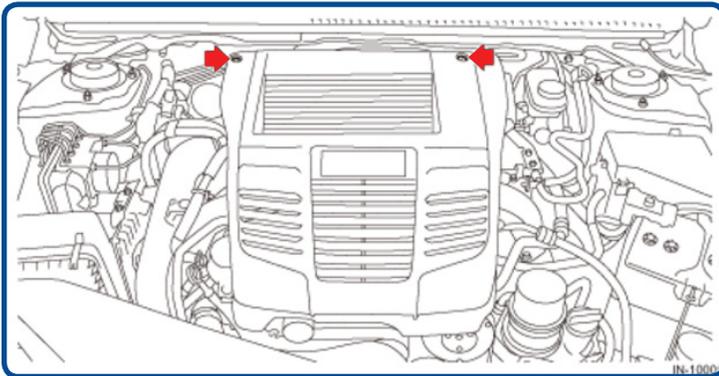
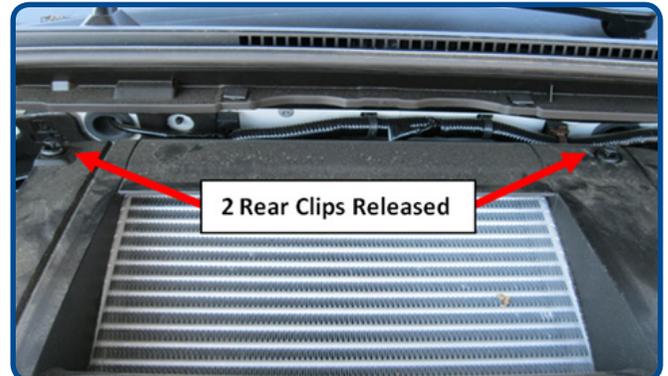
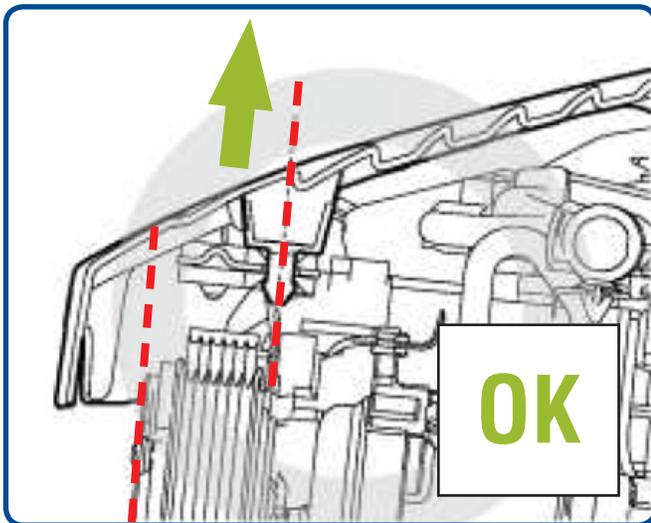
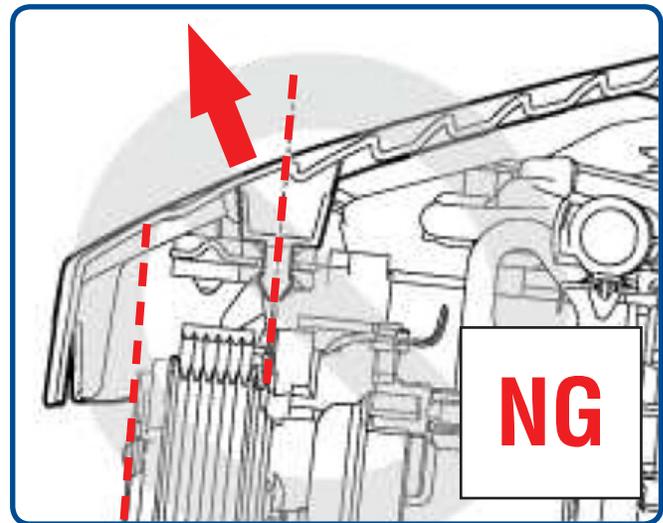
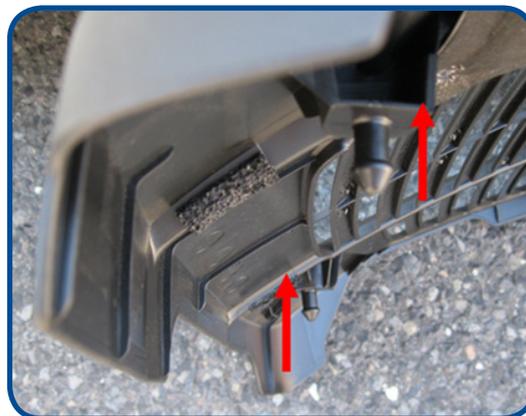
When removing the plastic engine cover on a 2015MY WRX, extra caution must be taken to release the two front pins from their rubber retaining grommets. The rear corners are secured with retaining clips. After removing the 2 clips, the cover must be **CAREFULLY** lifted **STRAIGHT UP** (parallel to the face of the A/C compressor pulley as shown in the illustrations below) to release the front pins otherwise, the cover will likely be damaged. Lifting the cover up at any other angle will usually break the pin portion(s) off the underside of the cover. This precaution is even more important to follow in colder temperatures. If the front pins are found to be sticking to the rubber grommets, sparingly apply a **very small** amount of non-silicone lubricant to the pins to make any future removal easier.

REMINDER: NEVER apply silicone lubricants or sprays onto or near any electrical connections or components.
