Safety Recall: V6 Engine Water Pump

(Supersedes 02-055, dated August 21, 2002)

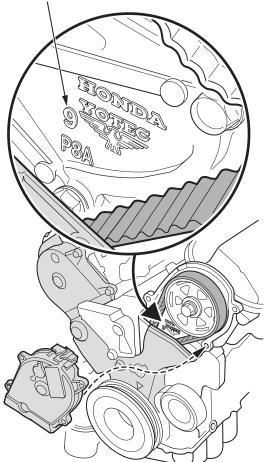
CASTING DIE NUMBER

- 1. Remove the timing belt front upper cover. Refer to Timing Belt Inspection in the appropriate service manual.
- 2. Inspect the casting die number on the water pump housing.
 - If the casting die number is "9," go to **REPAIR PROCEDURE**.
 - If the casting die number is any number other than "9," reinstall all removed parts, and center-punch the VIN.

1. Replace the timing belt and water pump. Refer to the Cylinder Head and Engine Cooling sections of the appropriate service manual.
