Applies To: **2006 Ridgeline** – From VIN 2HJYK1...6H500001 thru 2HJYK1...6H521114
2007 Ridgeline – From VIN 2HJYK1...7H500001 thru 2HJYK1...7H550722

April 15, 2008

Diagnosing and Repairing Water Leaks

(Supersedes 07-082, dated November 28, 2007, to update the information marked by the black bars)
 (Replaces 05-045, *Water Leak at Right Front Floor*, dated November 17, 2005, and 06-016, *Water Leak Near the Right Rear Door*, dated April 11, 2006.)

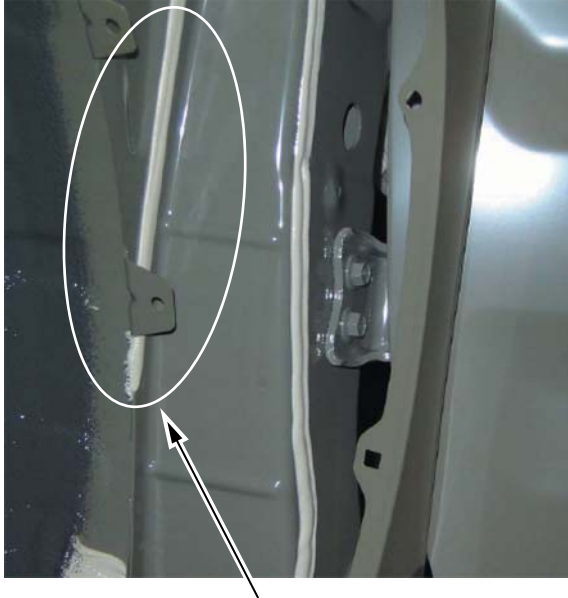
1. Remove the inner fender:
 - Refer to page 20-178 of the *2006–2008 Ridgeline Service Manual*, or
 - Online, enter keyword **FENDER**, and select **Front Inner Fender Replacement** from the list.
2. Inspect the seam sealer on the lower A-pillar behind the inner fender for gaps or incomplete sealing.

Inspect the seam sealer on the lower A-pillar behind the inner fender.

3. Apply sealer/sealant where it is missing.
4. Reinstall all removed parts.

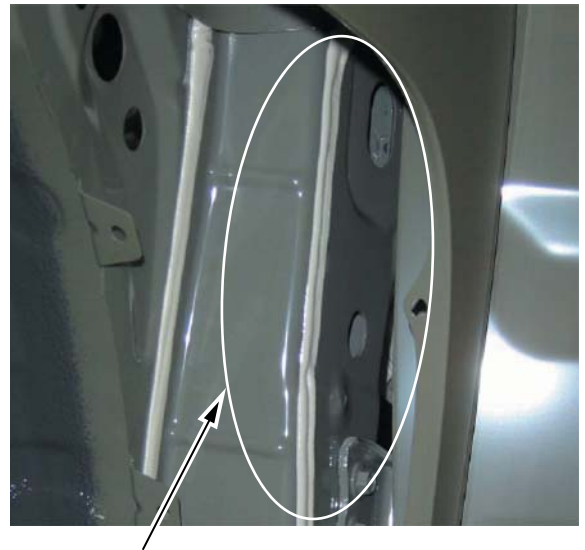
1. Remove the inner fender:
 - Refer to page 20-178 of the *2006–2008 Ridgeline Service Manual*, or
 - Online, enter keyword **FENDER**, and select **Front Inner Fender Replacement** from the list.
2. Inspect the sealer on the upper A-pillar between the front door hinges for gaps or incomplete sealing.

Inspect the seam sealer on the upper A-pillar between the front door hinges.

3. Apply sealer/sealant where it is missing.

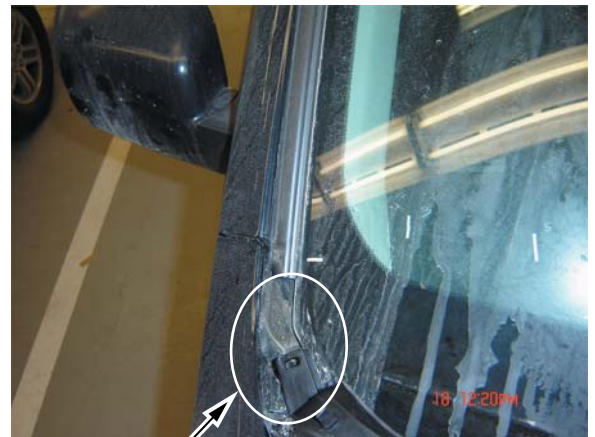
1. Check for missing sealer between the A-pillar and the cowl near the lower corner of the windshield. (Procedures C and F are different. See step 2 of DIAGNOSIS.)

Check for missing sealer between the A-pillar and cowl next to the lower corner of the windshield.

2. Apply sealer/sealant where it is missing.
3. Reinstall all removed parts.

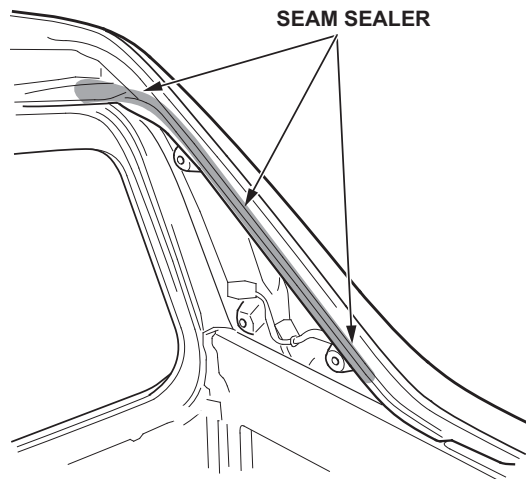
C-pillar
 From VIN 2HJYK1...6H500001 thru
 2HJYK1...6H551855

- Refer to page 20-135 of the service manual, or
 - Online, enter keyword **C-PILLAR**, and select **C-pillar Outer Trim Replacement** from the list.
5. Apply 3M Brushable Seam Sealer to the area shown.

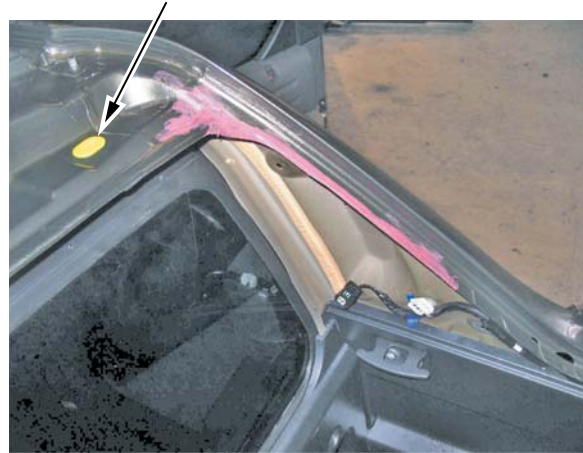
1. Remove the rear roof trim:
 - Refer to page 20-175 of the *2006-2008 Ridgeline Service Manual*, or
 - Online, enter keywords **ROOF TRIM**, and select **Rear Roof Trim Replacement** from the list.
2. Remove the roof trim grommet, and check for seam sealer underneath it. Clean any sealer that may be keeping the grommet from sealing to the body.

Check for seam sealer underneath the roof trim grommet.

3. Reinstall all parts in the reverse order of removal, and use new clips and grommets for the rear roof trim.

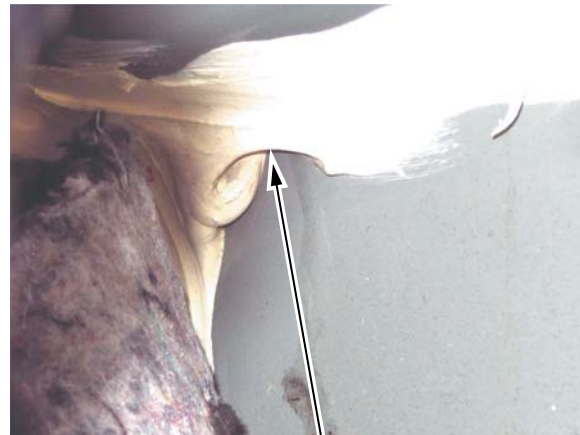
4. Check for missing sealer under the instrument panel, where the cowl area on the left and right sides meet the A-pillar.

Check for missing sealer.

5. Apply sealer to any areas where there are gaps or where it is missing.
6. Reinstall all removed parts.
