It's a New Tech 2 Look

Techline News

Cooling System Conditions on Vehicles Equipped with DEX-COOL™

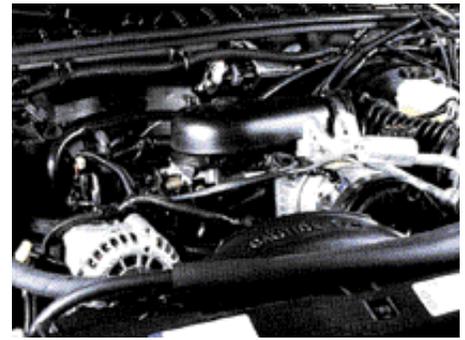
S/T Truck Equipped with 4.3L V6

Bulletin 99-06-02-012B outlines the most effective repair for this model. The contaminant has been identified as iron oxide, and the cleaning material recommended in the bulletin was selected because it was proven to be the most effective at cleaning this type of contaminant. It is very important to follow the steps outlined in the bulletin precisely. Cases where the procedure was not effective have almost always been traced to substitution of another cleaning material or the procedure was not strictly adhered to. The most common mistakes have been:

1. Running the flush while the engine operating temperature is too low. Heat acts as a catalyst in this procedure, and if the temperature of the system is not maintained according to the bulletin specifications, the

cleaning will not be effective.

2. Failing to correctly assess the level of contaminants in the radiator before beginning.

NOTE: As stated in the bulletin, it's important to determine if coolant is able to flow through the third row down from the top of the radiator. If not, the radiator core must be replaced before the flush procedure. This is because the cleaner must be able to flow past the contamination in order to clean it. In cases where the system can't achieve sufficient flow around the contaminants, the cleaner cannot be effective.

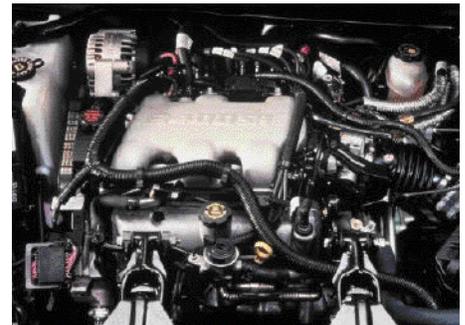
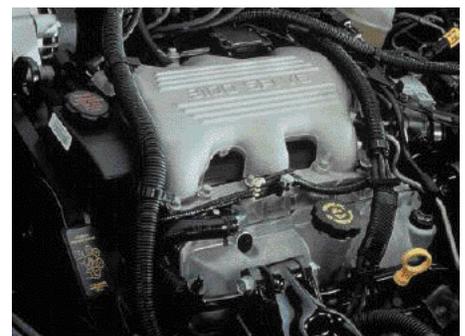
W Car / U Van Equipped with 3.1L or 3.4L V6

Bulletin 00-06-02-004 describes the appropriate repair procedure for the issues most often seen on these models. Although similar in appearance to the S/T issue, the material on the radiator caps of these models contains no iron oxide. It is much more gelatin-like in texture and is usually comprised of sealer pellet residue, hose material and/or other contaminants. It is very rare to see cases where the contamination evidenced on these radiator caps has spread beyond

the radiator neck. If contamination is suspected beyond the radiator neck, you may choose to remove the radiator end tanks for further inspection.

Replacement of the radiator cap, wiping out the radiator neck and topping off the system is all that is normally recommended for these models. Unless other symptoms are present, it is not necessary to flush the cooling system or replace the coolant on these models before their published maintenance/change interval.

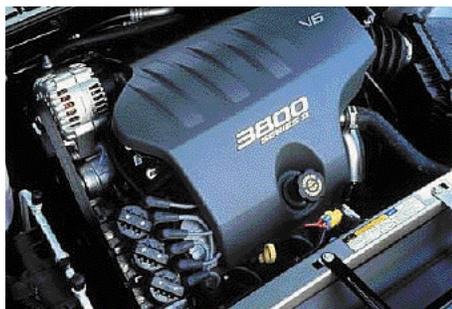
2000 LeSabre and Bonneville Equipped with 3.8L V6

Concerns on these models typically center around what is perceived as discolored coolant (usually dark and rust colored in appearance) and a ring of contamination around the inside of the coolant recovery bottle. Analysis has determined that both of these consist of excess sealer pellet material that was inadvertently installed at the assembly plant. Sealer pellet installation has since been discontinued on these models. Cleaning the coolant recovery bottle, topping up the system and checking the cap for proper function is all that is required on these models.

Finally, as stated in bulletin 99-06-02-012B, the radiator cap is not a good indicator of the general condition of the cooling

system. Typically the underside of the radiator cap will exhibit a greater amount of contamination than the rest of the system, due to the "beach" effect described earlier. Likewise, the color of the coolant is also not a good indicator of its general condition.

When performing repairs for S/T trucks, U vans and W cars, it may help to replace the standard radiator cap with a Standt model 10230 or 11230 radiator cap. These caps have a spring center design that may be less sensitive to the effects of low coolant contamination. You should also top off the radiator and fill the coolant recovery bottle to the *hot* mark when *cold*. These measures will combine to guard against the vehicle operating with the cooling system low on coolant. Inform the customer to check the level of the coolant recovery bottle regularly and to maintain it at the proper level by adding a 50/50 mix of DEX-COOL and water whenever it's found to be low.
