JAGUAR

IMPROVED ENGINE SUMP OIL SEALING

SERVICE BULLETIN

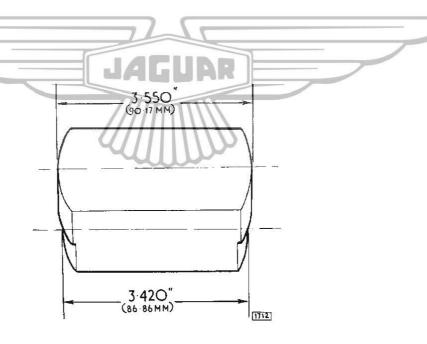
After the engine has been rebored to +.030" (+.76 mm), or if the bores will not clean up at .030", it will be necessary to replace the cylinder liners, bore out to standard and fit standard sized pistons.

The worn liners must be pressed out from the <u>bottom</u> using a stepped block (see illustration).

Before fitting the new liner lightly smear the cylinder walls with jointing compound at a point half-way down the bore and also smear the top outer surface of the liner.

Press in the new liners from the top and file, or lightly skim, the tops of the liners flush with the top face of cylinder block.

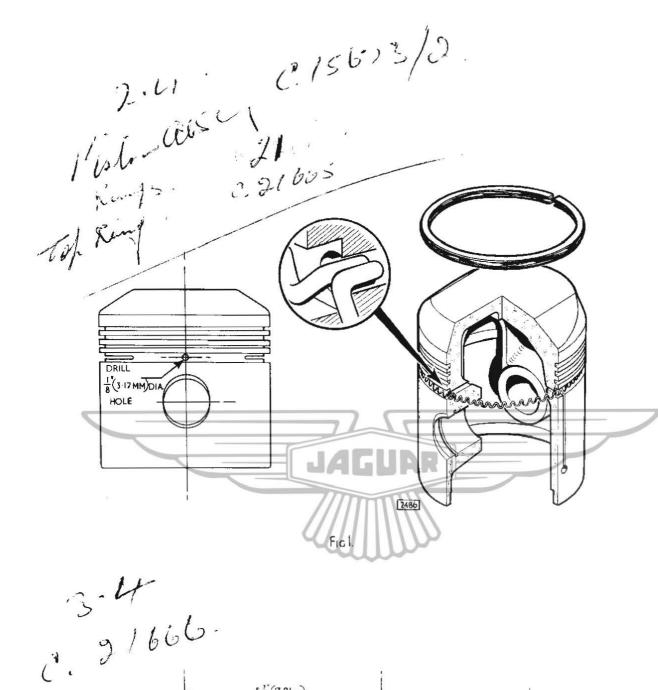
- 2.4 litre pistons will require an &" (3.17 mm) hole drilled in the centre of the oil control ring groove in line with the gudgeon pin bore. (See Fig 1)
- 3.4 litre engines must have the connecting rod modified inasmuch as a hole 1/32" (.79 mm) diameter is drilled at 45° and 5.7/16" (13.81 cm) from the centre of the big end bearing bore on the same side as the big end bearing shell retaining groove (See Fig 2). When fitted, the hole in the connecting rod must face forward and be pointing to the thrust (inlet) side of the engine. In the case of the 2.4 litre engine, the connecting rod already includes an oil feed hole.

The oil control ring gap when fitted is .015" - .033", (.38 - .83 mm).

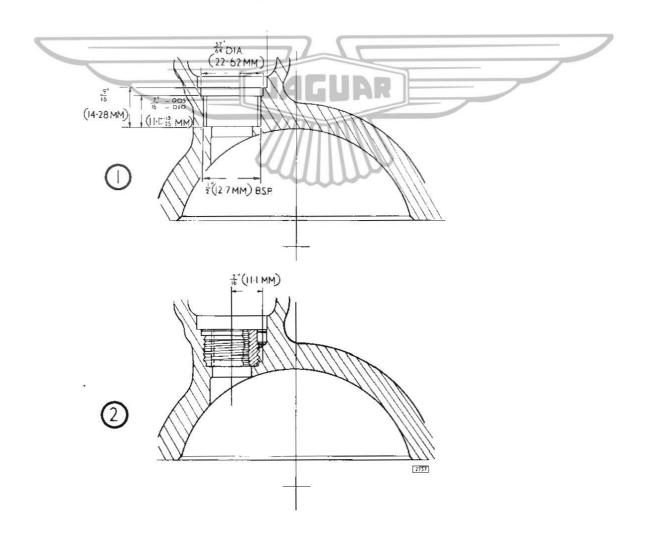
Drive in the locking pin (C.22382) and make sure that the pin is below the surface as in Fig.2.

To secure, peen over the aluminium on the chamfered portion of the insert and also the locking pin.

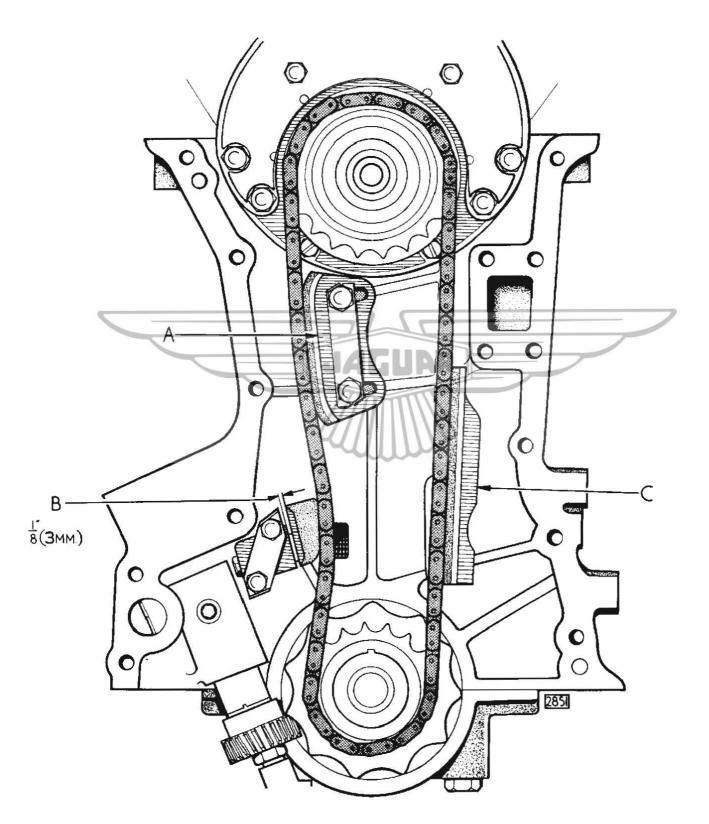
The original type secured to the upper timing chain bracket is replaced by a damper secured to two tapped bosses in the cylinder block (see illustration). Shorter bolts are now fitted to the upper timing chain bracket.

When fitting a new lower timing chain, set the intermediate damper (A) in light contact with the chain when there is an ½" (3mm) gap (B) between the rubber slipper and the tensioner body. In the case of a worn chain the gap (B) may have to be increased to avoid fouling between the chain and the cylinder block. Set the lower damper (C) in light contact with the chain.
