PACKARD DIVISION

STUDEBAKER-PACKARD CORPORATION

# counselor

MARCH, 1956

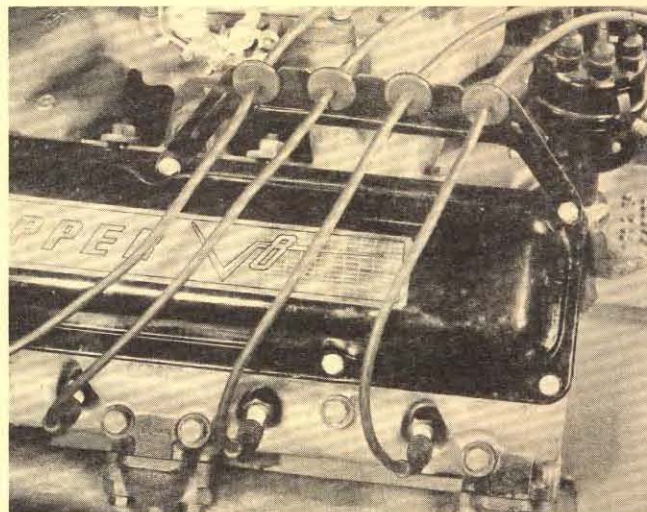
Occasional reports have been received of the V 8 Engine failing to respond smoothly on acceleration particularly in the 20 to 40 M.P.H. speed range. This condition is generally diagnosed as faulty carburetion, but in many cases it is caused by a cross-fire between No. 5 and No. 7 cylinders.

Cross-firing may be caused by pinched ignition cable wires between fingers of the cable supports breaking the wire insulation, separation of the dipped rubber from the cable supports or wires running parallel too close to one another for enough distance to permit capacitive coupling.

Number 7 cylinder fires 90° crankshaft travel after No. 5 cylinder, cross-firing will cause No. 7 cylinder to fire at the same time No. 5 fires as they both are charged with fuel.

Should cross-firing occur, examine the ignition cables for broken insulation and if found satisfactory, install new ignition cable supports as shown in the illustration. The new supports spread the cables farther apart and the rubber grommets hold the cables at a greater distance from the metal supports.

1. Lift the ignition cables from between the support fingers on all four supports, remove and discard the cylinder head supports and the supports under the coil.

2. Install the new supports as shown in the illustration by attaching the supports under the center and rear cap screws for the rocker cover. Only one support is used per side.
3. Install the grommets on the cables and position the grommets in the supports leaving the cables at the approximate length shown.
4. It will be necessary to cut off some of the cables to obtain proper length between the support and the distributor cap. Remove the cables one at a time from the distributor cap, remove the cable terminals and cut off the amount of cable as listed and reinstall the terminal and cable in the cap.

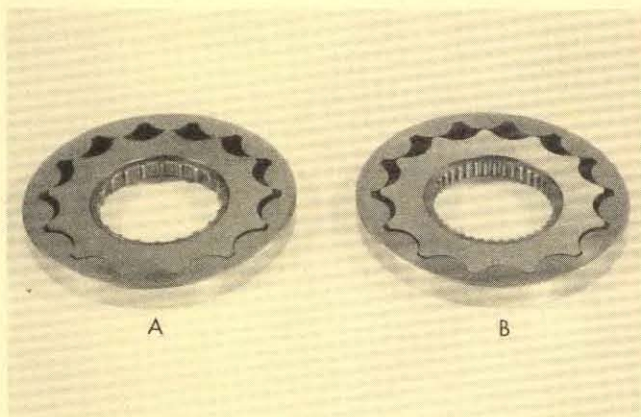
Fig. 1

Several reports have been received of worn or stripped splines on the converter pump shaft where it engages with the front oil pump rotor and in some cases, the splines in the rotor were worn or stripped. This condition may occur in 54th Series Gear-Start transmissions, 55th and early 56th Series Ultramatic transmissions.

"A" figure 1, shows the front oil pump rotor having 20 internal splines that is used in 54th Series Gear-Start, 55th and early 56th Series Ultramatic transmissions.

56th Series transmissions starting with serial numbers A-9681, B-6012, C-1143, D-1862 have front oil pumps with the direct clutch passage in the rear and also have the rotors with 40 tooth splines on the internal driving section, "B" figure 1.

Whenever worn or stripped splines are found on one of the units, always replace both units to provide proper spline mesh.

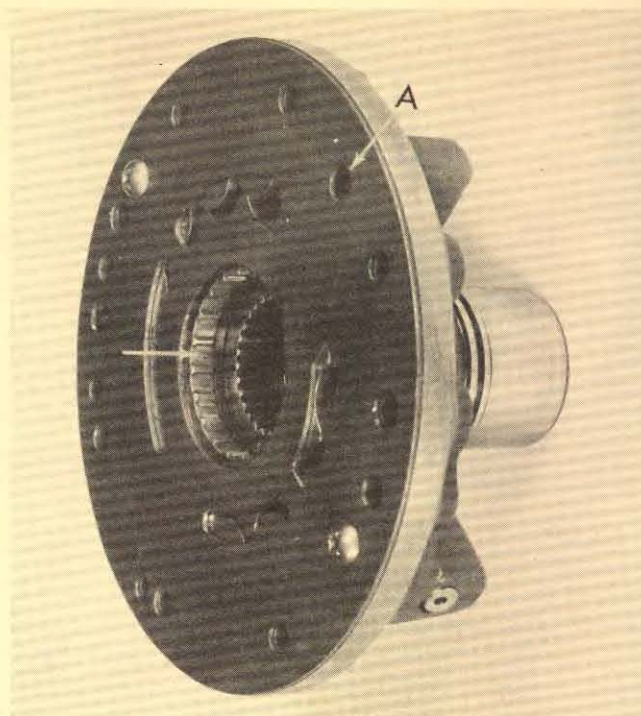
Fig. 2

On 54th Series Gear-Start, all 55th and 56th Series Ultramatic transmissions up to transmission serial number A-6481, B-4741, C-1057, oil pressure for the direct drive clutch came out of a passage on the front side of the pump. See "A" figure 2. The oil pressure is directed through a passage in the bell housing, then past the open splines in the rotor to the input shaft.

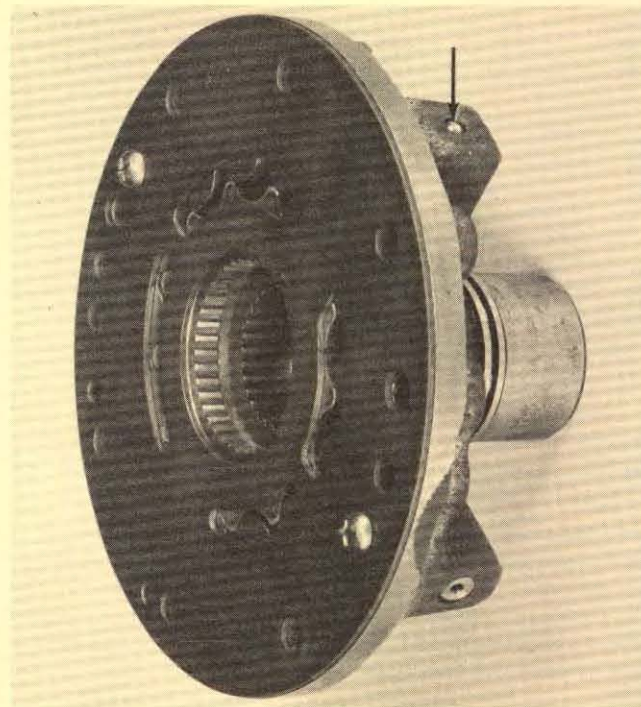
Fig. 3

56th Series transmissions after the above serial numbers have front oil pumps with the direct clutch oil passage in the rear side of the pump. "See arrow figure 3," also note the oil passage hole is not in the front plate. However, *these pumps have the 20 tooth*

*splined rotors.* (40 tooth rotor is shown in the illustration.)

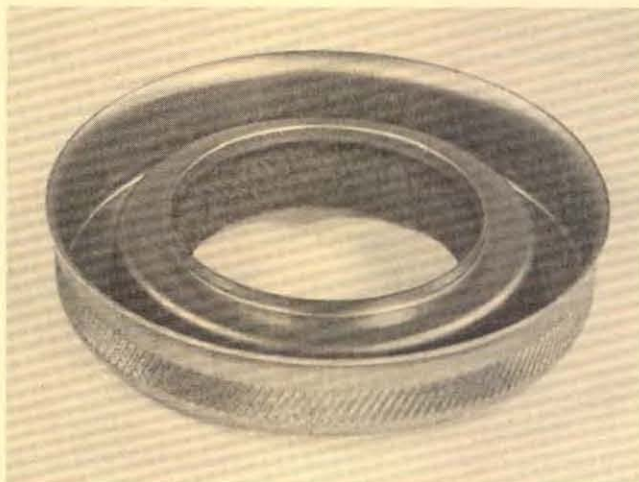
A few reports have been received of the front oil seal loosening and turning in the chain cover making it necessary to replace both the seal and cover to stop the leak.

Production is now using a seal with the outer diameter of the retainer knurled to prevent the seal from turning. "See illustration."

The new seal with the knurled retainer will press tightly into the cover even in cases where an old seal has turned.

When installing a new front oil seal, it is important that the instructions be followed as described on page 27 in the "Engine Section" of your Service Manual.
