# SERVICE BULLETIN

Classification: EC05-016a	Reference: NTB06-039a	Date: May 17, 2006
------------------------------	--------------------------	-----------------------

## 2004 – 2005 ALTIMA; MIL ON P1273 (QR25 ENGINE) MAY BE CAUSED BY THE REAR O2 SENSOR

**APPLIED VEHICLE:** 2004 - 2005 Altima (L31) with QR25 (4 cyl) engine only

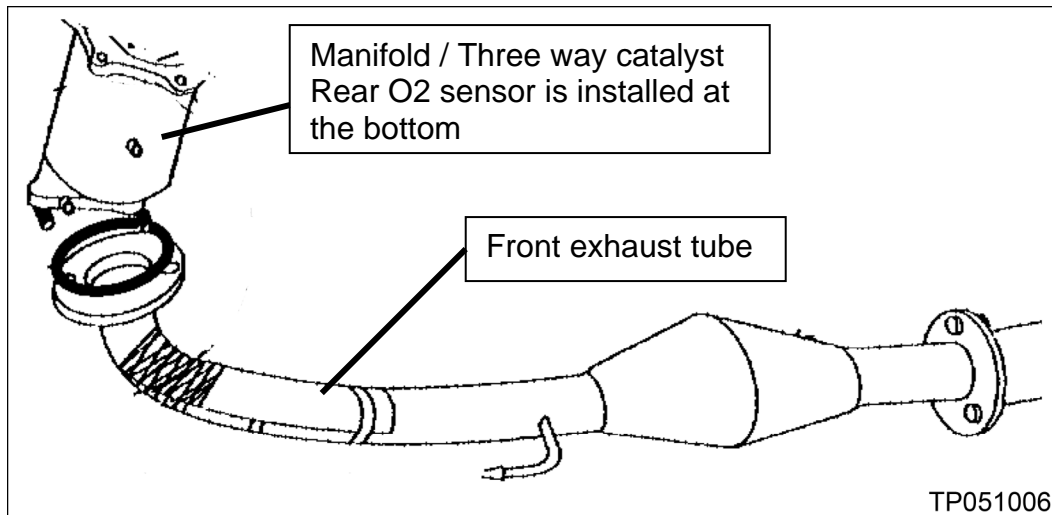
Figure 2

- a. Lift the car in the air with the engine running at idle.
- b. Carefully inspect the exhaust system for leaks between the engine and just after the Rear O2 sensor.

- c. Inspect carefully: Pay special attention to the welded parts of the front tube and the sealed joints between the exhaust manifold and the front tube.

- e. If you find an exhaust leak, the leak is the likely cause of DTC P1273.

- **So this bulletin does not apply.**
- Repair the exhaust leak as needed using repair information from the Service Manual and ASIST.
- Make sure to clear Self Learn and erase DTC after exhaust leak is repaired.
