SERVICE BULLETIN

Subject: Installation of Concentric Slave Cylinder (CSC)

Issue Date: DJSB-022-CSC-Apr/12

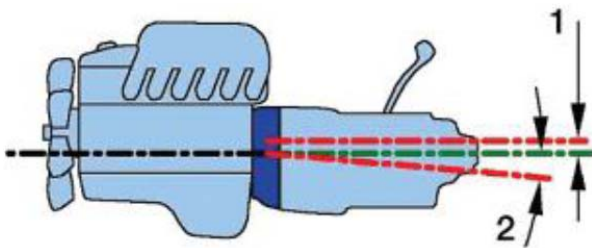
2. Angular misalignment

1: parallel offset; 2: Angular offset

- ✓ Excessive axial or angular (or both) CSC assembly error (reference to gear shaft) lead to a reduced functional and service life of CSC **reducing the life of the shaft seal (gearbox input shaft seal).**

- ✓ The root cause for excessive axial or angular (or both) CSC assembly error is to be found in alignment errors between engine and shaft. Possible cause of misalignment are:

- Centring between engine and gear box is not correct (deformation, heavy dirt or wear);
 - Other parts (e.g. grounding straps) trapped between engine and gear box during installation);

- Flange bolts loose or not properly tightened;
 - Close-tolerance sleeves or pins missing / damaged;
 - Gearbox input shaft with no guidance as pilot bearing in the flywheel is absent or badly worn;

- Clutch bell housing warped because attaching bolts have not been evenly tightened or deformed due to the effect of force such as dropping or striking hard when fitting;

- In case of excessive axial and angular misalignment and shaft seal wear, shaft rotation can generate mineral oil mist that could go in contact with internal **CSC primary seal with high volume change** leading to leakage and low service life.
