Triumph TR7 GM Saturn / Bosch Alternator Upgrade

Greg Bober, Copyright 7 Sept 2008, Rev 1.2 (originally written 4 Sept 2005)

Abstract

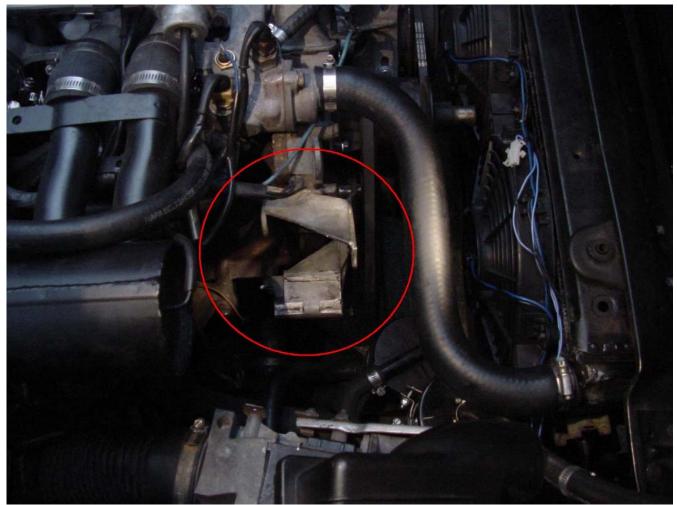
Picture 1: Old alternator removed from engine mounting brackets.

- 1. Remove the air by-pass hose that connects from the by-pass valve located almost above the alternator, and hose from the intake plenum to the top of the charcoal canister. Fold these hoses back and out of the way.
- 2. Remove upper adjustment bracket bolt supporting the top mounting ear of the alternator.
- 3. Disconnect electrical connections from the rear of the existing Lucas alternator.
- 4. Disconnect the lower mounting bolt thru the Lucas alternator's lower mounting holes. When removing this lower bolt, be prepared hold the 10 Lbs. alternator.
- 5. Loosen and fold up the upper mounting bracket out of the way and as far back as possible.
- 6. Lift and remove the old Lucas alternator from the engine compartment. (See Picture 1.)

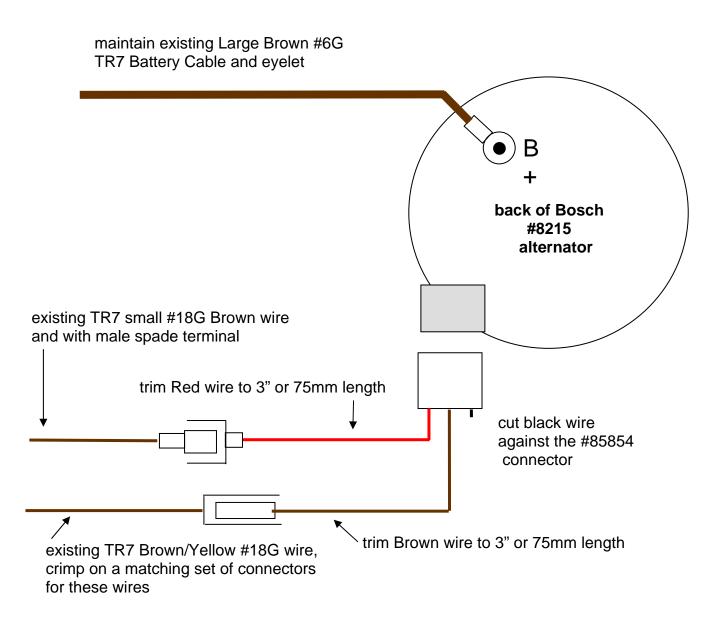
Picture 2: Bosch #8215 Alternator to TR7 wiring diagram through the #85854 pig tail harness.

- 16. Install the long bolt through the lower alternator mounts first to support the alternator's weight.
- 17. Install the high current, big Brown battery wire in the TR7 to the B+ stud bolt on the back of the #8215 alternator. (See also Picture 2.)

- 18. Connect the #85854 pig tail harness's Red wire to the TR7's small Brown wire via their mating connectors.
- 19. Connect the pig tail harness's Brown wire to the TR7's small Brown/Yellow wire via their mating connectors.

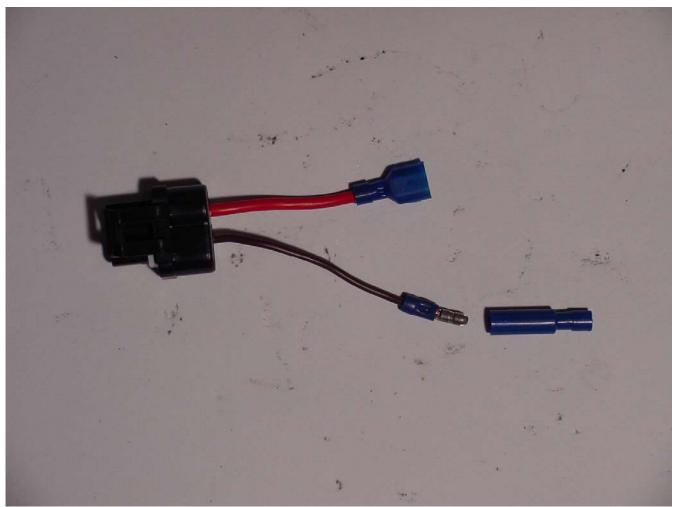
Picture 3: The #85854 Pigtail harness Black wire removed & connectors crimped on Red & Brown wires. Mating wiring harness barrel shaped connector is shown on the right.

- 7. On the #85854 pig tail harness, cut & remove black wire. It is not needed. Cut it at the base of the connector so that nothing can accidentally short against this particular wire.

- 8. Cut the red and brown wires 3 inches or 75mm long (See Picture 2 and 3).
- 9. Crimp a barrel shaped terminal on the Bown pig tail harnesses wire.
- 10. Crimp a mating barrel shaped connector on the Brown/Yellow wire in the TR7 that used to connect to the rear of the Lucas alternator.

- 11. Crimp a sleeved, male spade terminal connector on the Red wire of the pig tail harness.
- 12. The pig tail harness should appear as shown in Picture 3.

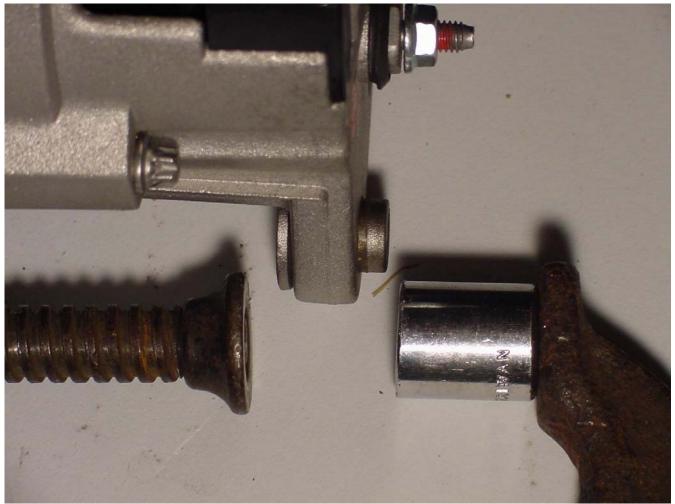
Picture 4: Pushing the Bosch #8215 Alternator's mounting insert deeper into its hole.

- 14. With a clamp, squeeze the mounting insert on the Bosch #8215 alternator deeper into its mounting hole as deep as possible, the extra 1mm is all my new alternator needed to fit the alternator into my TR7. Depending upon fit in your vehicle, this may not be required. (See Picture 4.)

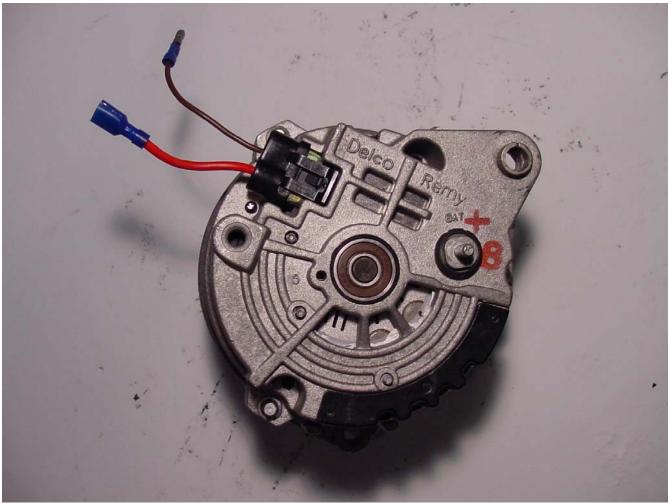
Picture 5: Alternator with the pig tail harness installed.

- 15. Plug the little harness made in Steps 7 through 12 into the socket located in the back of the Bosch #8215 alternator. (See Picture 5.)

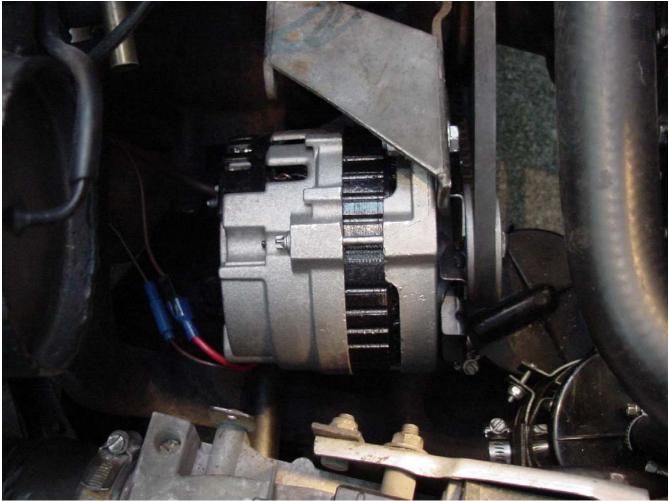
Picture 6: New Alternator electrically installed.

- 21. Install the alternator belt around the pulley.
- 22. Pull the alternator away from the engine to increase tension on the belt and then completely tightened the upper mounting bracket bolt. Then tighten the lower alternator mounting bolt. (See Picture 6.)

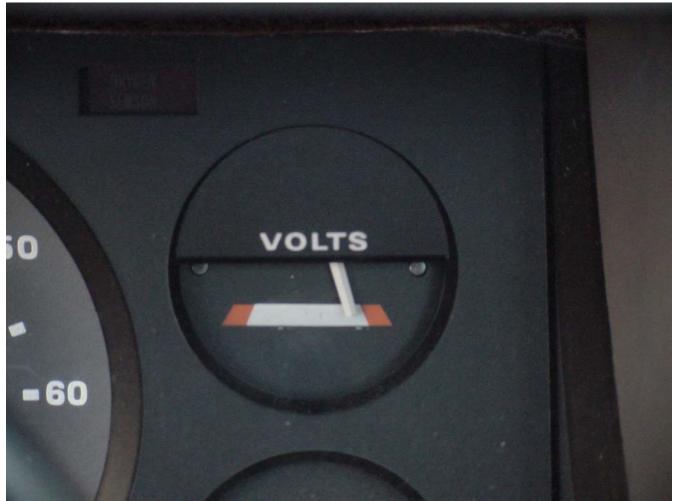
- Start the vehicle, and measure the voltage applied to the battery with little electrical loading (headlamps and all other vehicle features OFF). The #8215 alternator on my vehicle was applying 14.7V across the battery's terminals.
- Check the instrument panel's "Volts" gauge, the meter's pointer should be located near the maximum "normal" or white zone demarcation (see Picture 7).

Picture 7: TR7's Voltage Meter, pointer location showing the Alternator is "charging" the battery.
