Bolt Contacting Front Suspension Fore Link

Classification	Repair Bulletin	Section/Group	31 - Suspension	Country/Region	All
Year	2012-2015	Model	Model S	Version	All

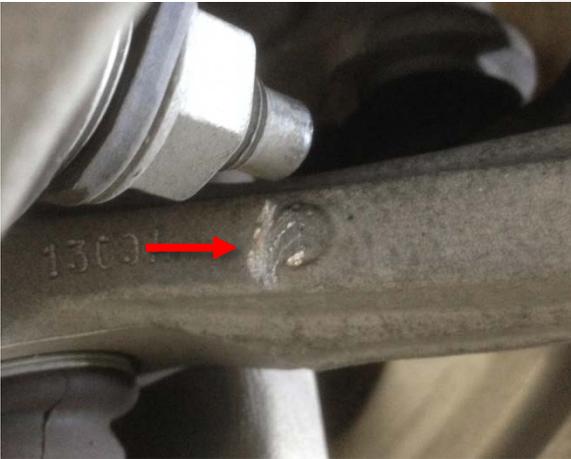
Figure 1 (LH fore link)

1. Raise the vehicle (refer to Service Manual procedure 10000205).
2. Check for marks on the rear-facing side of the LH and RH suspension fore links (Figures 1 and 2):
 - If there are no visible marks on the LH and RH fore links, discontinue this procedure.
 - If there are marks on either fore link, continue to the next step.

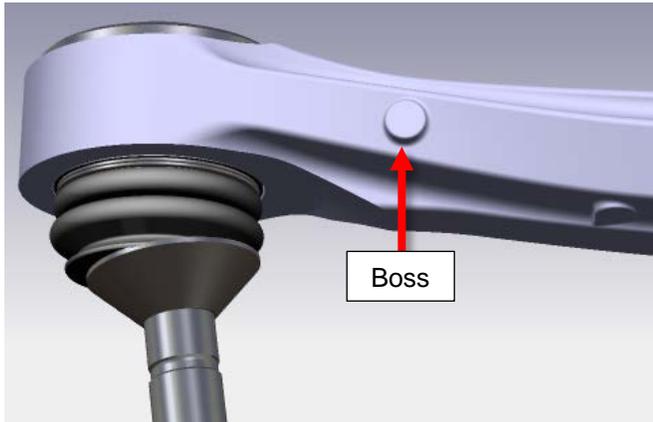
Figure 3

3. Check the locations and depth of the mark(s) on the LH and RH fore link(s).
 - If there is evidence of contact outside of the circular protruding boss (Figure 3) and the surface is indented, replace the fore link (refer to Service Manual procedure 31013402), then continue to the next step.
 - If there is an indentation that does not extend outside of the boss, compare the depth of the indentation to the height of the boss. If the indentation is deeper than the height of the boss, replace the fore link (refer to Service Manual procedure 31013402), then continue to the next step.
 - If the mark does not extend beyond the boss, and there is no indentation (Figure 4) or if the indentation does not exceed the height of the boss, continue to the next step.

4. Replace both the LH and RH lower shock absorber bolts with the updated parts (torque 140 Nm).
