PACKARD DIVISION

STUDEBAKER-PACKARD CORPORATION

Counselor

AUGUST, 1955

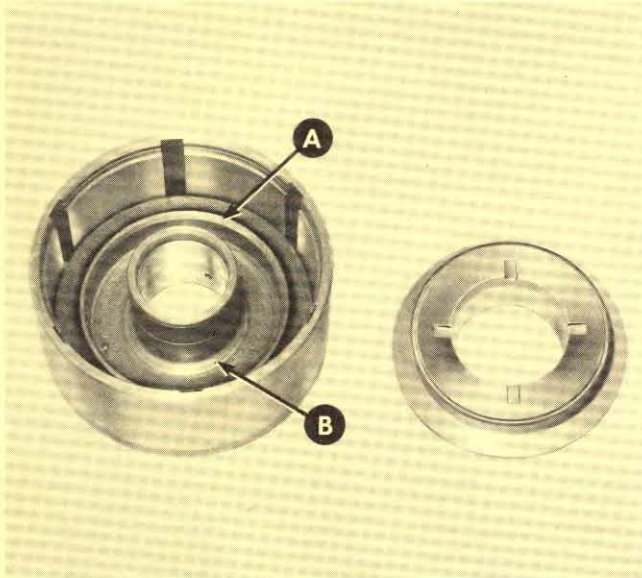
Engine runaway during low to high shifts has been reported on a few 55th Series cars, that could not be corrected by changing the throttle rod adjustment to raise the throttle pressure in the transmission.

In some instances, it has been found that the high range clutch piston in the released position rests on the milled surface indicated by "B" in the illustration restricting the oil pressure to the back of the piston causing slow engagement of the clutch.

When the piston is in its released position, the flange on the piston should rest on the shoulder "A" in the high range clutch housing, leaving .031" clearance between the end of the piston and the milled surface marked "B" which provides a means for the oil pressure to engage the clutch.

If the piston is found to be touching or resting on the milled surface "B" in the clutch housing, oil passages can be provided by filing four grooves in the piston as shown.

Using the edge of a 12" file, carefully file four grooves equally spaced 1/16" deep and 1/4" outward from the chamfered center hole in the piston.

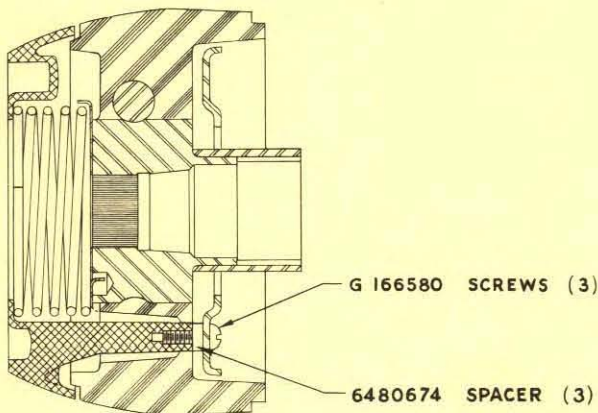
A few reports have been received of the horn button not making contact when the horn ring is pushed down at the location in line with the spoke of the steering wheel.

This condition can be corrected by installing spacers and longer screws between the steering wheel and the horn ring contact plate as follows:

1. Pry out the horn button and remove the steering wheel assembly.

2. Remove the three screws that attaches the contact plate to the steering wheel, install the three spacers No. 6480674 behind the plate and secure the plate with the three new longer screws No. G-166580. "See illustration."

3. Align the steering wheel in the straight ahead position, tighten it securely and reinstall the horn button.
