NATIONAL TRANSPORTATION SAFETY BOARD
Office of Aviation Safety
Washington, D.C. 20594

Horizontal Stabilizer Trim Actuator Factual Report

June 5, 2014

A. ACCIDENT DCA12RA025

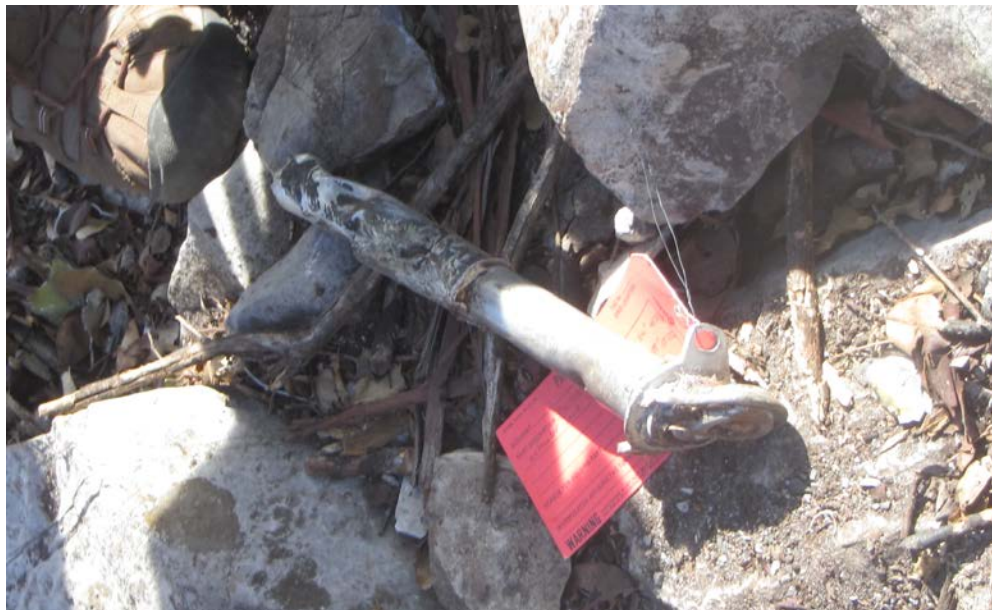
The horizontal stabilizer actuator jackscrew was recovered at the accident site by DGAC investigators during the on-scene portion of the investigation. See Figure 1.

Figure 1 - The Horizontal Stabilizer Actuator, jackscrew segment, in its found location at accident site (Photograph courtesy of the DGAC).

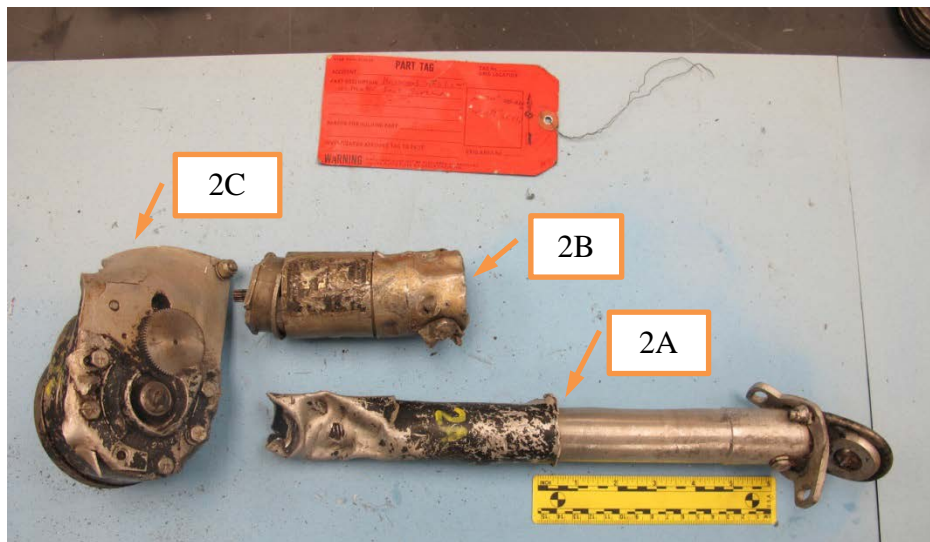
2A – Is the jackscrew assembly and one attachment point. This attachment point connects the actuator assembly to the horizontal stabilizer.

2B – Is one of the actuator motors. The actuator motor is approximately 5 inches long and 2 inches in diameter. The actuator design contains two motors, only one motor was present at the inspection. Note: this segment was not retained following the September, 2013 examination; the segment was returned to the DGAC, and therefore not examined during this activity.

2C – Is one of the attachment points, the gear box housing and the jack screw interface. This attachment point connects the actuator to the vertical stabilizer. The jackscrew and tie rod were fractured adjacent to the gearbox. The gearbox housing plate was bent and 1 bolt was sheared from the attaching hole.

Figure 2 - Pieces of the horizontal stabilizer actuator, as received.

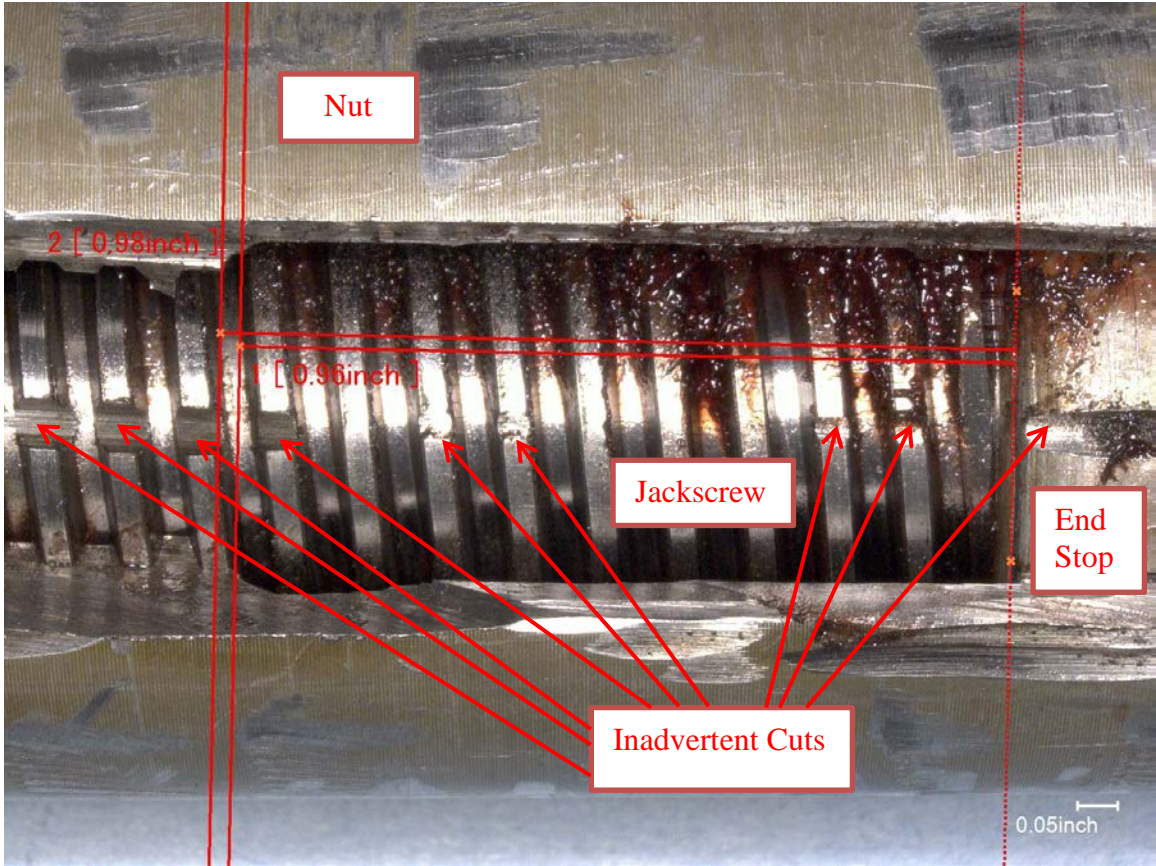
- h) Using computer imaging measurement software, the distance between the threaded jackscrew end stop and the end of the threaded section of the inner sleeve was measured as 0.96 – 0.98 inches. See Figure 3.

Figure 3 - Jackscrew Thread Measurement.

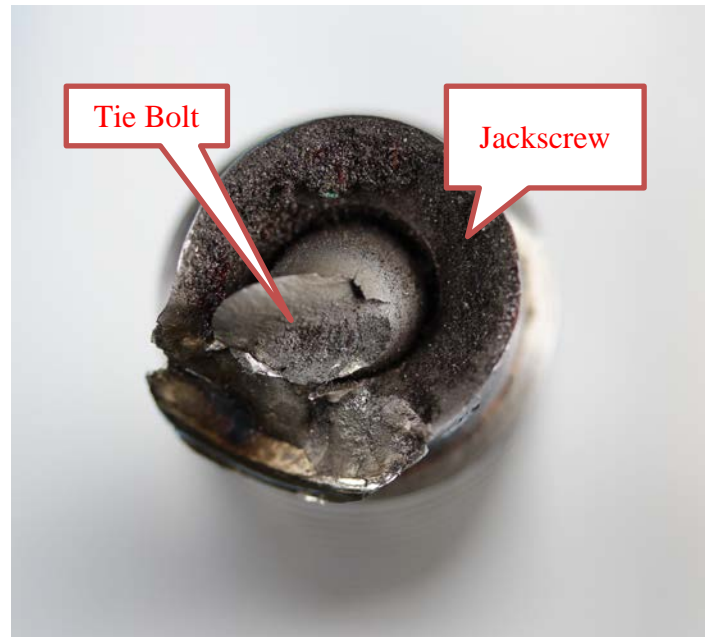
According to the NTSB Senior Materials Engineer, a visual inspection of the actuator jackscrew and tie bolt fracture surfaces located at the base of the actuator gearbox housing exhibited evidence of single cycle bending overstress. Based on the installed position of the actuator, the direction of the fracture indicated a fracturing force aft and to the left. See Figure 4.

Figure 4 - Actuator Jackscrew Fracture Surface.

According to the NTSB Senior Materials Engineer, the 6-7 degree bend of the jackscrew thread was not in the same direction as the bending overstress.

According to the NTSB Senior Materials Engineer, the actuator's inner tie rod exhibited visual evidence of extensive yielding adjacent to the fracture surface.

According to the Senior Materials Engineer, the fracture surfaces on component 2C matches the fracture surfaces of 2A.

According to the Senior Materials Engineer, no evidence of pre-existing damage, corrosion or fatigue was noted in the examined components.
