FINAL REPORT

AAIU Report No: 2011-003
State File No: IRL00908039
Published: 7/2/2011

Manufacturer: Beechcraft

Model: 77 Skipper

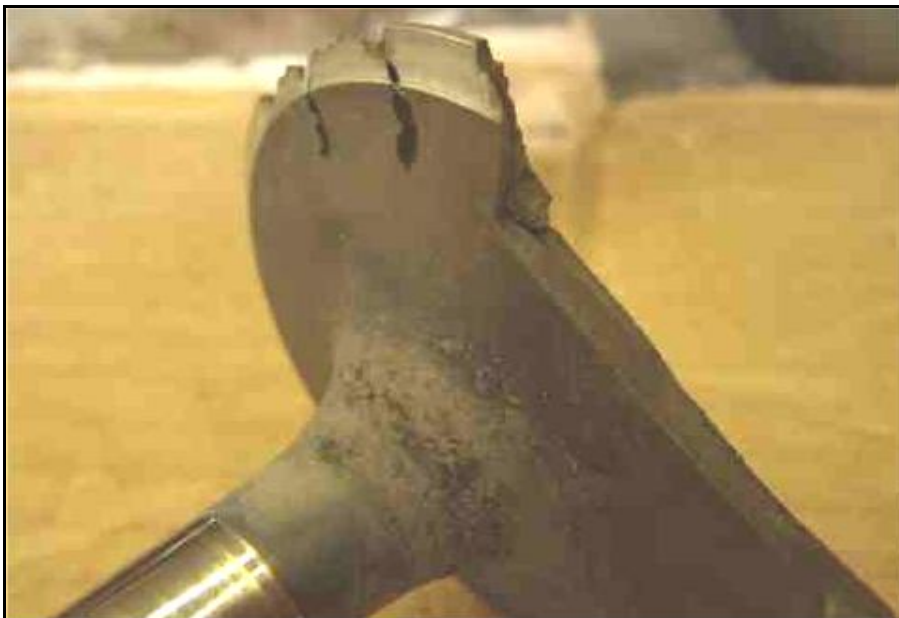
Photo No. 1: No. 2 Inlet valve

The inlet valves in both cylinders No. 2 and No. 3 were found damaged with radial cracking and guttering⁹ extending from the valve seat towards the stem. No evidence of a sticking valve stem was seen on any of the valves.

The No. 2 inlet valve (**Photo No. 1**) had a missing segment and several rough, jagged regions near the head outer diameter, which shows evidence of guttering. These areas also had radially oriented cracks.

The No. 2 inlet valve head displayed a microstructure of tempered martensite with alloy carbides, which is the normal microstructure for this material and component. The Engine Manufacturer's report stated that many of the jagged features on the No. 2 inlet valve appeared more like guttering than fracture surfaces. The main chordal surface and at least one of the intersecting radial surfaces were clearly fractured. These fracture surfaces were generally in poor condition, covered with combustion products and oxide scale. (See valve in **Photo No. 1** prior to cleaning).

The initial cracking and guttering in the No. 2 inlet valve progressed to the point where a significant portion of the valve head departed, thus opening the compression chamber to the inlet manifold. Consequently, power was no longer available from that cylinder.

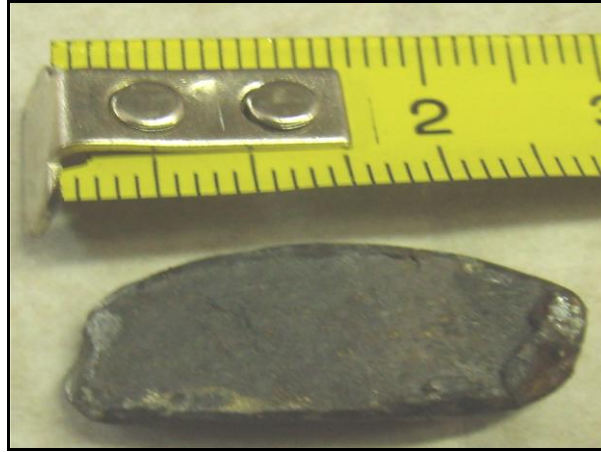
Photo No. 2: No. 2 Inlet valve segment

The missing segment (**Photo No. 2**) from the No. 2 inlet valve head was discovered in cylinder No. 4 and was 2.5 cm long. Score marks were found in the inlet manifold (mounted underneath the engine) consistent with the passage of the valve head segment from cylinder No. 2 to No. 4 in a pulsating pressure pattern.

Having broken off, the segment of No. 2 inlet valve was “hammered” by the piston against the cylinder head for a number of cycles. It was then ejected through the inlet valve duct down into the inlet manifold by pulsating pressure, generated by the piston and blowback through the broken valve head. From there, it transferred to the No. 4 inlet duct where it oscillated for some time, scoring that duct, before being ingested up into cylinder No. 4 where again it was “hammered” between the cylinder head and the piston causing significant indentations to both, and further power loss. In the meantime, it is probable that the pressure pulsations leaking through the broken No. 2 inlet valve affected the airflow and fuel/air mixture distribution in the inlet manifold leading to the other cylinders.

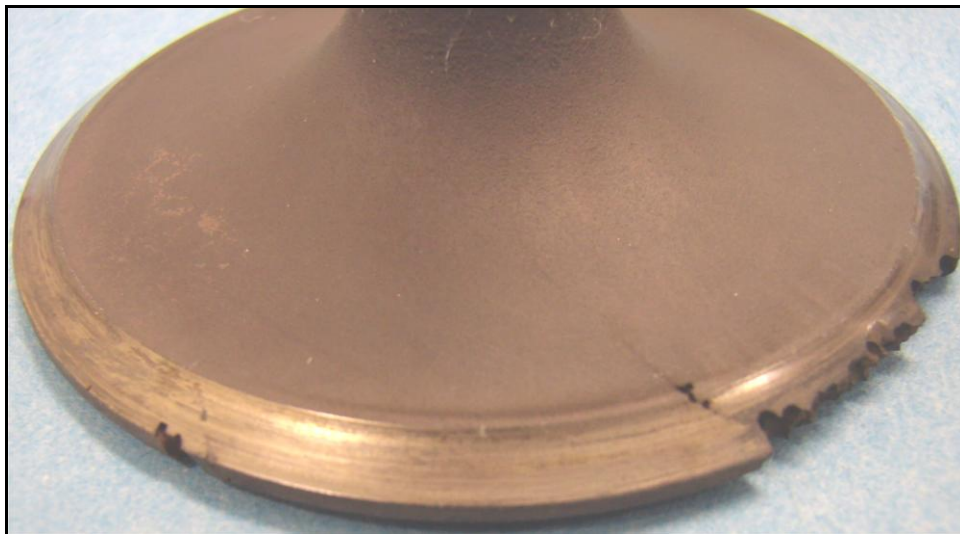
Photo No. 3: No. 3 Inlet valve

The No. 3 inlet valve also had several regions of radial cracking and guttering, near the outer diameter of the head (**Photo No. 3**).

The inlet valves were measured and their dimensions conformed to specification with the exception of an elongated No. 3 inlet valve, which was found to exceed the maximum allowable length by 0.001 inch. This suggested that the inlet valve might have been stretched slightly longer than its initial length. The No. 2 inlet valve's edge thickness at the head outer diameter and its stem diameter, were measured by optical comparator, and both conformed to engineering specifications.

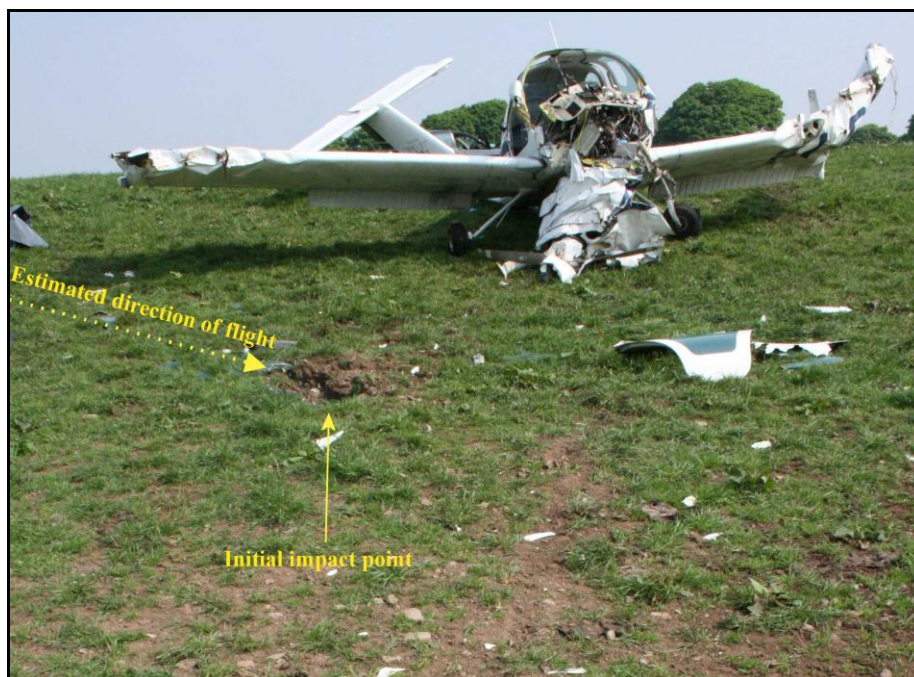
Photo No. 4: Final resting position of EI-BHT

The aircraft came to rest pointing down the northern slope of this depression, slightly left wing low (see **Photo No. 4**). Although the fuselage and wings were intact, the empennage was twisted to the right. The left wing was crumpled and bent upwards from mid span. The right wing had impact marks on its outer leading edge but had suffered much less damage. The flaps on both wings were extended. Both main undercarriage legs and wheels remained attached. Flight control continuity was established although both control columns were found fractured at the point of entry into the instrument panel.

The front of the aircraft, including the instrument panel, was severely damaged. The nose gear assembly and engine bearers had severed; the engine remained attached solely by control cables and hoses. The propeller flange was fractured as a result of the impact. Witness marks on the propeller did not show signs of significant rotation at impact, however both blades were bent slightly aft.

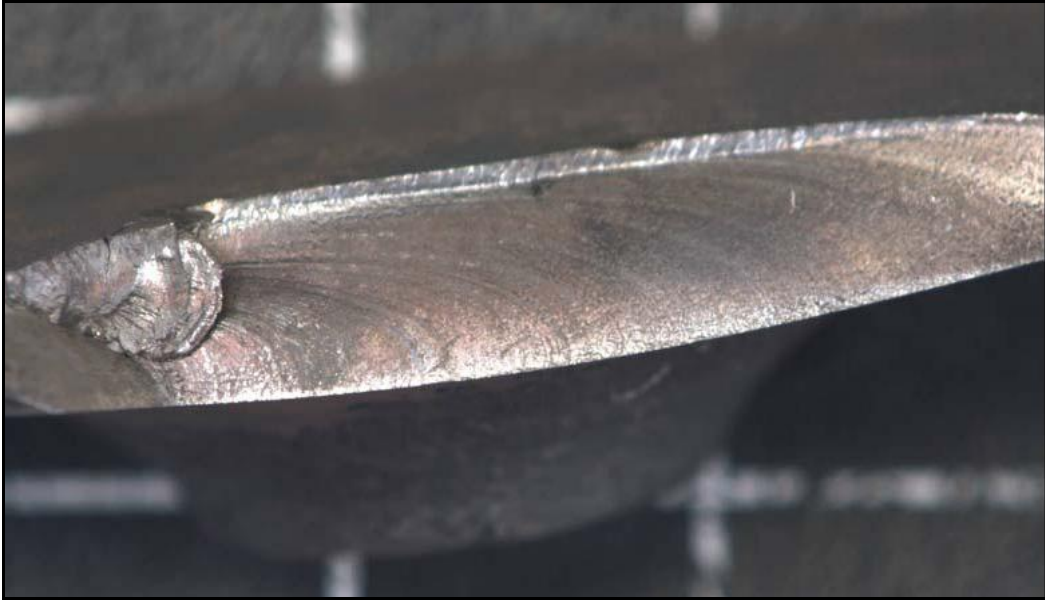
Photo No. 6: No. 2 Inlet valve fatigue crack (Engine Manufacturer's photo)

Nevertheless, having been cleaned, beach marks¹² were clearly visible, particularly on the chordal crack. The beach marks show that the cracks initiated from an origin at or near the underside surface, near the outer edge contact seat, but the exact origin site could not be determined. **Photo No. 6** shows that the chordal crack grew from left to right and from top to bottom (as seen in the photograph), in a semi-elliptical shape. The radial crack grew from the contact seat area, inward toward the chordal crack, and may have initiated the chordal crack. Striations were observed during microscopic examination.

The Engine Manufacturer's report concluded that the inlet valve conformed to the engineering requirements for alloy chemistry, hardness, and microstructure. However, the valve length was greater than allowed, indicating that it may have become stretched during service. Valve stretching indicated a probable exposure to excessive temperatures and/or higher than usual loading.

The appearance of the valve head edges in many locations seemed more consistent with high temperature guttering, rather than simple cracking; however, the large piece that broke off from the No. 2 inlet valve's head separated as a result of fatigue crack growth. The fatigue cracks were initiated at or near the valve seat contact area. The stretched condition of one valve, and the general appearance of the valves and spark plugs, suggested that detonation or pre-ignition may have played a role. The Engine Manufacturer concluded that the most likely scenario appears to be the following:

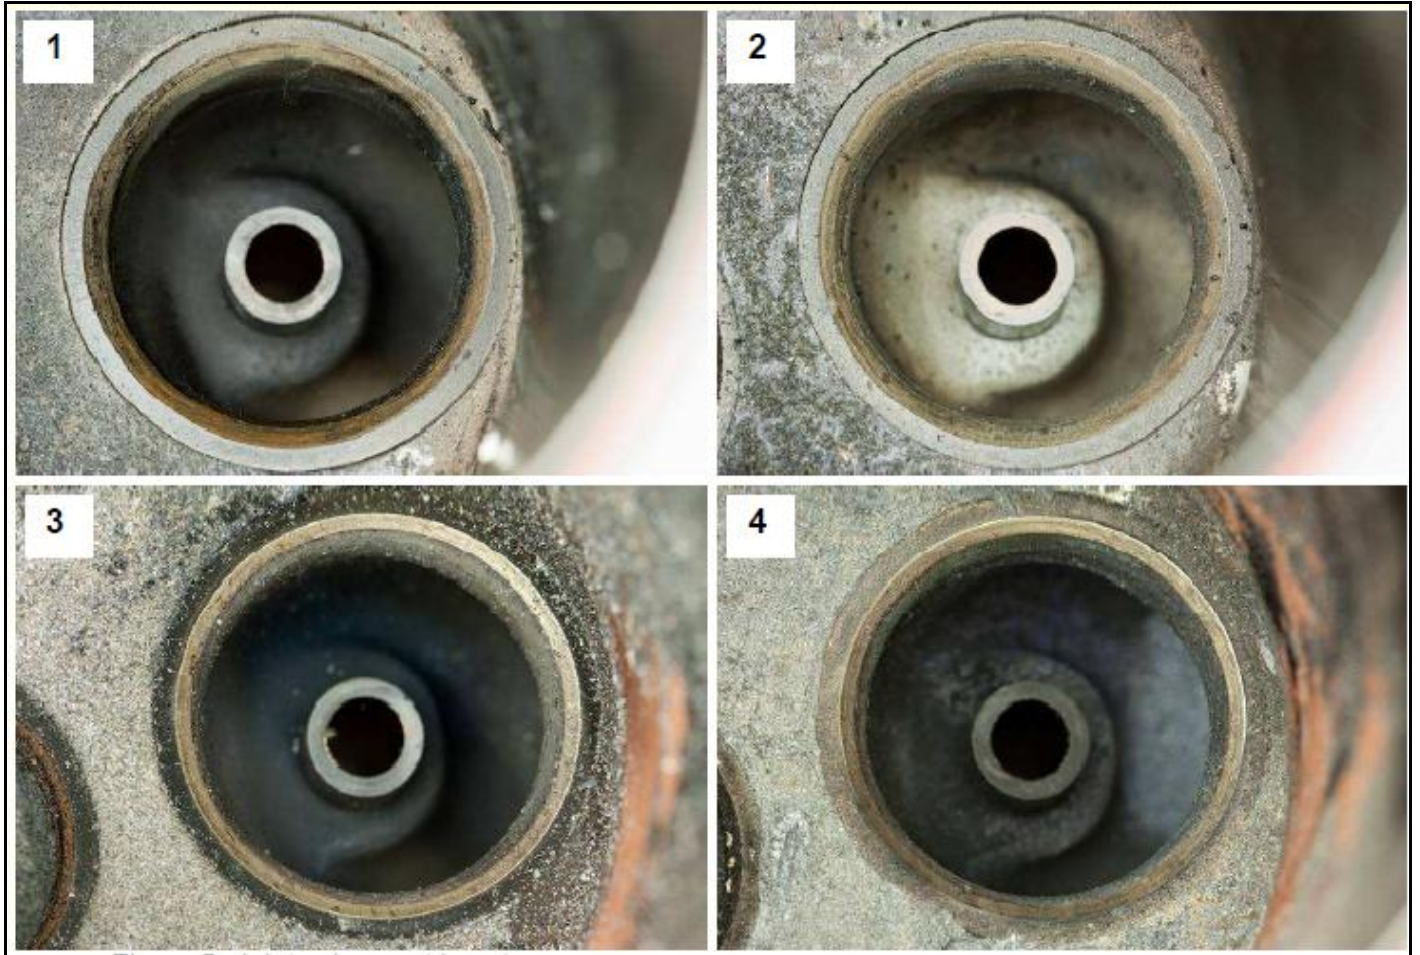
Inlet valve seat inserts (Facility's photograph)

The Report stated that the valve seat inserts from the four cylinders were examined in detail to determine if damaged inserts had resulted in overheating of the valves (see **Appendix A**). Detailed visual examination with a stereo optical microscope did not identify any defects that could account for overheating in the valves. Replicas were taken from each of the seat inserts to allow the angle and width of the face to be measured. The angle of all four seat inserts measured 30°, which conformed to the required specification for the inlet seat inserts. The width of the face measured approximately 2.5 mm on seat inserts No. 1, 2 and 3, whereas the width of the face of seat insert No. 4 measured approximately 2.2 mm. Although seat insert No. 4 was slightly different from the remaining three, it did not account for the overheating of valves No. 2 and 3.

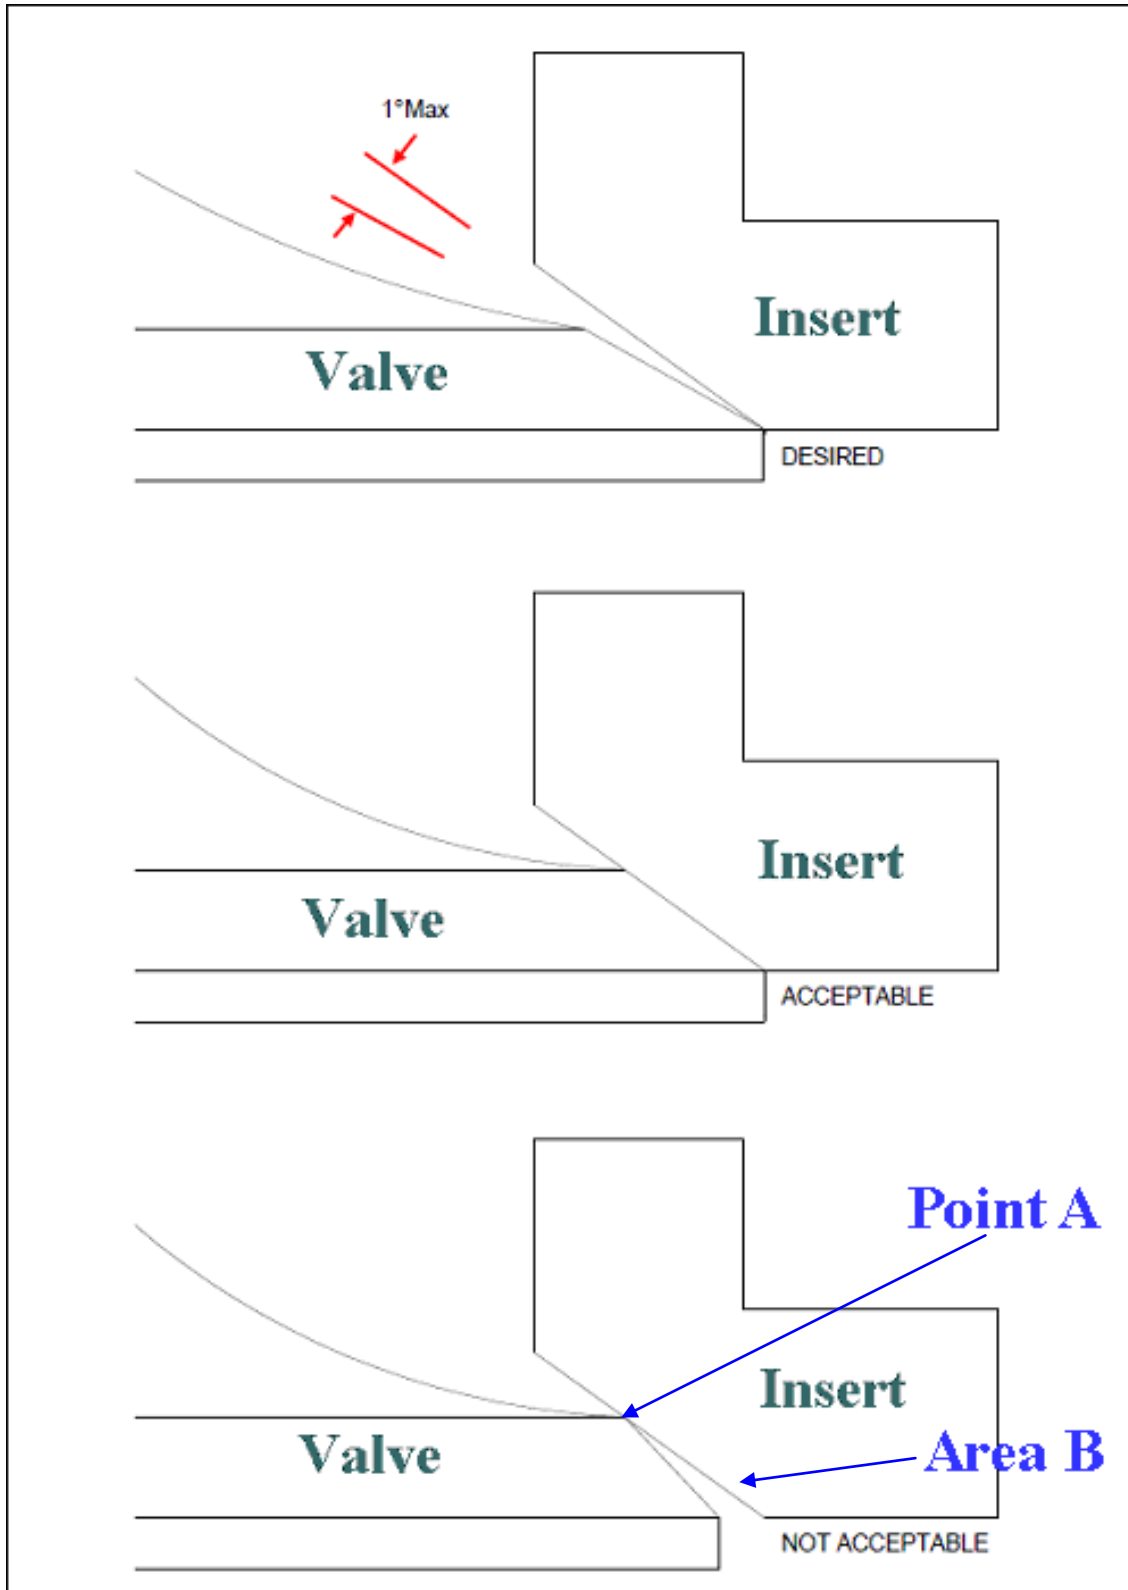
Valve Seat Insert Contact (Facility's drawing)

As there was a difference in the thickness of the valves, the valve profiles were examined with a shadowgraph and a difference in valve profile was found between the failed and serviceable valves. The angle between the valve stem and seat was measured as 60° in valves No. 1 and 4 and 58.75° in valve No. 3. The angle of No. 2 valve seat could not be measured, as the engine manufacturer had removed the valve stem and sectioned the valve head during its earlier metallurgical examination; however the Facility considered that the seat angles of valves No. 2 and 3 were probably similar due to the shadowgraph showing very similar profiles. According to the Service Manual the desired contact between the valve seat and seat insert is a point contact at the outer edge of the seat with a maximum of a 1° angle between the seat and insert. (See diagram **Appendix B**). Whereas full contact between the seat and insert (i.e. a 0° angle) is considered acceptable, it is not acceptable to have point contact at the inner edge of the seat (negative angle), as this creates a gap at the outer edge where exhaust gases can flow.

If it is assumed that the contact between the seats and inserts of valves No. 1 and 4 was acceptable, then valves No. 2 and 3, in which the seat angle was 1.25° different, must have had point contact at the inner edge of the seat and hence been unacceptable. The 1.25° difference between seat angles of the failed valves and the serviceable valves had resulted in unacceptable valve seating that allowed hot exhaust gases to flow between the seat and insert at the outer edge. This led to localised overheating, which had caused radial cracks, and eventually a large chordal fatigue crack liberated a section of the valve head.
