HP LaserJet 9000,9050, 9000mfp, 9040mfp and 9050mfp Series Printers-TWI: Troubleshooting and Resolving 13.20 Paper Jam Error Messages

Document number BPL90217

This document will assist in troubleshooting 13.20.00 paper jams. Any of the following can cause 13.20 errors.

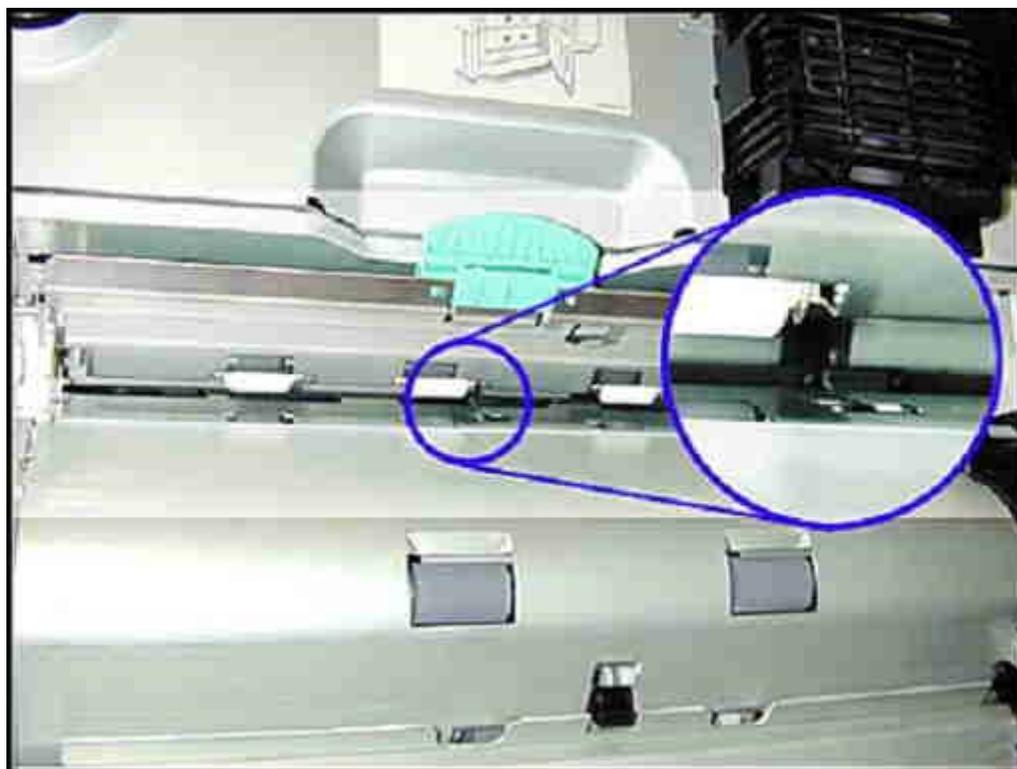
Figure 1: Close up of registration sensor

- The printer engine.
 - All input trays, including Trays 1 and 4 if equipped.
1. Open the right door and lift up the registration flap. A folded piece of paper can get stuck where the PS2 sensor is; use a flashlight to look carefully in this area. See Figure 1.

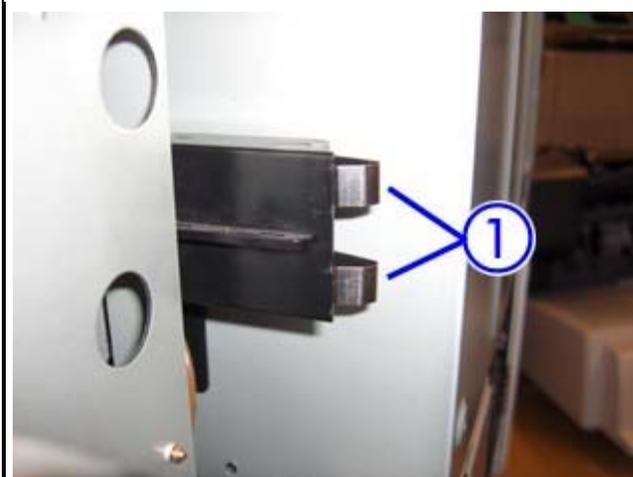
Figure 24: Contacts in wrong position

During removal/replacement, the Fuser High Voltage Cable contacts can be knocked out of place from the fixing connector holder assembly. As a result, the contacts cannot align with

1 - Fuser cable contacts are to the right of the housing

the contacts on the HVPS. This error will occur when one or both of the contacts are out of place (Figure 16, call-out 1).

Instructions:
 1. Remove the back cover.
 2. Remove the High Voltage Power Supply (HVPS).
 3. Push the contacts to the left so they cover the left edge of the housing (Figure 17, call-out 1).
 4. As shown above (Figure 17, call-out 1) when the leaf spring contacts are pushed on top of the connector holder housing, the contacts cannot make contact with the pressure roller bias and the paper wrap detection connections on the HVPS. Once repositioned, the contacts will now make contact with the HVPS.
 5. If readjusting the leaf spring contacts does not fix the problem, send an HVPS and a fuser high voltage cable.

NOTE: In most cases, simply repositioning the leaf spring contacts will resolve the issue. *Do not* replace the HVPS and the fuser high voltage cable *until* the leaf spring contacts have been positioned correctly to the left of the housing.

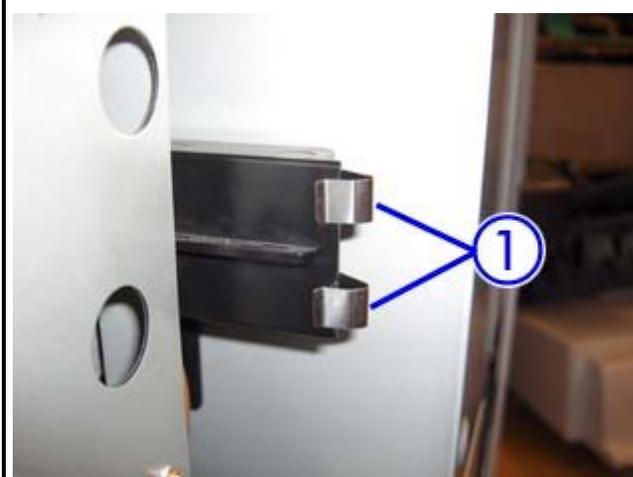
Figure 25: Contacts in correct position

1 - Contacts are over the left edge of the housing

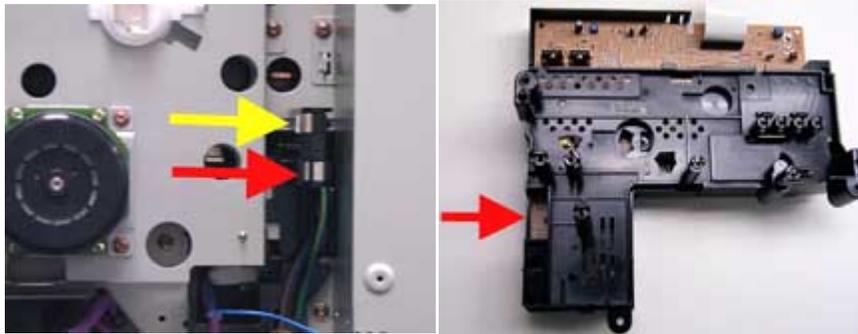
Figure 1

Nothing, many would say, but recently after reinstalling an HVPS into an HP LJ 9000 printer, we started getting instant 13.20 paper jams. What could be going on? After checking for paper that may have been left in the machine and verifying the flags were ok, I opened the Service Manual (OK, I was really stumped). One of the steps in the Service Manual is to verify the proper seating of the leaf springs under the HVPS. After removing the HVPS, I found that one of these leaf springs was bent to the right (Figure 1) and out of the case. These leaf springs should be to the left over the case, so when you reinstall the HVPS, the contacts on the board touch the leaf springs. These contacts are labeled TB1009 & TB1010 on the HVPS (Figure 2).

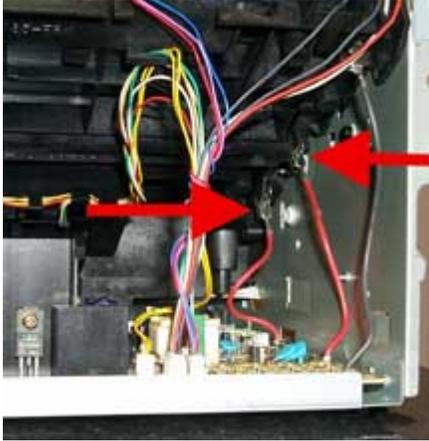
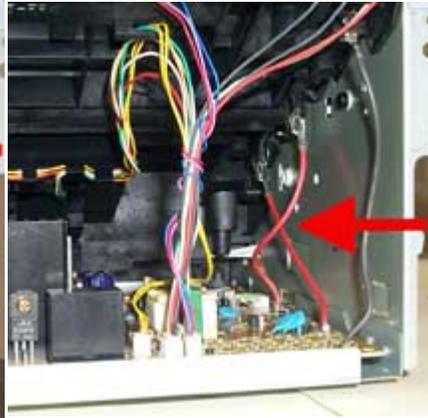
I began troubleshooting by checking all the sensor flags, which were all intact and moving freely. Then, I checked the door open switch and the toner cartridge, finding no problems. I contacted HP technical support and they suggested that either the motor was the cause of this problem or the formatter, which could be giving a false error. Both were changed with no effect. I even tried changing out the engine control board, with no success. However, upon reinstallation, it was noticed that the HVPS contacts, J301 & J304 could be cross-connected. I referred to the manual once again and guess what--the contacts were in fact hooked up in reverse, causing the printer to not recognize the toner cartridge (see Figures 4 and 5 for the correct and incorrect connections).

Upon further investigation, the customer had admitted to trying to fix the printer himself for a separate problem, and not knowing which wire went to where, he assumed it didn't matter. When connecting these wires, note that both are red and both connect the exact same way. It's important not to cross them as they go straight up to their appropriate connectors (again, see Figures 4 and 5 for the proper and improper connections).
