**URGENT FIELD SAFETY NOTICE**

**Dialog<sup>+</sup> SW 9.xx Two Pump Machines (incl. HDF online)  
in which level regulation spare parts were exchanged**

**R-2014-002**

**Assembly and Detailed Testing Instruction**

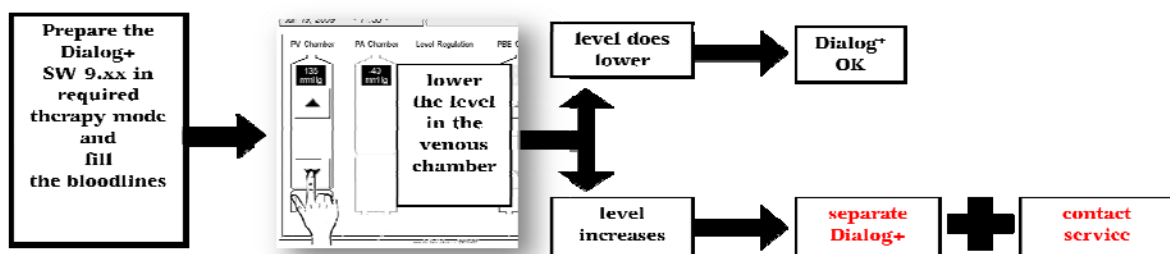
1. Prepare the Dialog<sup>+</sup> in the required therapy mode and fill the bloodlines. The venous chamber should be half-full.
2. Lower the level in the **venous chamber** by pressing the function key
3. Observe the level in the venous chamber
  - a. if the level lowers, the Dialog<sup>+</sup> is working correctly
  - b. if the level increases, the Dialog<sup>+</sup> working faulty, separate and label the Dialog<sup>+</sup> and contact your service technician

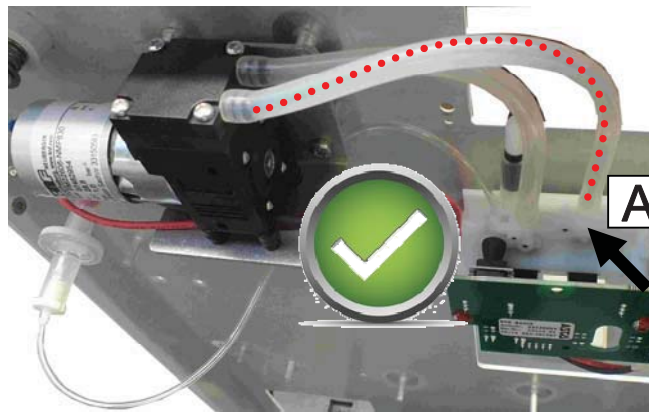
It is technically possible to connect the two tubes between the diaphragm pump and the valve block level regulation wrongly during a service activity when the diaphragm pump or when the valve block level regulation is replaced, i.e. the tubing can be inverted **B** at the pump or at the valve block. This inverted connection **B** will cause a malfunction of the level regulation system during the required functional check. Only in a single-needle cross-over treatment the intended increasing of the level of the arterial cross-over chamber can actually lead to an air infusion into the patient through the arterial patient connection.

Fig.: Correct connection **A**

The correct connection of the tubing **A** shall be ensured after assembly by a visual check, as well as a functional check by increasing and decreasing the levels inside the chambers using the *Up* and *Down* icons in a simulated treatment. The machine shall be released for patient use only if the level regulation works correctly, i.e. the level decreases when the *Down* icon is activated and the level increases when the *Up* icon is activated. This check shall be performed for all chambers of the connected tubing system to ensure the correct function of the option.

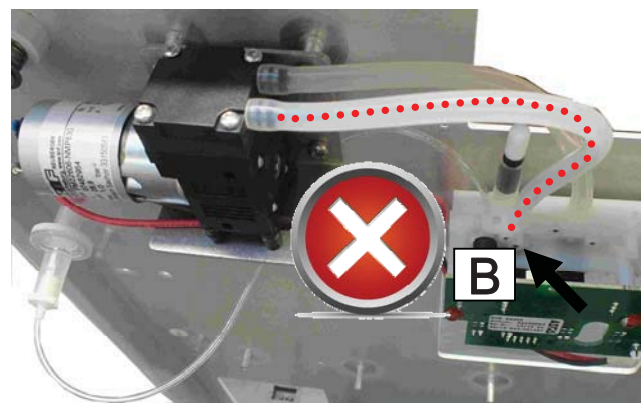
Fig.: Incorrect connection **B****3. Service Activities**

- Prepare the machine for a simulated treatment.
- Activate the *Up* and *Down* icons for each chamber.
- Confirm that the levels in the respective chambers actually increase and decrease.
