~ Kansaki KBW 10 Transmission Fluid Leak Repair ~

Replacing the oil seal, O ring and locking nut on *Spináche*

1989 Island Packet 35

Spring 2015

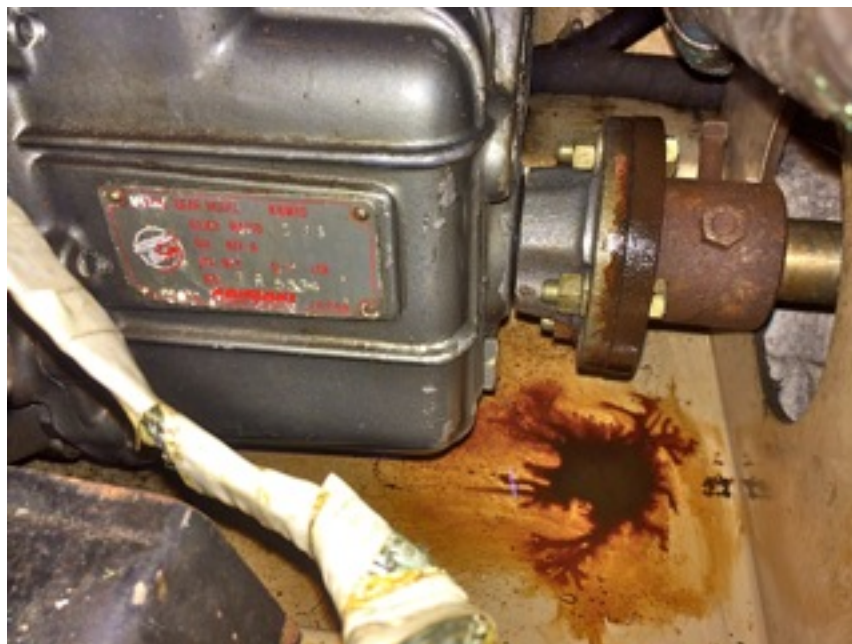
Back in the spring of 2007, while preparing for my last Marion-Bermuda race, I discovered transmission fluid leaking from the shaft couplings behind the transmission block. A certified Yanmar service center told me it was the rear transmission seal that had failed, so I had them fix it. Since a certified Yanmar mechanic will only fix this seal by taking the entire transmission out of the boat and taking it to their shop (a big production), it was a big expense, costing nearly \$1,300. While they were in there, they replaced some other stuff (the "damper disc"?) in the transmission because, as they said, "This opportunity is never likely to arise again!"
Murphy must have been listening.

This past summer, 7 years and 750 engine hours later, I discovered this.....

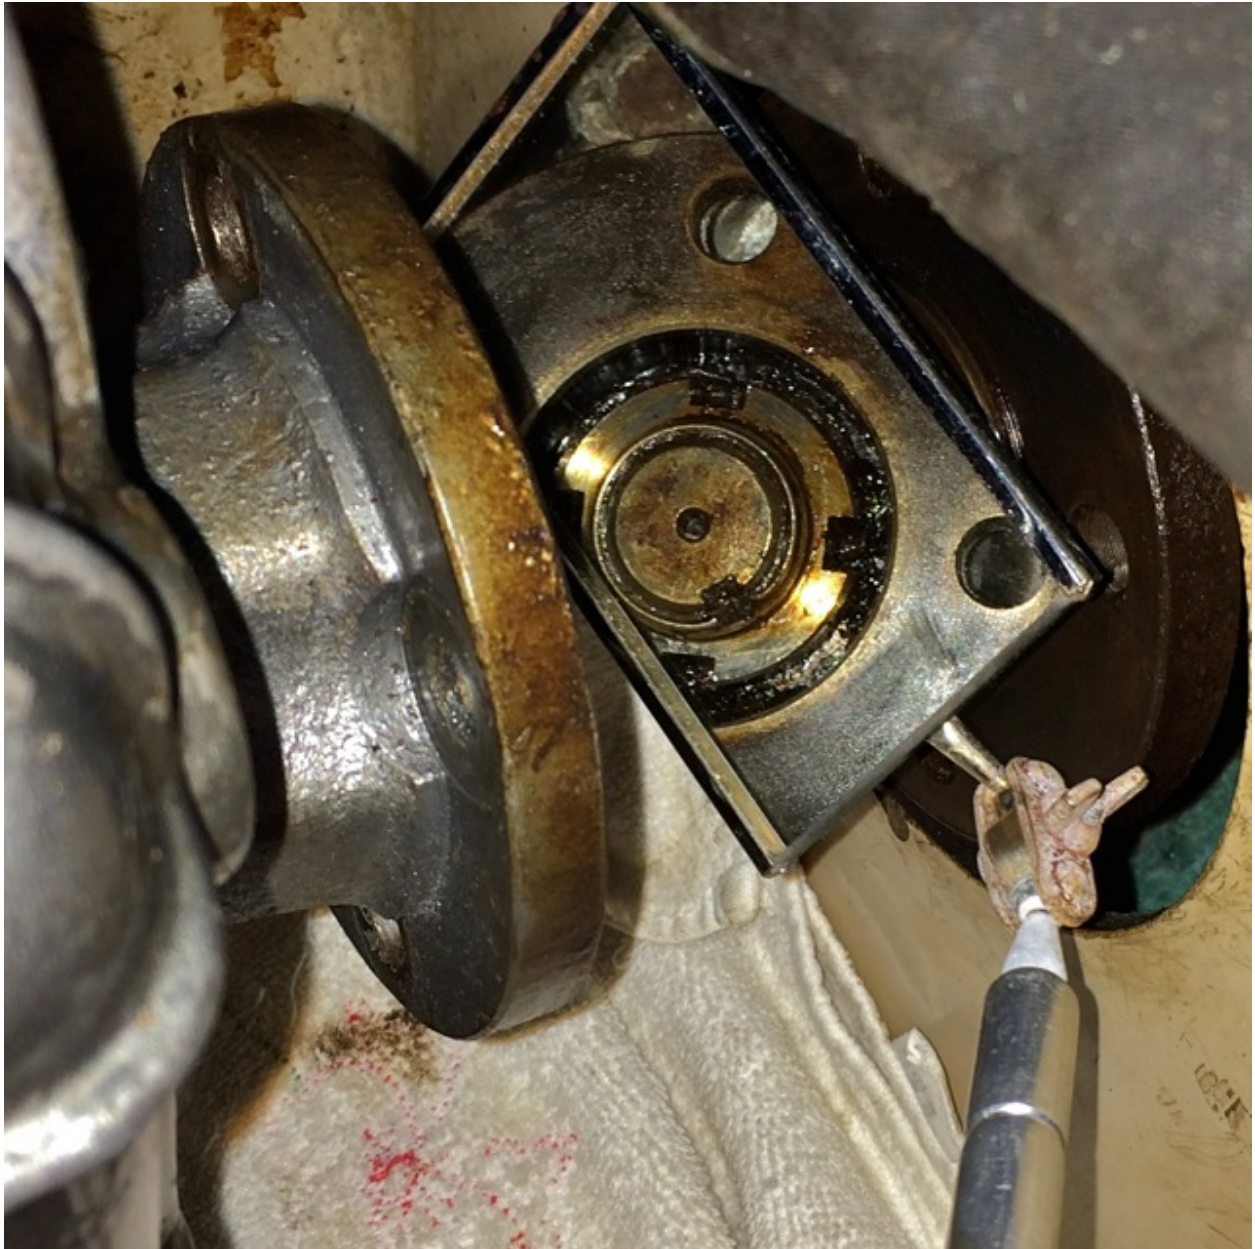
The prop shaft coupling now was moved aft through the bulkhead opening. Using "smoke and mirrors", I could see the locking nut that holds the output coupling to the shaft. Note the caulking dent, notched into the shaft key slot, that keeps the nut from backing off in reverse. Notice also all the dried up greasy transmission fluid that has accumulated inside the coupling and around the nut...

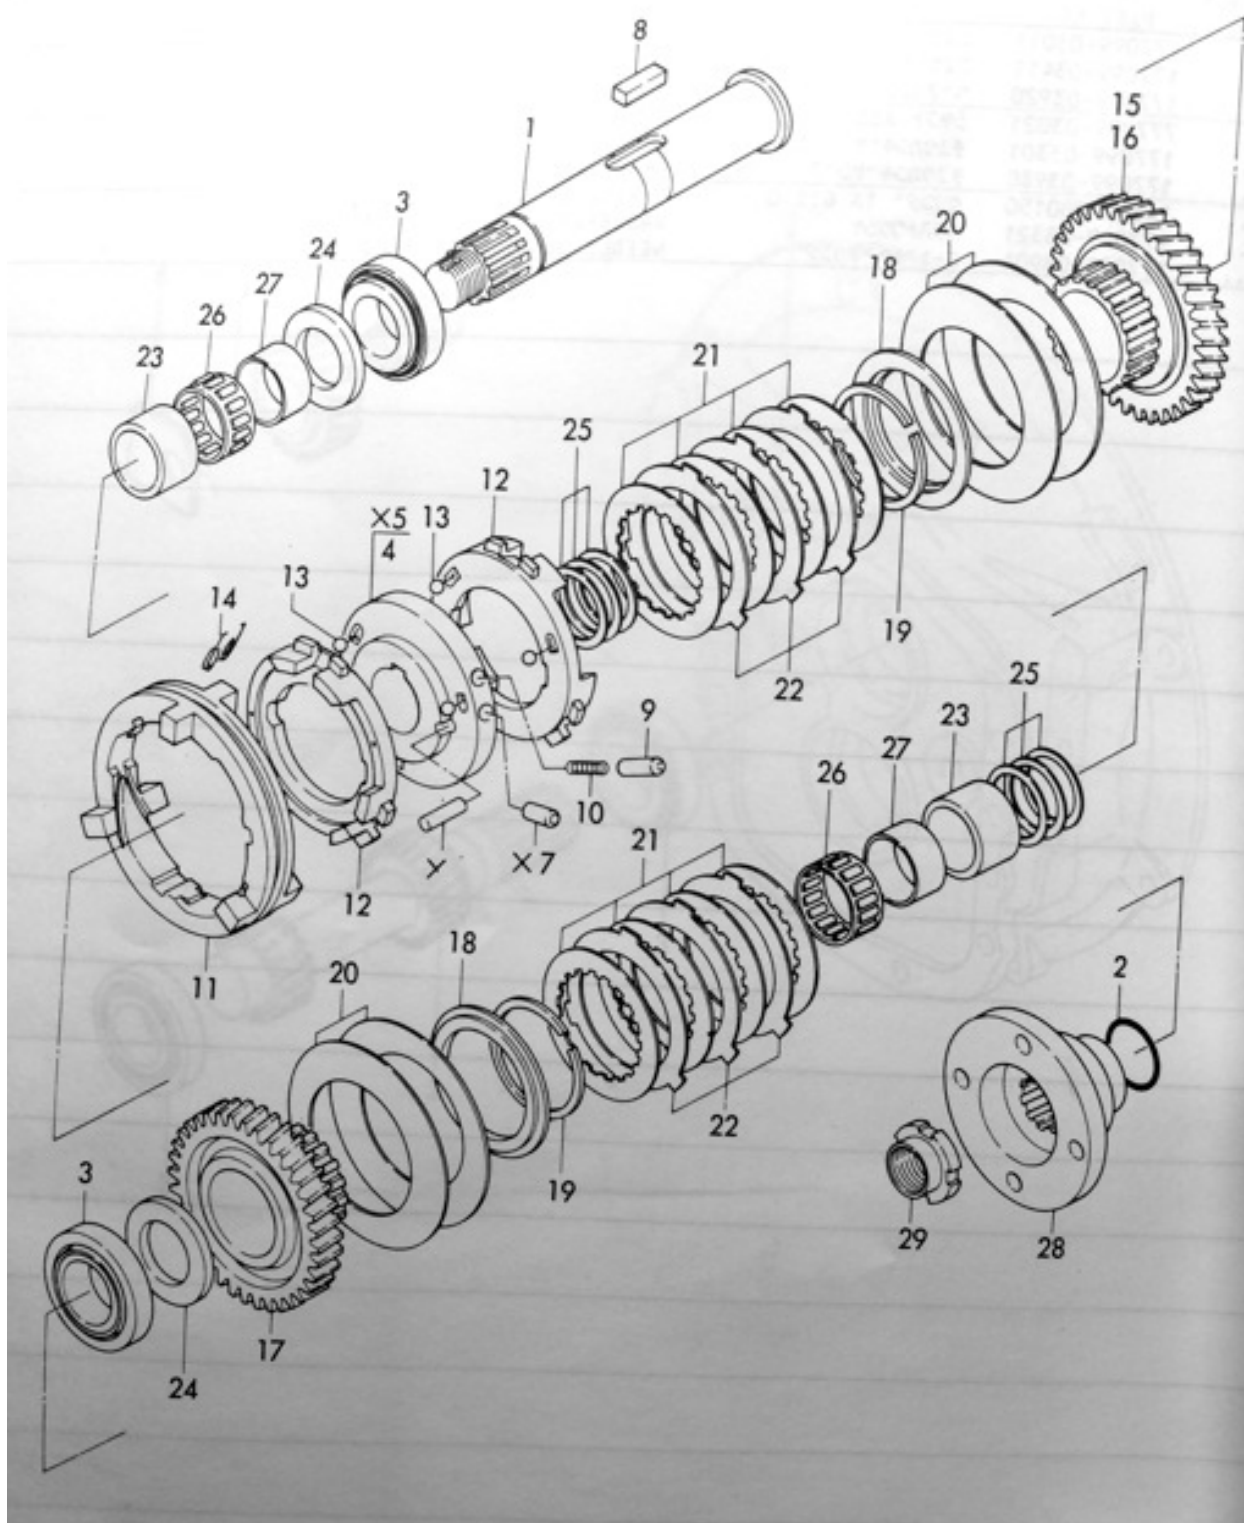
The diagram on the next page, from the **Yanmar Service Manual**, shows the parts of the transmission we are dealing with in this repair.

1. the splined end of the output shaft (#1)
2. the groove that runs around the shaft just forward of the splines (the double line just near where the #1 line meets the shaft in the drawing)
3. the outer roller bearing (#3 bottom left)
4. the O ring (#2),
5. the output coupling (#28)
6. the locking nut (#29)

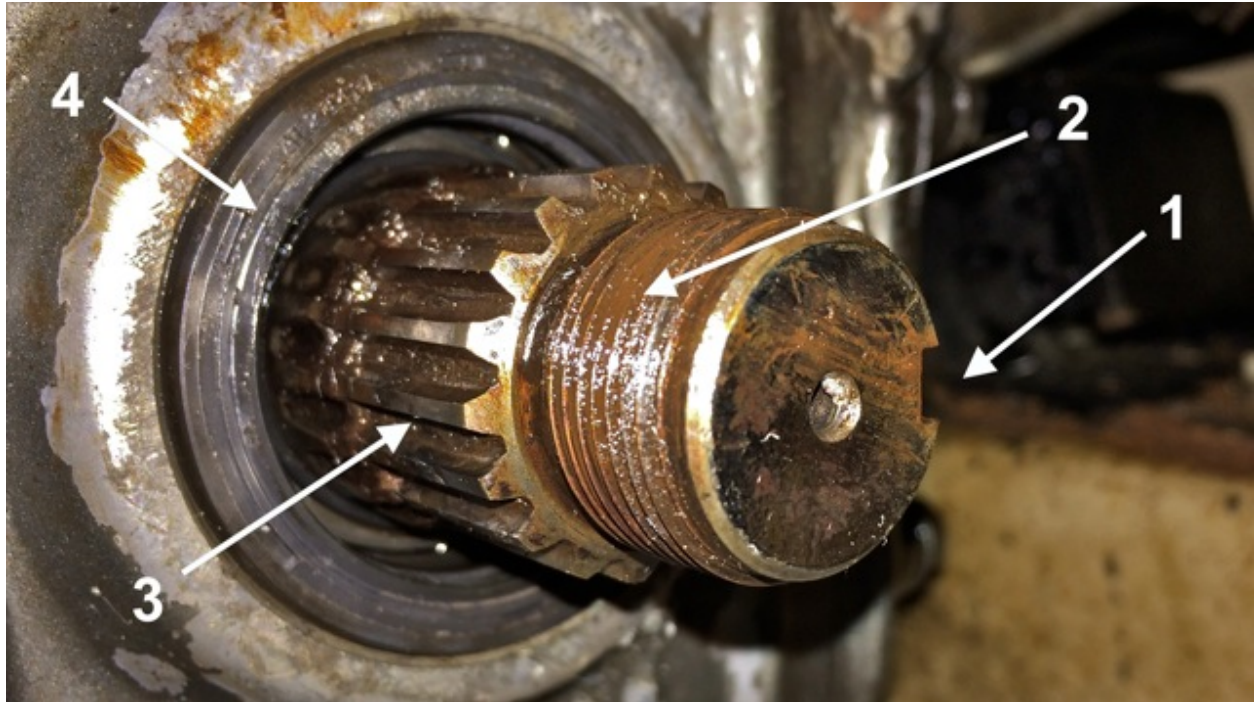
Here is the shaft exiting the transmission housing after removing the coupling.

1. key slot - for caulking (denting) the lip of the locking nut once tightly threaded
2. threads for the locking nut (right handed)
3. splines - integrate the coupling with the shaft
4. oil seal - prevents oil from leaking between the housing and the coupling

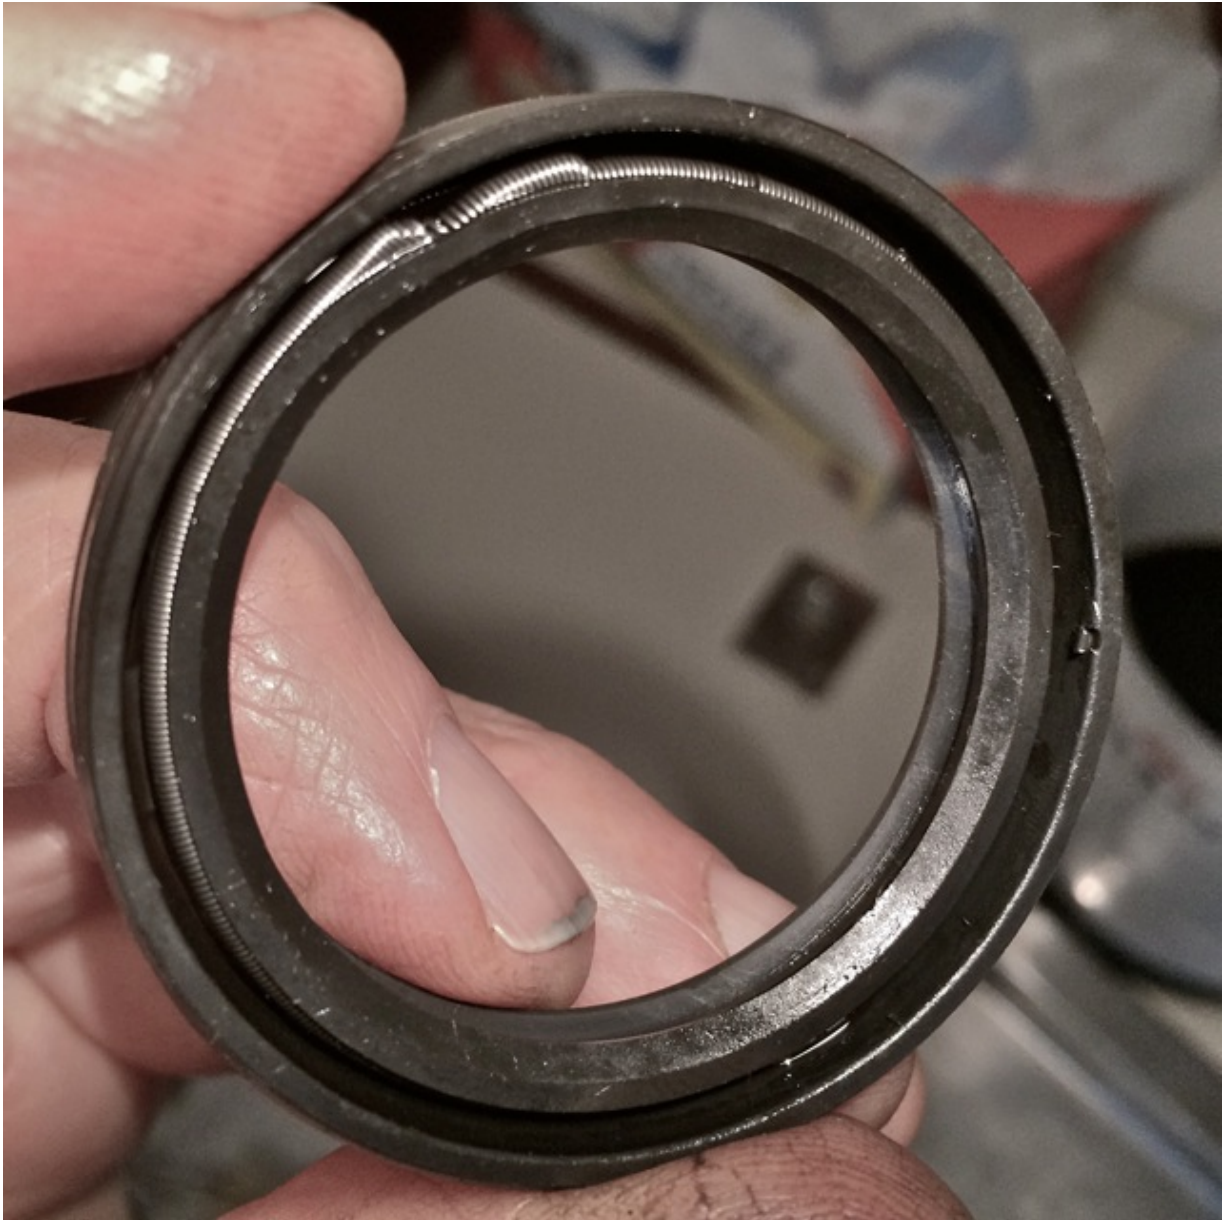
The oil seal is a hard plastic ring that fits snugly in the housing. It has 2 parallel flexible lips on the inner side that seal against the coupling. In the middle is a spring that encircles the flexible lips and keeps them pressed against the coupling. I damaged the spring taking the seal out. Otherwise it appeared to be doing its job..

A failed oil seal was not my problem, because the oil was leaking along the shaft and inside the couplings (not around them).

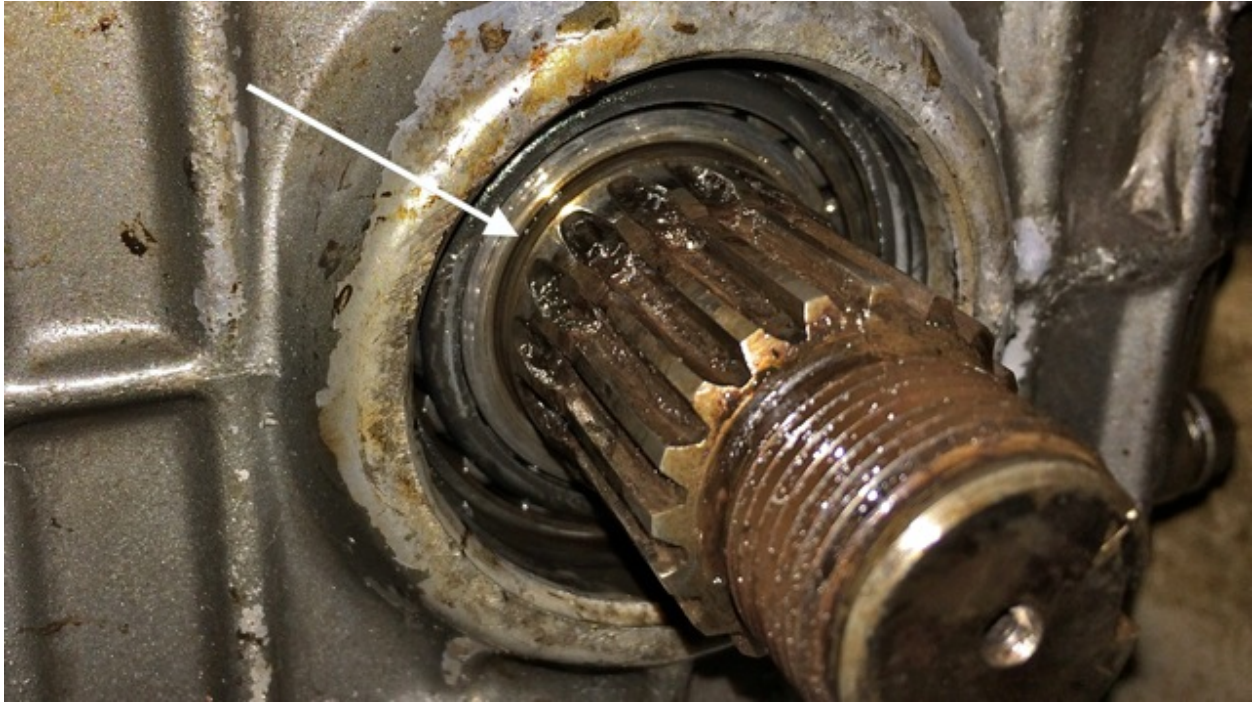
So my problem had to be the O ring.

Now, with the oil seal out of the way, I could see the O ring.
The arrow shows the position of the O ring where the roller bearing meets the shaft...

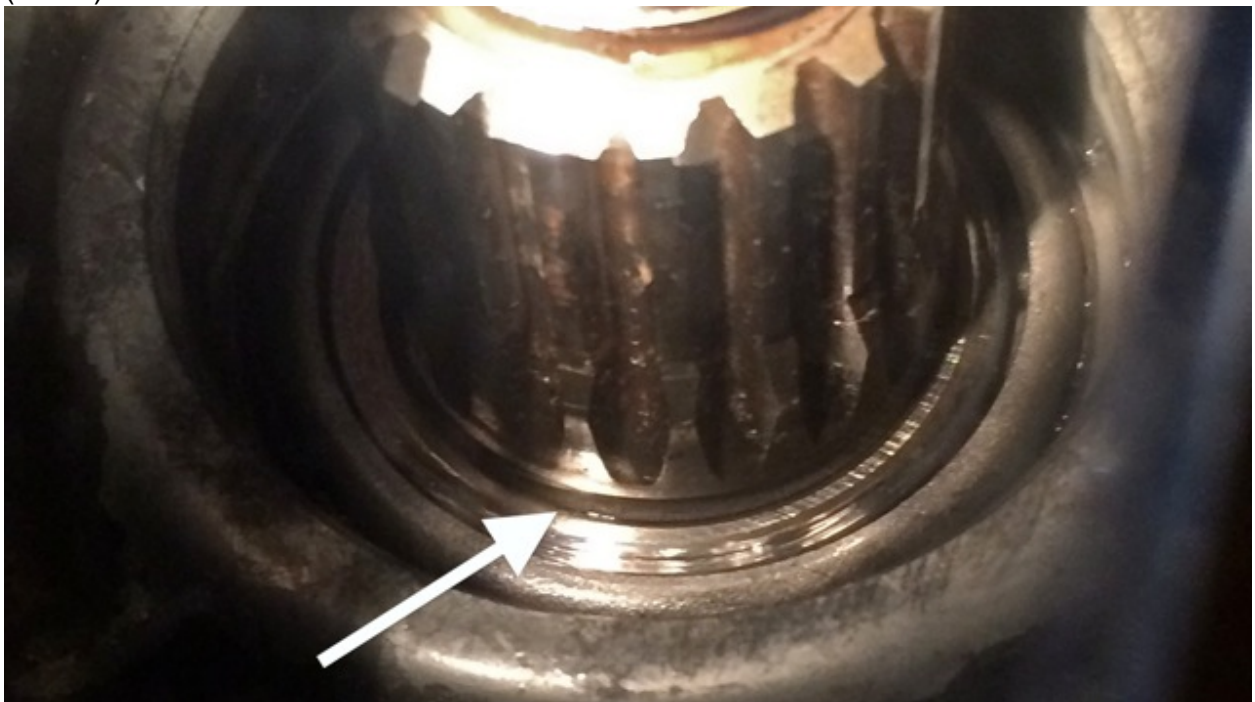
I picked the O ring out with a small flathead screwdriver and then cleaned the entire area with WD-40, mineral spirits and finally 90% alcohol to remove all the transmission oil. Then I could see the groove in the shaft that the O ring had been sitting in (arrow)....

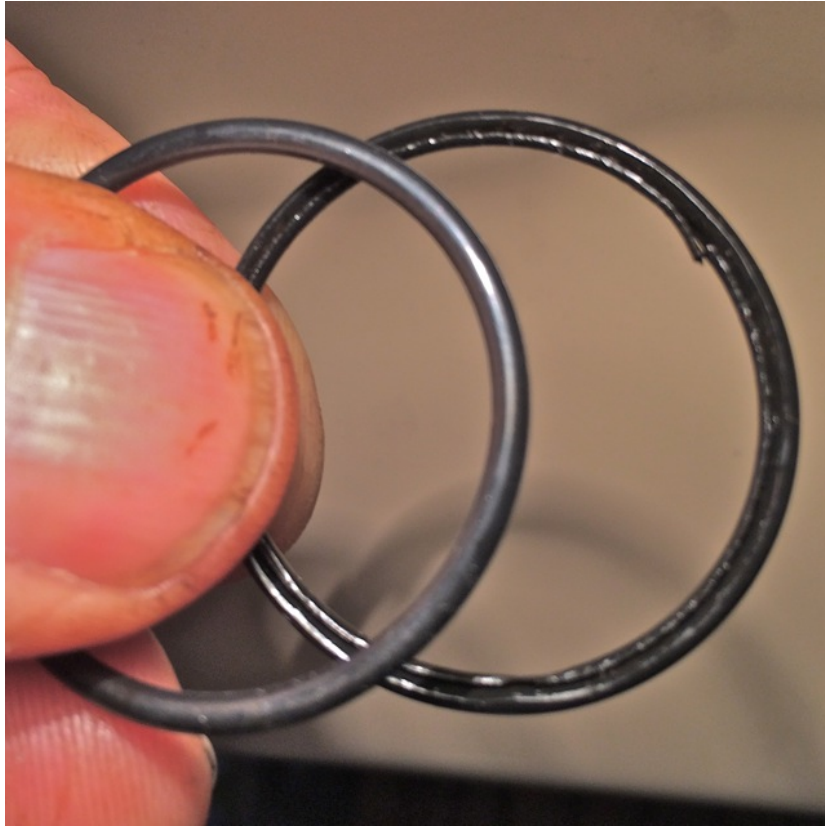
The new O ring on the left and the damaged one on the right...

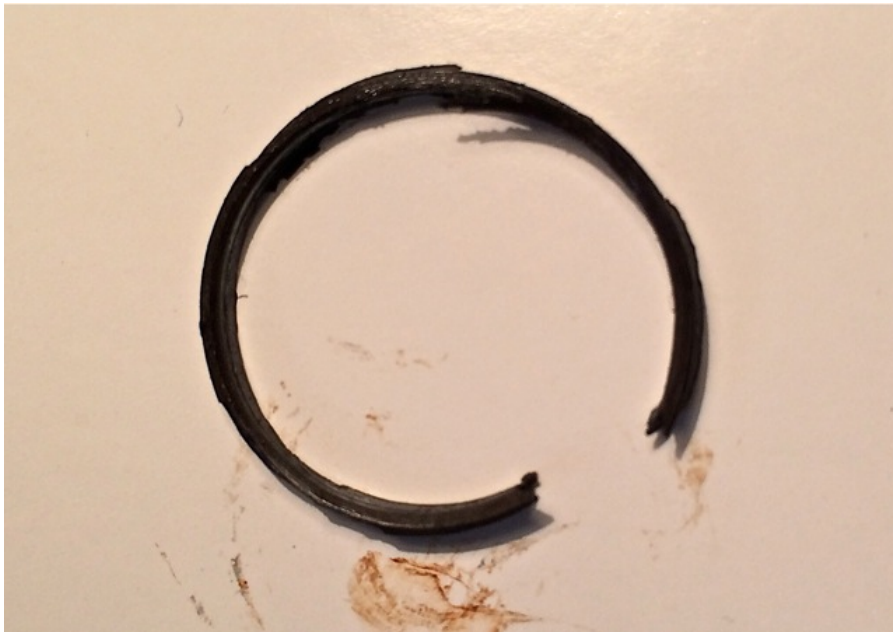
A piece I found floating around in there....
