Piper Aircraft Corporation

SERVICE No. 977 BULLETIN

DATE: December 12, 1994

Inspection of Wing Rear Attach Fitting and Addition of Inspection Access Panels.

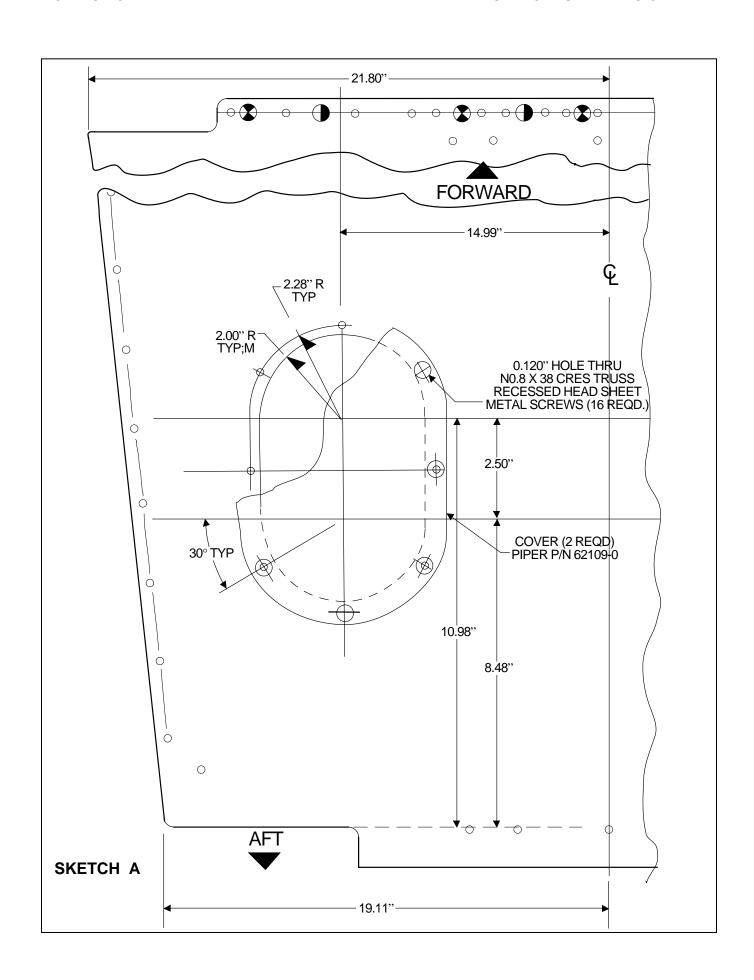
While Sketch A shows the hole in the left side of the baggage compartment, a similar hole is also cut out in the right side baggage compartment floor. Installation will require two each inspection access covers, Piper P/N 62109-0. (If desired, these covers may be fabricated locally.)

- (4) Measure two points 14.99 inches each side of the reference centerline. Joining these two points will form the centerlines of each inspection hole.

- (5) Measure two points on each side of each centerline of both holes at distances of 8.48 inches and 10.98 inches from the aft edge of the baggage compartment floor.

- (6) Connect the two 8.48" points and the two 10.98" points so that the resulting lines cross the centerline of each hole.
 - (7) Using the intersection of the lines constructed in step (6) with each hole's centerline as the center, scribe an arc having a radius of 2.00"

- (8) Draw a line (four lines total) tangent to the each side of the arcs constructed on step (7).
 - (9) There should now be two ovals, like the one in Sketch A, laid out on each side of the baggage compartment floor.

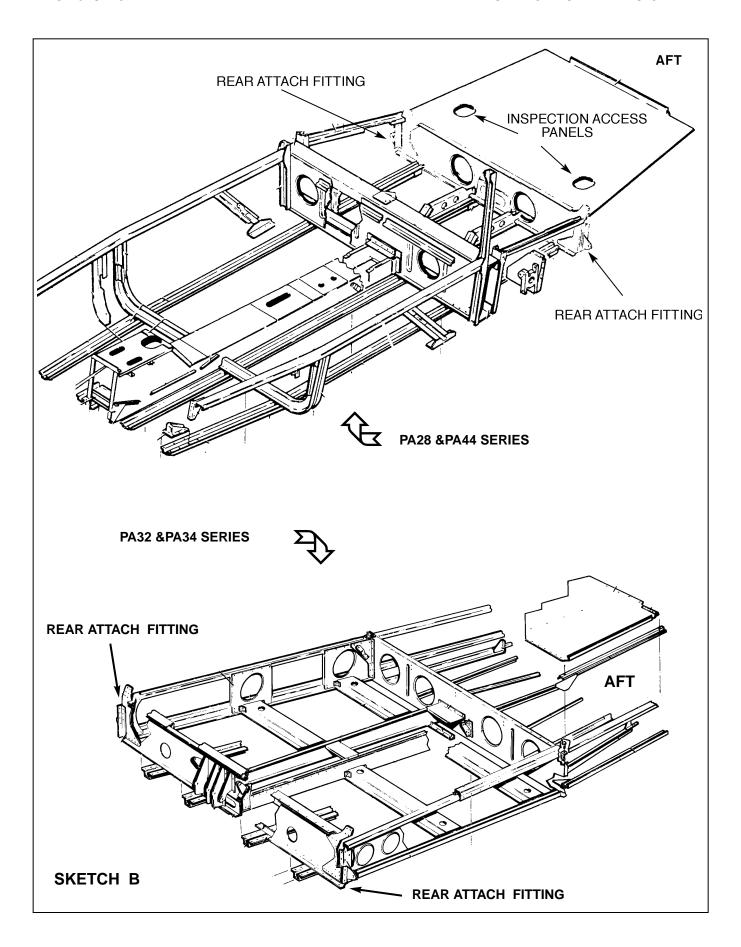
- 3. Inspect thoroughly the left and right rear wing attach fittings for evidence of flaking paint and/or corrosion. (Flaking paint may be a symptom of hidden corrosion.) If no corrosion exists, continue with these instructions. If corrosion is superficial and there is no metal flaking and/or pitting, clean and paint fittings. (Use good quality aircraft primer) If corrosion is found, consult the appropriate Illustrated Piper Parts Catalog for replacement part numbers and obtain and install new parts before continued operation. (See Sketch B and Instructions on page 7 for removal and re-installation.)

- 6. Remove bolt from wing rear spar and fuselage attach fitting.
- 7. Carefully drill out the rivets that attach the fitting to the spar.
- 8. With all the rivets removed, remove wing attach fitting from the aircraft. Discard fitting.

- 9. Clean and inspect the areas that were under bracket for any signs of corrosion.
- 10. If corrosion is found, repair or replace parts as necessary. Coat the area with primer and allow to dry.

- 11. If no corrosion is found, coat the area with primer. Allow time to dry.
- 12. Install new wing attach fitting and align rivet holes. It may be necessary to ream open the bolt hole to proper size. The hole is close tolerance and should be .3115 / .3135 (5/16) or .3745 / .3765 (3/8) depending on model and year. Replace attach fitting bolt should there be any sign of wear or corrosion.

- 13. Re-rivet wing attach fitting into place with appropriate fasteners. (See note at bottom of page.)
- 14. Install wing spar and fuselage attach fitting bolt per appropriate section of the Maintenance Manual.

- 15. Seal edges of attach fittings with PRC PR1422 (or equivalent) before installing interior.
- 16. Complete same process to the opposite side.
- 17. Reinstall cargo door floorboard and interior and seats. Connect battery and check for operation.
