Ball Joint Replacement for 2005 F-250 6.0L SuperDuty SRW, 4x4 with ESOF

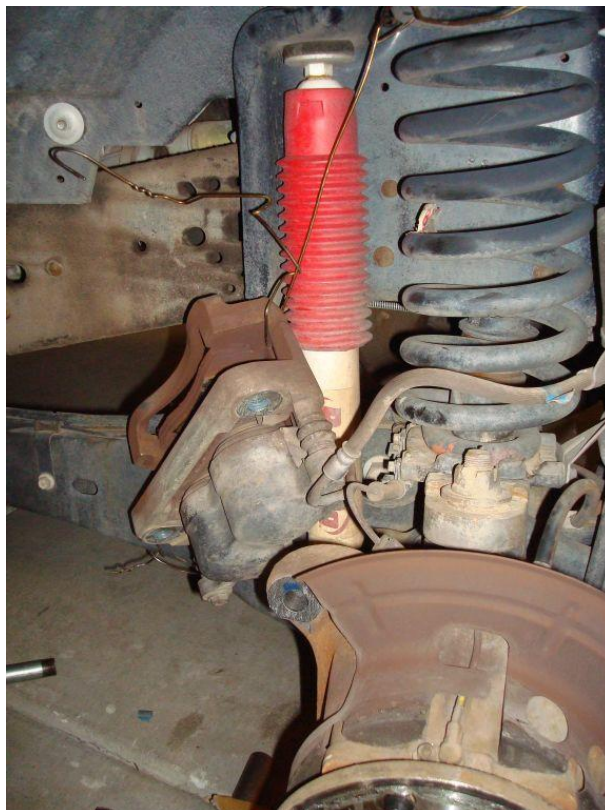
1) Brake caliper removed. You must not let the caliper hang by the hose; I use an old coat hanger to suspend the caliper. Be warned: the caliper bolts took an incredible amount of muscle not only to break them loose, but to fully extract them (mine were coated with a lot of thread lock). I had to use a pipe slipped over the end of my socket wrench to break them loose. 2 Brake caliper bolts reinstallation torque = 225 Nm (166 lb-ft).

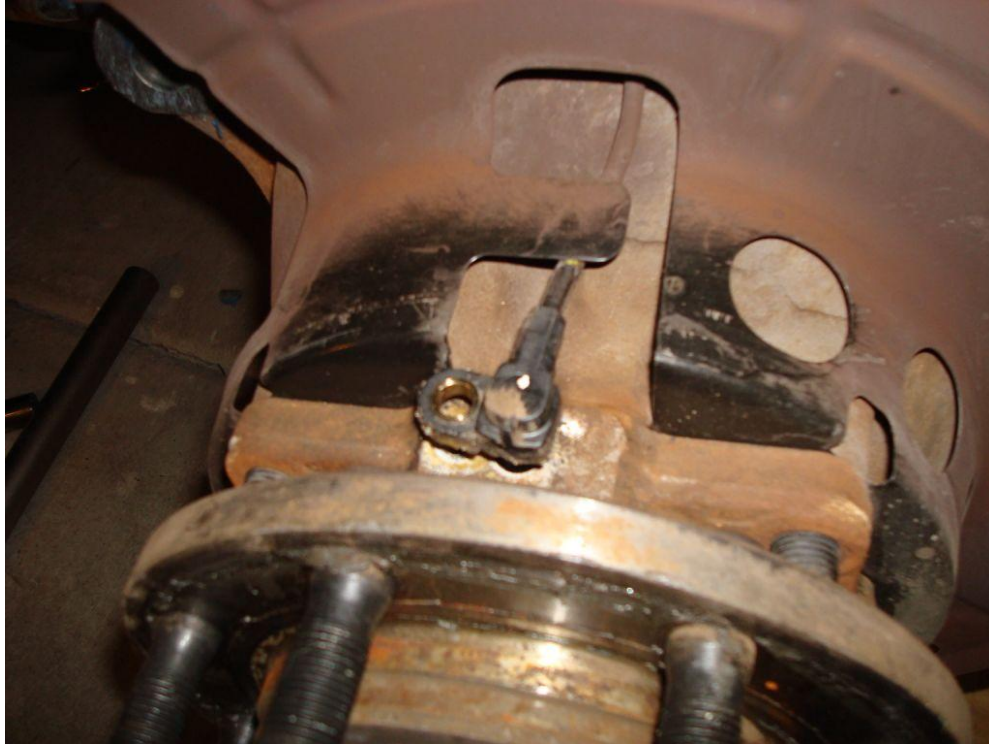
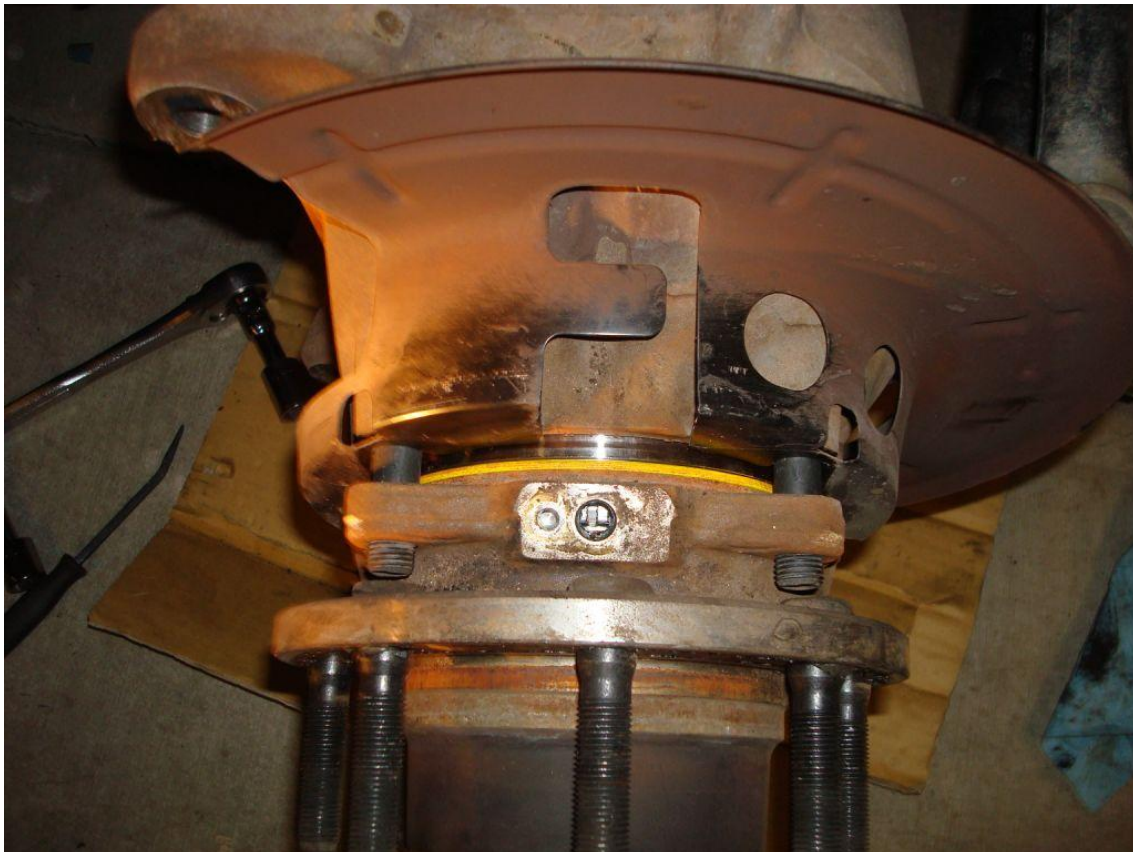
2) Removing the ABS sensor. There was so much brake dust and dirt on the outside of mine, that I initially had a hard time figuring out what portion of it actually separated from the hub. I suppose you could leave it in place and just unfasten enough retaining clips to set the hub off to the side, but I found it far easier to remove it. There is a small sealing o-ring that provides a little bit of resistance when first pulling it out. The bottom photo shows it removed completely, and the hub is actually pulled out a bit from the steering knuckle. 1 ABS sensor reinstallation torque = 18 Nm (13 lb-ft)

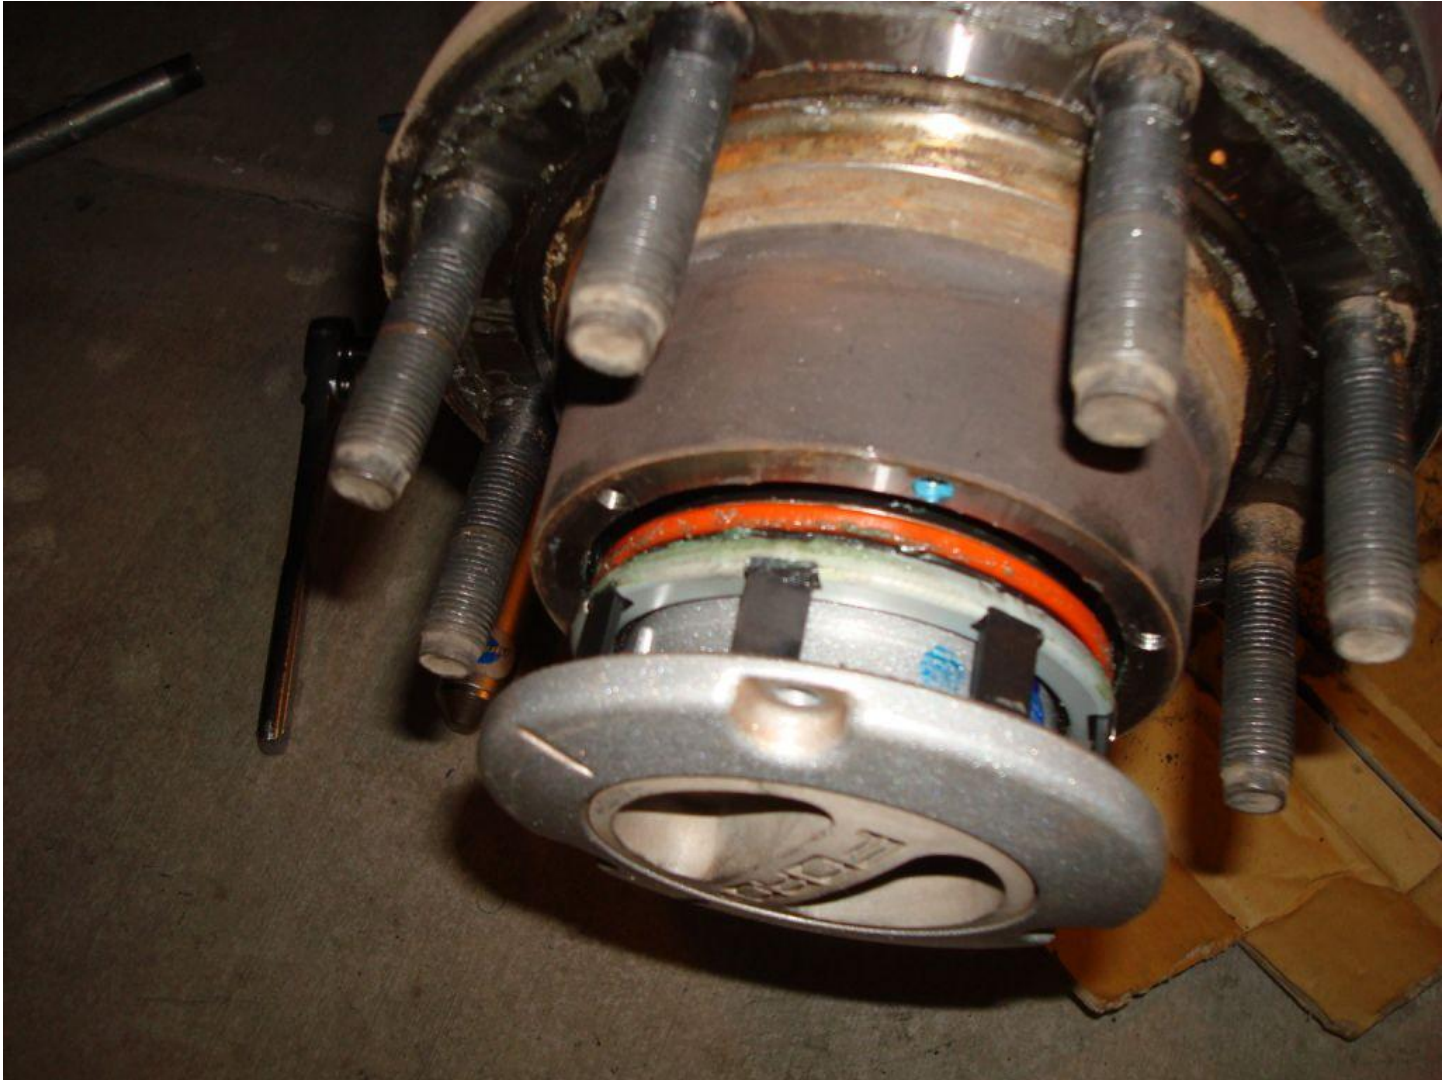
3) Hub lock pulled free. This is held in with three small Torx screws. The service manual says you might have to jiggle the drive shaft a bit to loosen the spline fit, though mine came out with ease. You might have to gently pry it loose from the hub face, the gasket can sometimes be a little sticky. There is a Ford service kit for the hub lock which includes a new o-ring (orange one seen below) and a new gasket that fits between the hub face and the hub lock flange. They claim a new o-ring and gasket should be used when removing and installing the hub lock - you might be able to get away without replacing it, but you run the risk of creating a vacuum leak, which will cause your hubs not to automatically lock when selecting 4x4 from the dash. 3 hub lock Torx screws reinstallation torque = 6 Nm (55 lb-in)

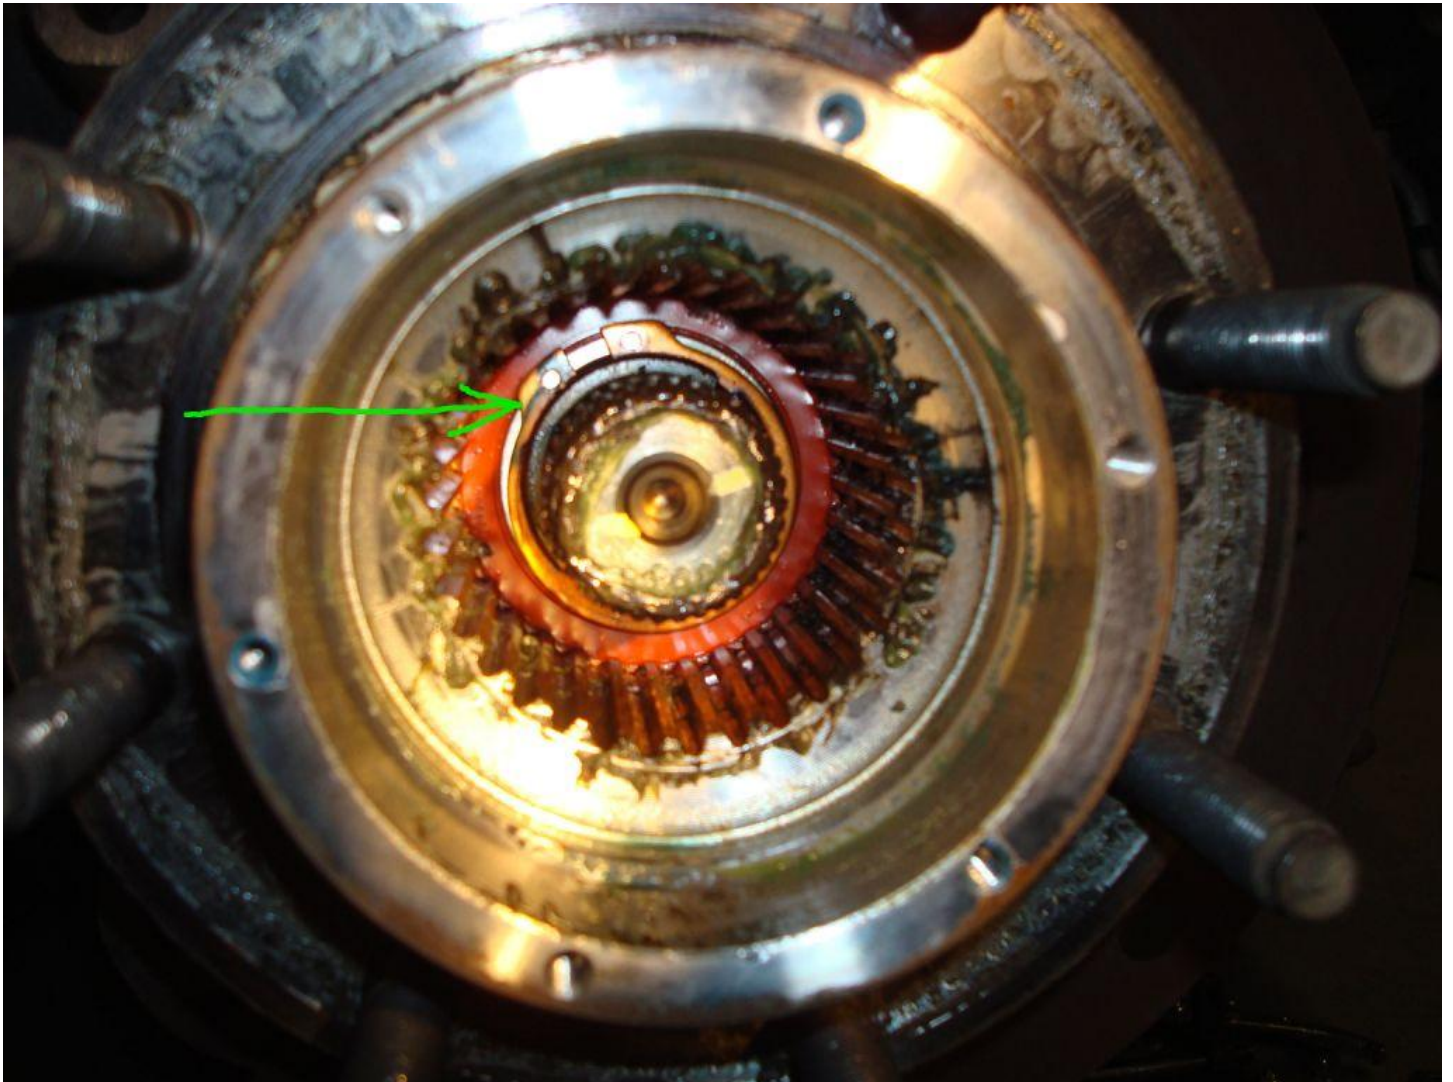
4) Snap ring. Oh the dreaded snap ring. This is what's visible when the hub lock is removed. Out of this entire job, this snap ring was one of the two most frustrating aspects (the other being the ball joints themselves, more on that later). There is not a lot of clearance between the OD of the spline on the drive shaft and the ID of the spline on the hub. This, combined with the depth that the snap ring sits at, makes it difficult to extract.

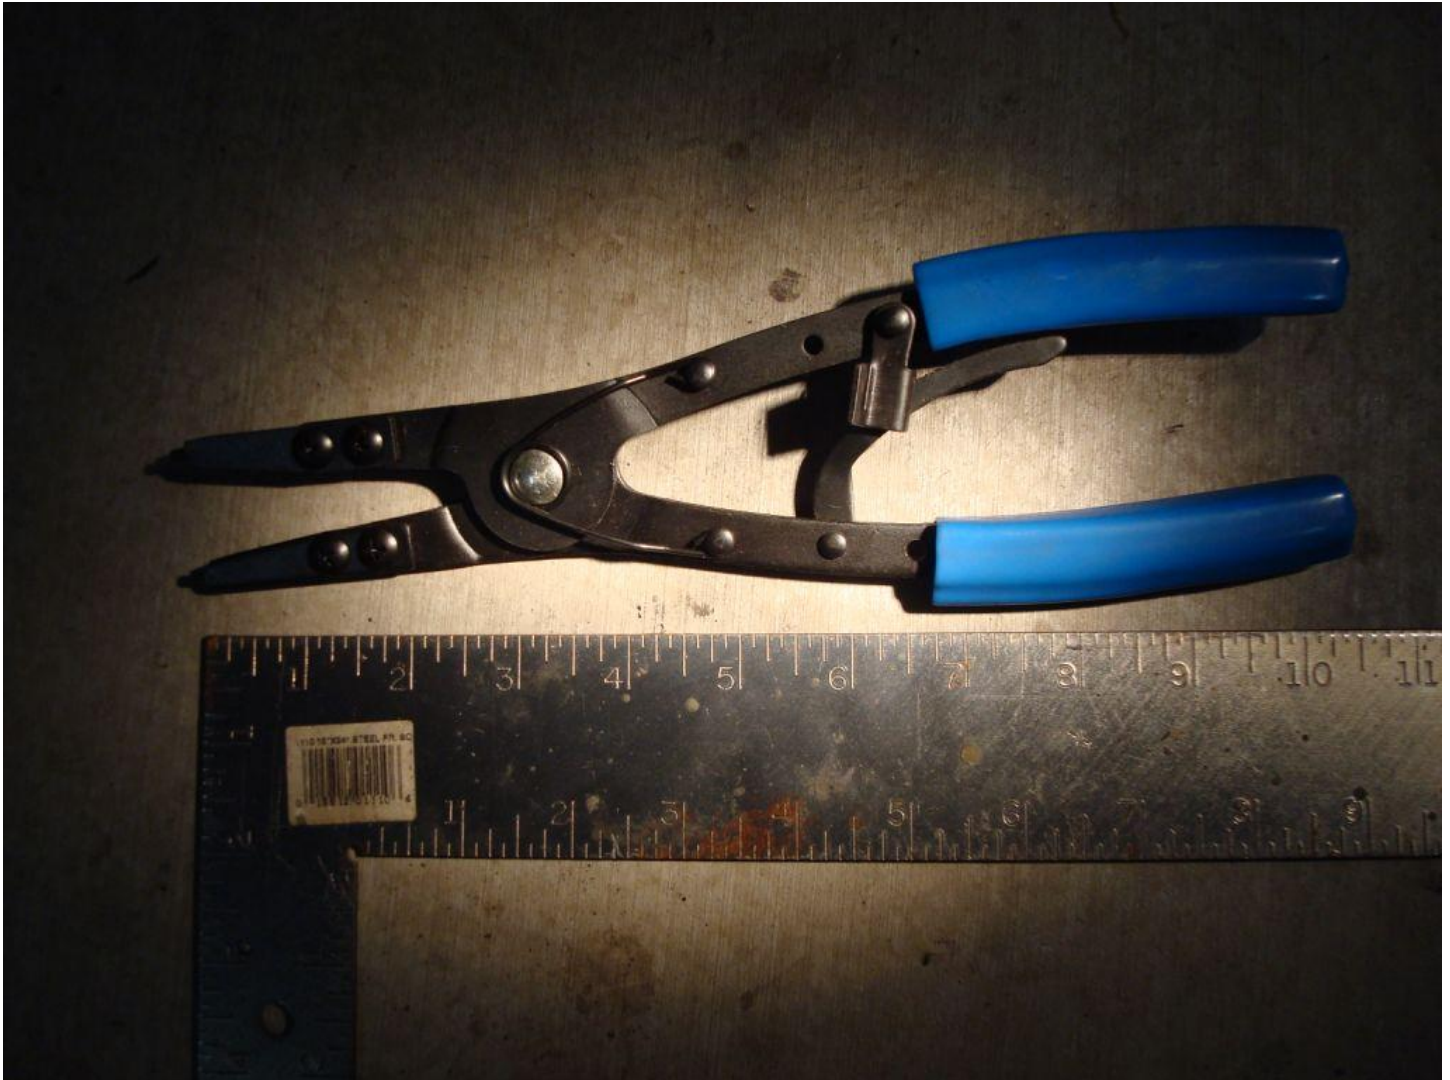
Adding to the frustration is that **none** of the normal, readily available sources of inexpensive auto tools (AutoZone, Checker, Napa, Carquest, Craftsman, Pep Boys, etc) carry a set of snap ring pliers that are long enough. Trust me. I spent all day Saturday driving around to these places. The only place that had something viable was Harbor Freight. A friend of mine classified Harbor Freight as "a great place to get a tool if you need it to last just for the day". That couldn't be more true when it comes to their snap ring pliers. They did have a large set of snap ring pliers that are deep enough, but I bent the first set, and had to go back and get another set (I was more gentle this time). Note the required length of the pliers below - the pliers need to reach about 4 inches in to get to the snap ring. If I were to do this job again, I would get with a local Snap-On or Matco rep and spend the money for the correct tool. It will turn 30 min of cursing and swearing (per side) into a simple 5 second task.

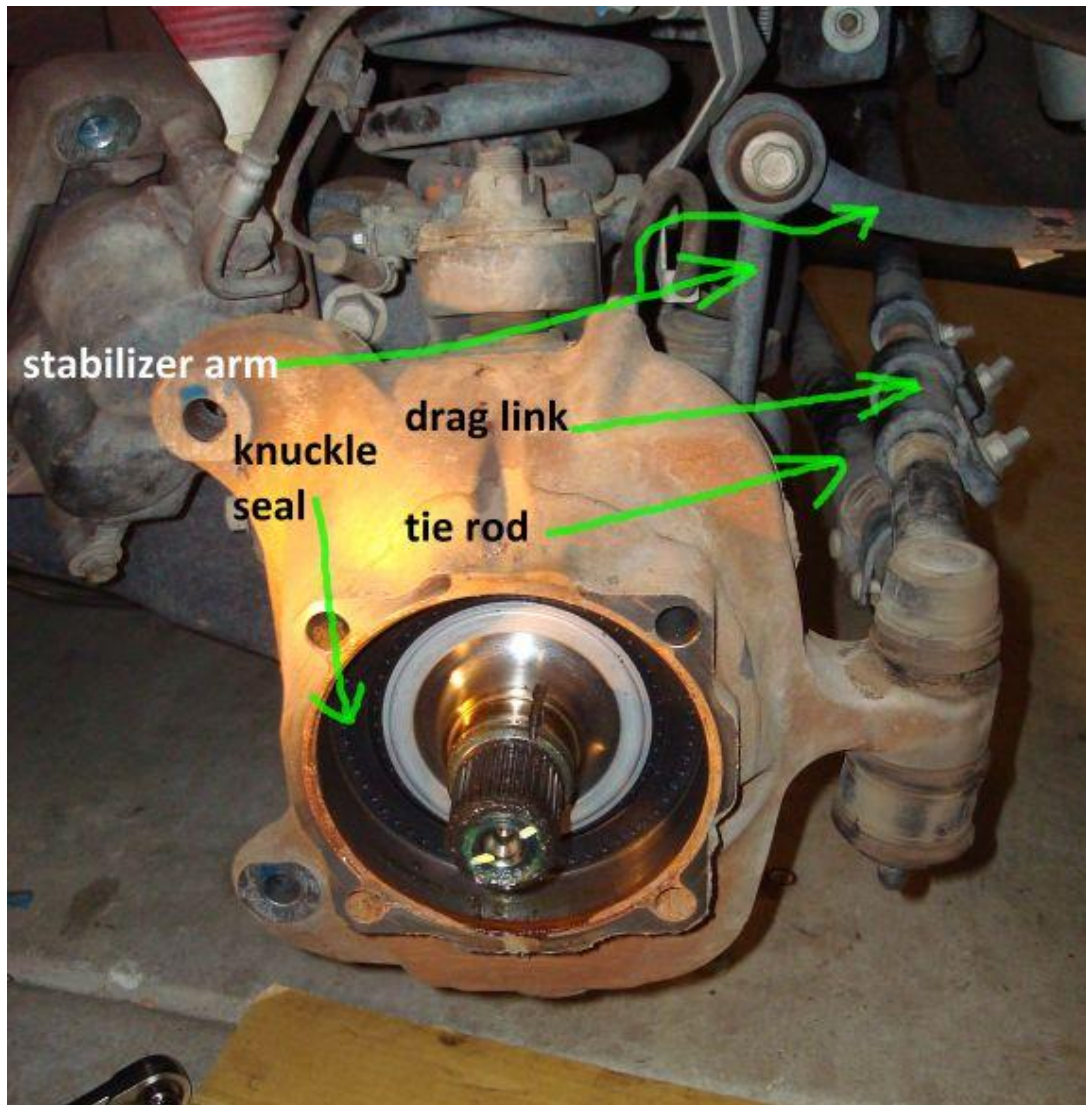
5) Now that the !@\$# snap ring is removed, remove the 4 nuts on the backside of the steering knuckle and the hub can be pulled free and set to the side. Note the large black seal inside the steering knuckle. This is a very tight fit, and needs to be pounded on from the back side to remove it (which subsequently destroys it, requiring a new one for re-assembly). Before removing it, measure the depth where the seal sits - this will come in handy when installing the new one. In order to get better access to the back side, I found it easier to disconnect the tie rod end first, allowing the knuckle to swing about on the ball joints. This way you can pound a couple times on one side, swing it, pound on the other side, etc. This seal may be harder to remove than you think. Keep pounding, it will eventually come out. 4 hub nuts
reinstallation torque = 180 Nm (133 lb-ft)

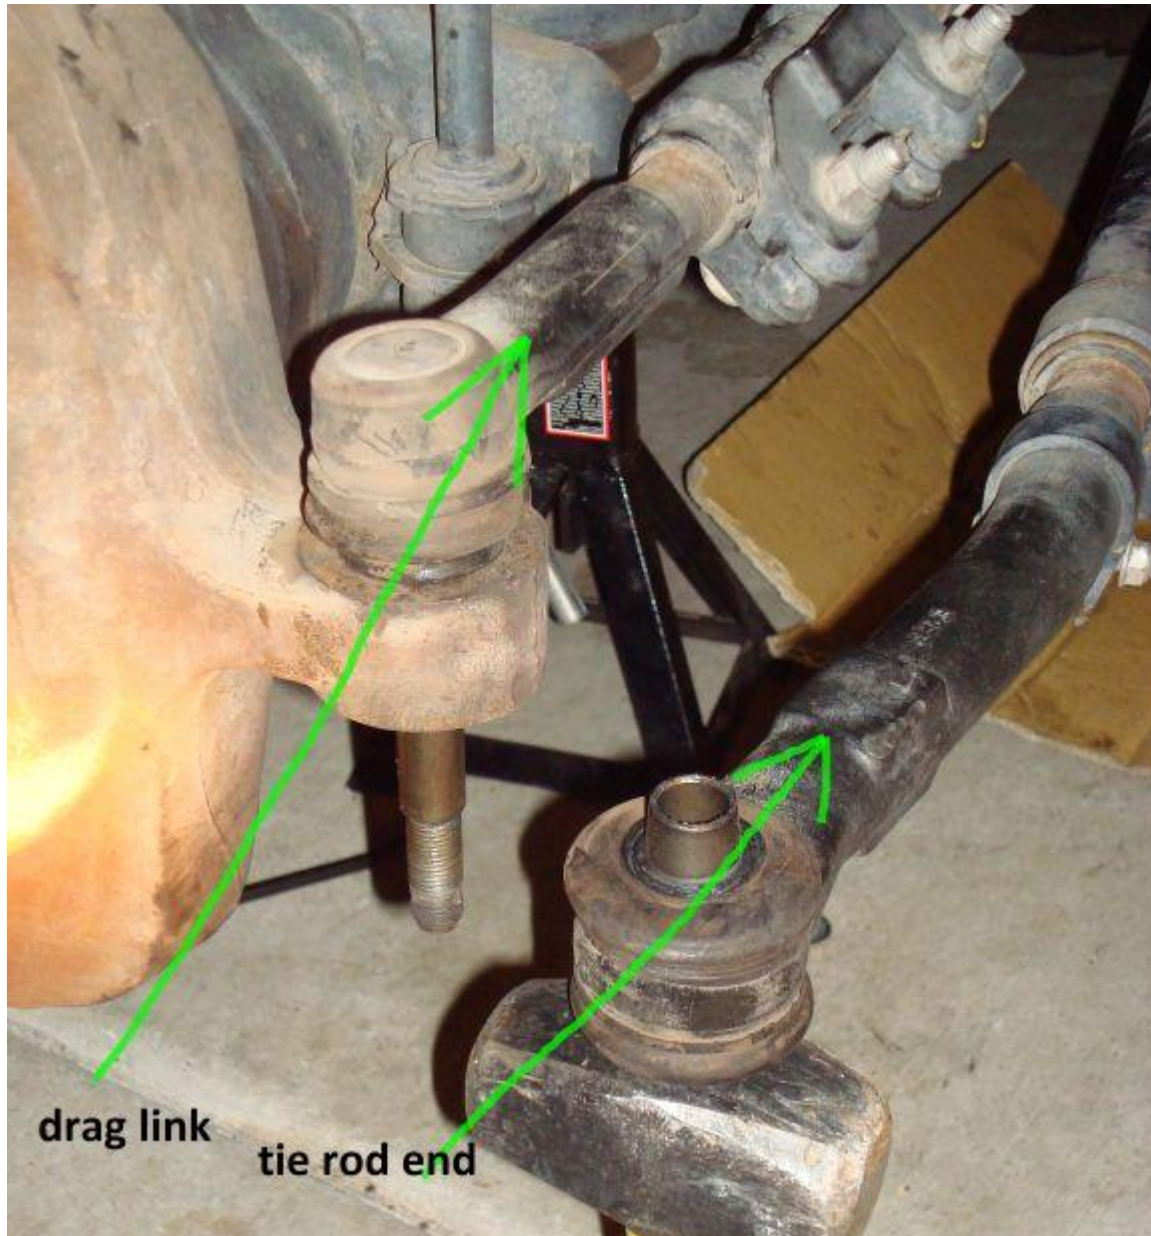
6) The driver's side tie rod end is easy, but the passenger side is a little more difficult since it's attached to the drag link. I found it easiest to loosen the nut so it's flush with the bottom of the drag link stud and give it a couple whacks from the bottom with a small sledgehammer. I tried a couple different pullers that I rented, but there's no good spot for all the puller arms to grab on to. The drag link will not pull completely free from the steering knuckle without loosening the stabilizer bar nut (both sides) and swinging the stabilizer bar up and out of the way. When you're done, grab another wire hanger and secure both the tie rod and drag link out of the way. In the picture below, the tie rod end is precariously balanced on the sledgehammer just for the picture, don't leave it this way! 1 Tie rod end nut reinstalation torque = 70 Nm (52 lb-ft)

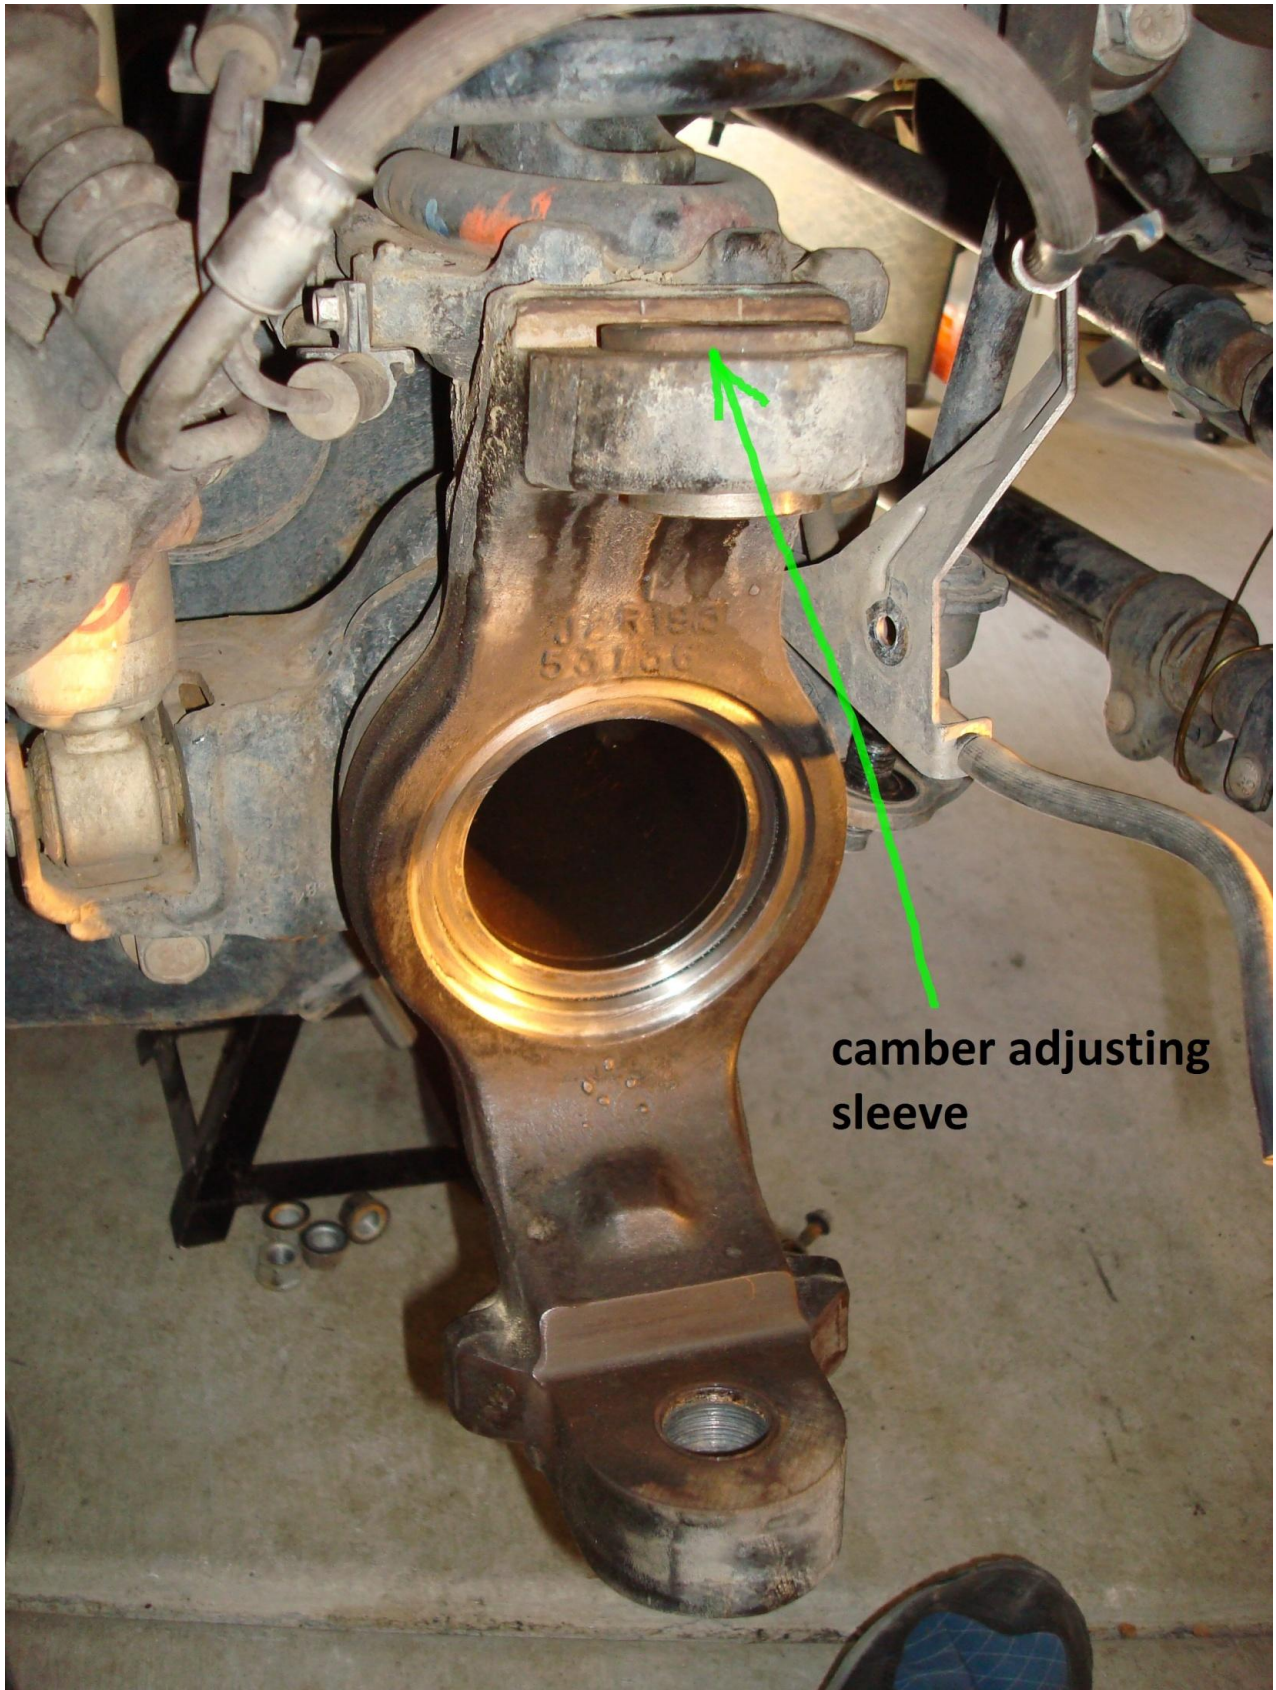
7) Loosen the nuts on the ball joints to be flush with the stud, then start whacking with the sledgehammer. With the nuts still on the stud, this will retain the steering knuckle (very heavy) and keep it from crashing to the floor. This is what it looks like with the steering knuckle removed:

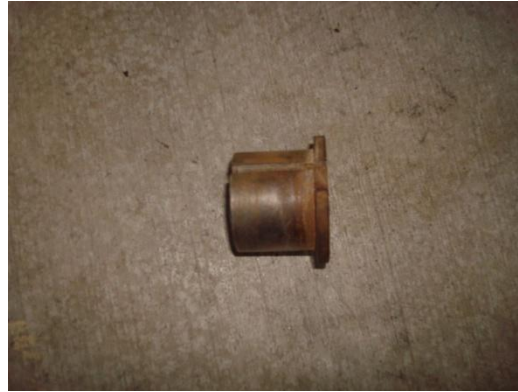
8) Unlike earlier model years, you don't have to worry about messing up the position of the camber adjusting sleeve upon reinstallation of the steering knuckle. As long as the flat edge is facing inward, that's all you have to worry about.

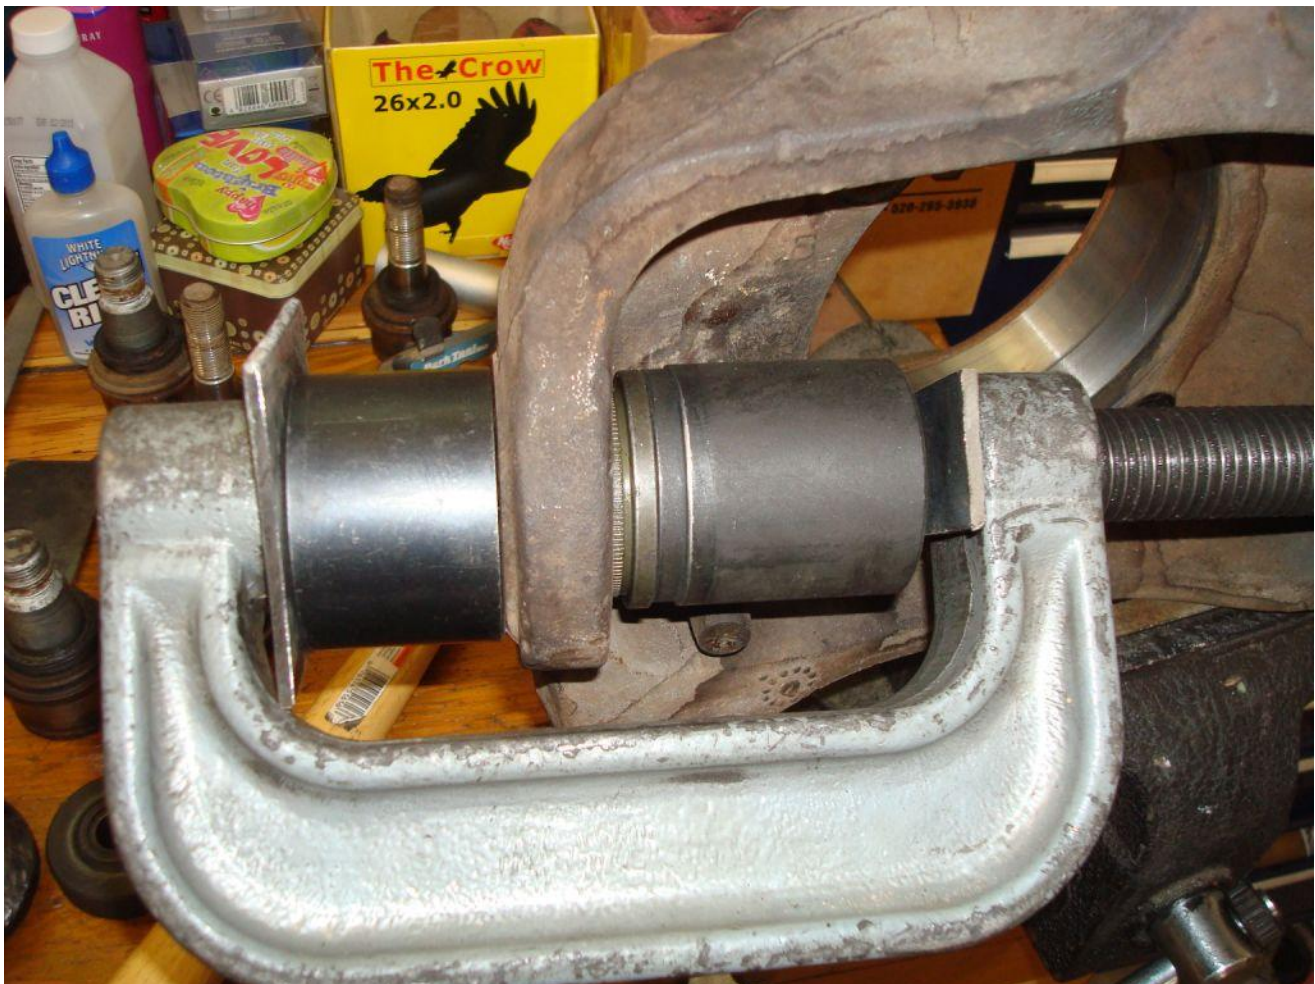
9) Removing and installing and the ball joints from the steering knuckle - the other single most frustrating aspect of the job. Not that it's particularly hard, if you have the right tools. The ball joint press kits and oversized 4WD adapter kits that you can rent from the auto parts stores don't have the right sized (diameter and depth) adapters to make this part of the job go smoothly. I solved it by rigging up a combination of adapters and plate steel to finally get it to work, but not after several attempts of trying different combinations (and more cursing). It was kind of like working on a puzzle with pieces from another puzzle, but trying to force them together anyway. Depending on what you have lying around your garage, you might have something that will work in a similar fashion:

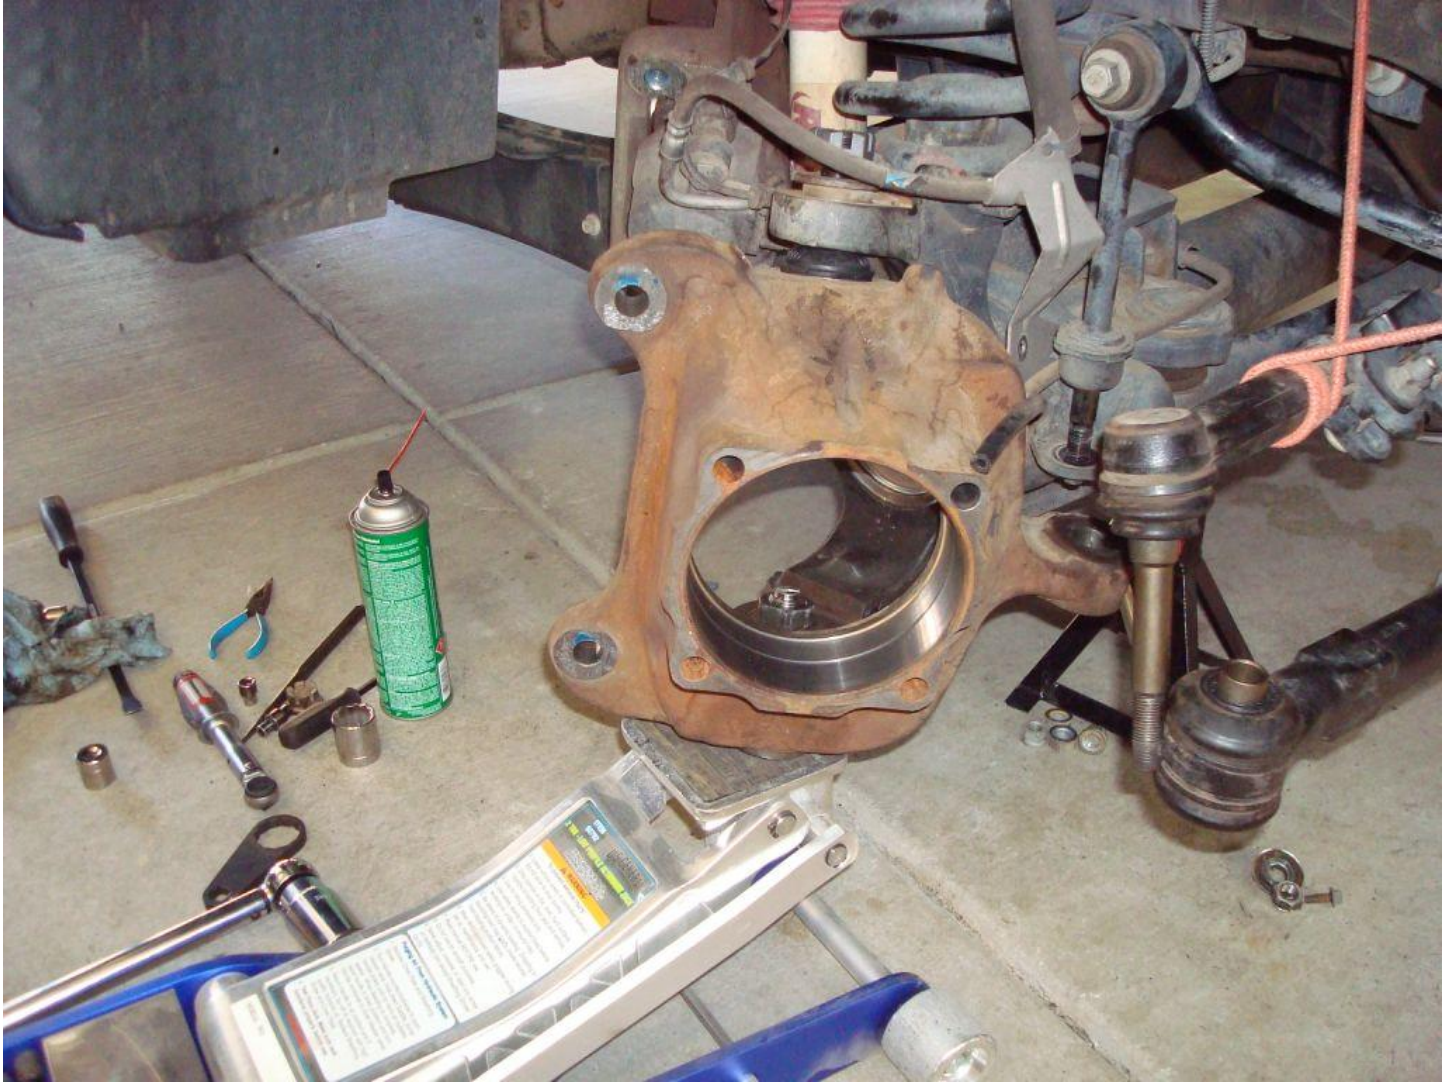
10) This is just a shot of a good tip I read in one of the other write-ups. When you first begin to tighten the lower ball joint nut, eventually the stud will begin to turn in the joint instead of the nut turning on the stud shaft. By placing a floor jack under the knuckle and providing a bit of pressure, the stud will begin to seat in the knuckle, keeping it from turning and allowing the nut to turn on the stud shaft once again. You can also see in this shot the stabilizer arm that was loosened to provide room for the drag link to be removed from the steering knuckle. Carefully follow the torque instructions that came with the new ball joints.

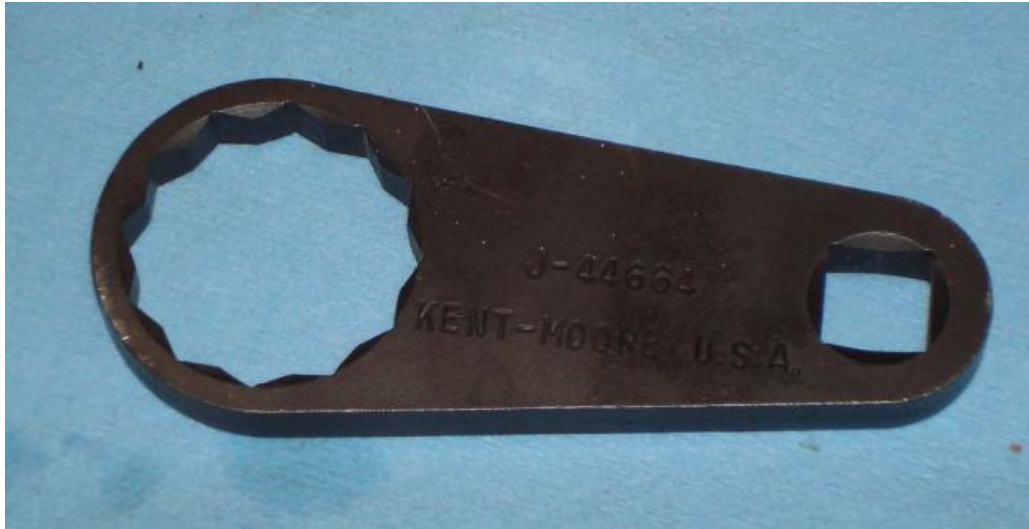
11) I forgot to take a picture of the top ball joint nut during install, but this is important to note. Surprise! On the Moog ball joints, it's a 33mm nut, bigger than the OEM nut. What does this mean? Because the centerline of the upper ball joint is angled towards the coil spring, the larger nut means that you will not be able to get a socket and a torque wrench on this larger nut (at least I couldn't). Solution? A crowfoot. Problem is, good luck finding that 33 mm crowfoot. I poked around on eBay and scored this handy dandy item for a mere \$25:

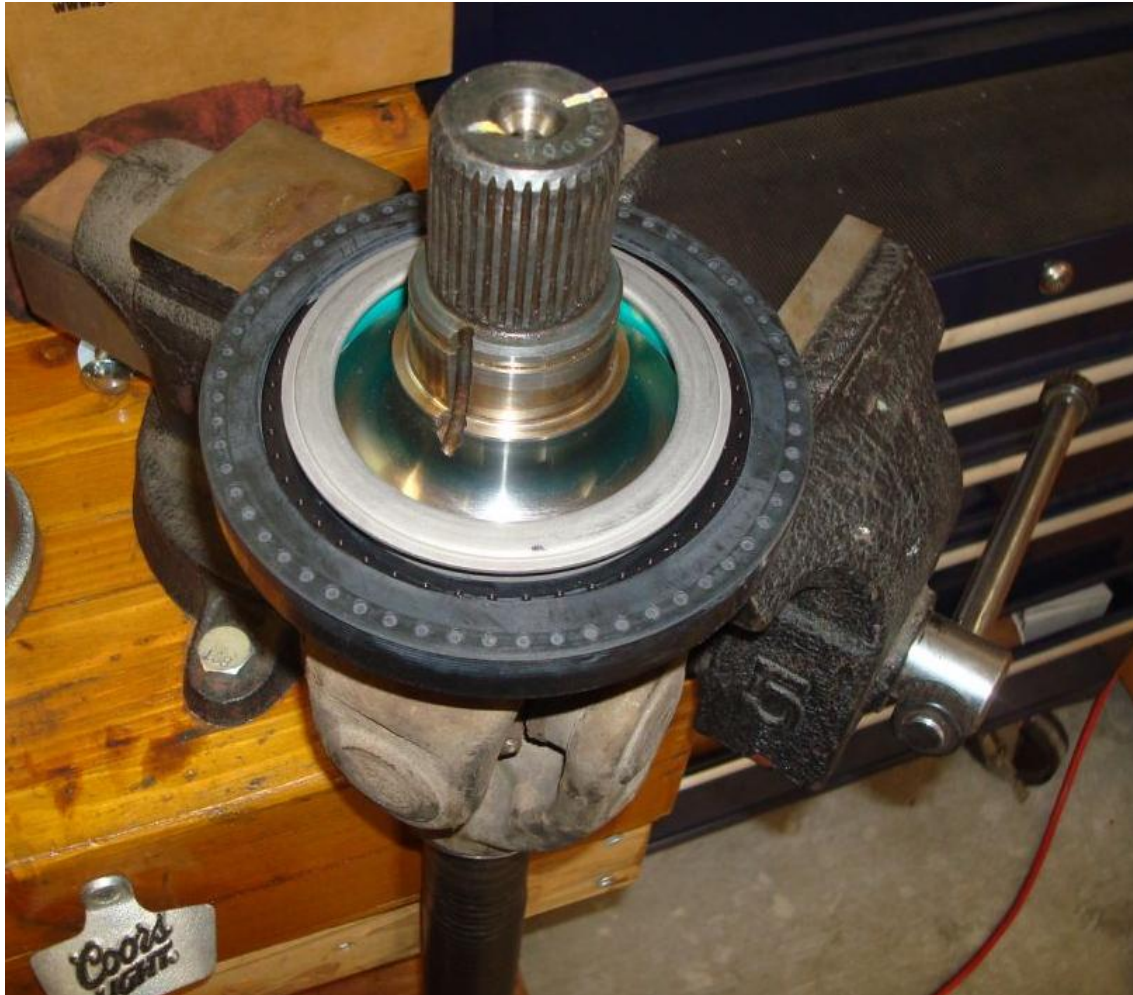
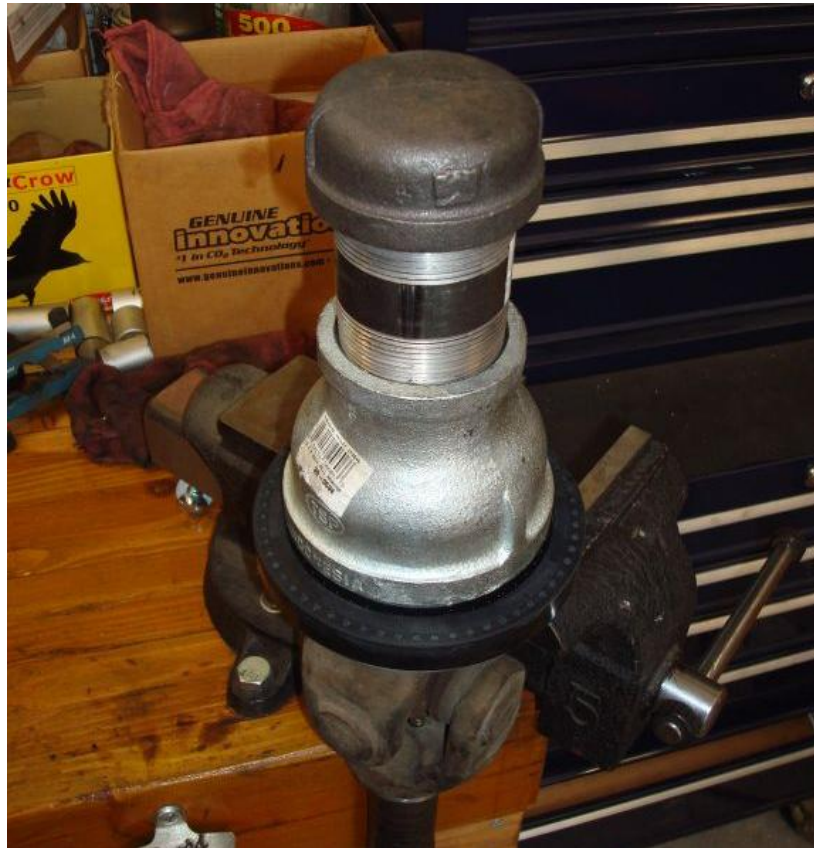
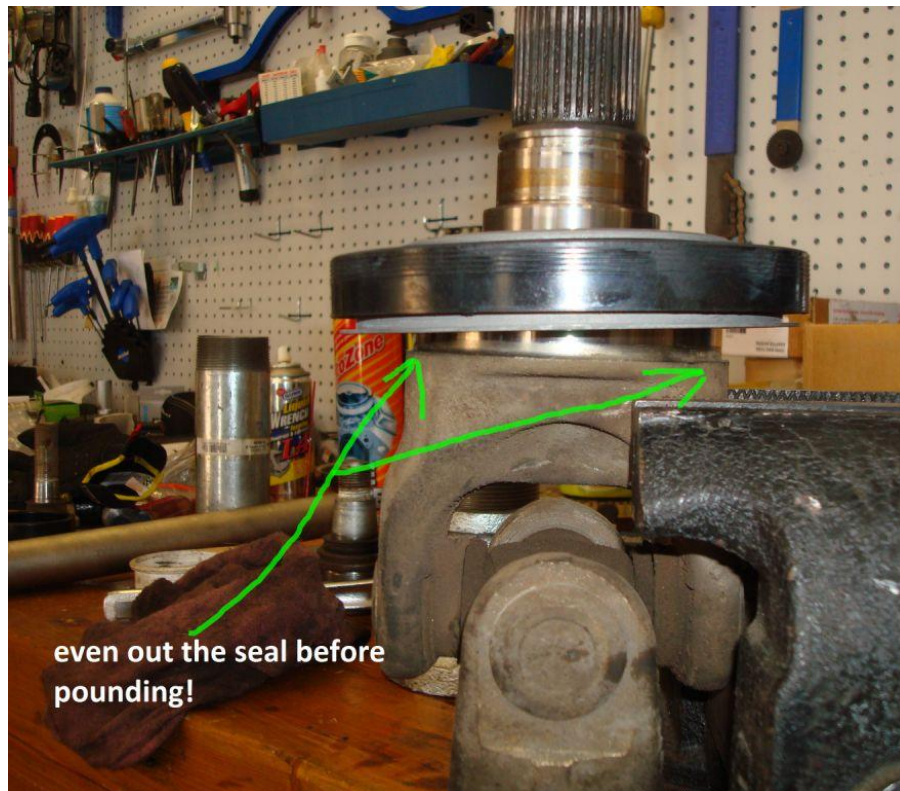
12) Installing the new drive shaft / steering knuckle seal. At my local Ace Hardware store I found some plumbing pieces that ended up working adequately as a seal installation tool. A galvanized 2" cap, pipe, and 3" X 2" reducer screwed together to fit the job nicely. Just be careful to get the seal started evenly. This is where the Ford tool would save some headaches - I'm assuming it pilots on some portion of the shaft to seat the seal evenly. I hung the axle from my vice just above the u-joint - I can't imagine trying to do it any other way.

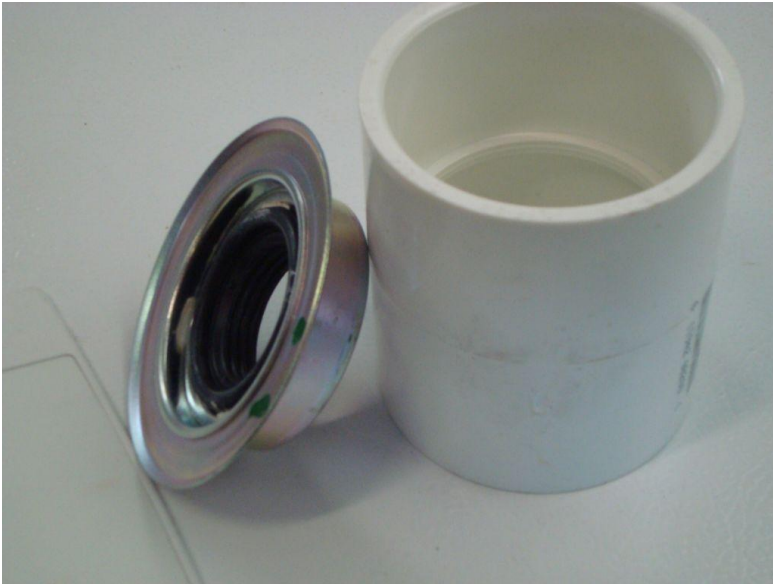
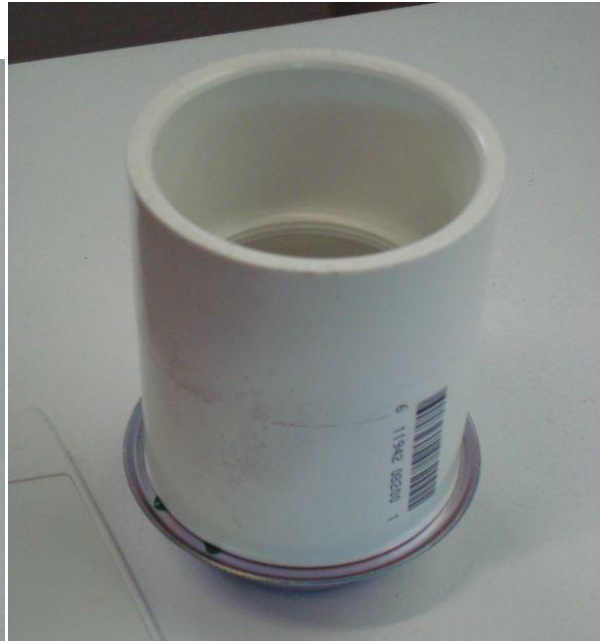
13) Axle tube seal (i.e. dust seal). This is an updated seal that superseded the one that was on my truck. Rather than fitting on the axle shaft, it lightly presses into the flange on the end of the axle tube. I found that a 4" PVC coupler with a piece of wood to lightly bang on made a perfect tool to press this in place:

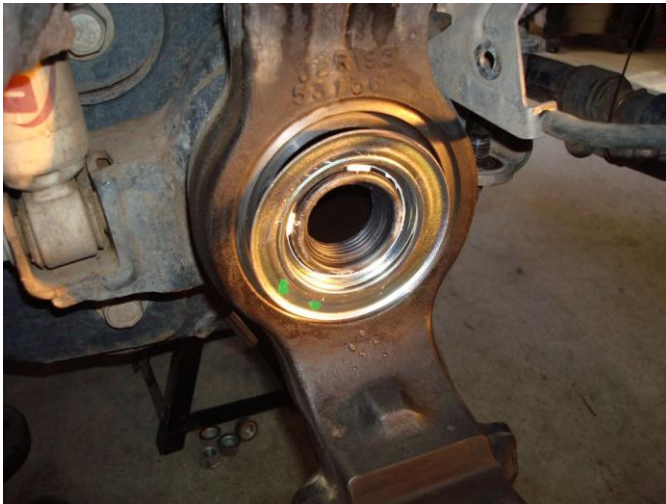
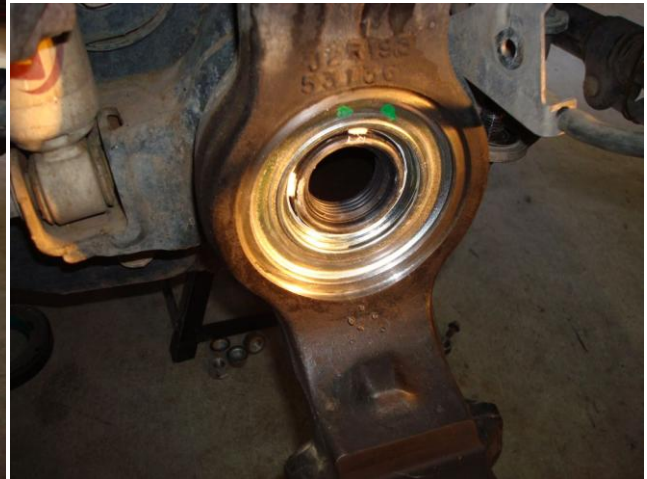
This is the seal before and after installation:

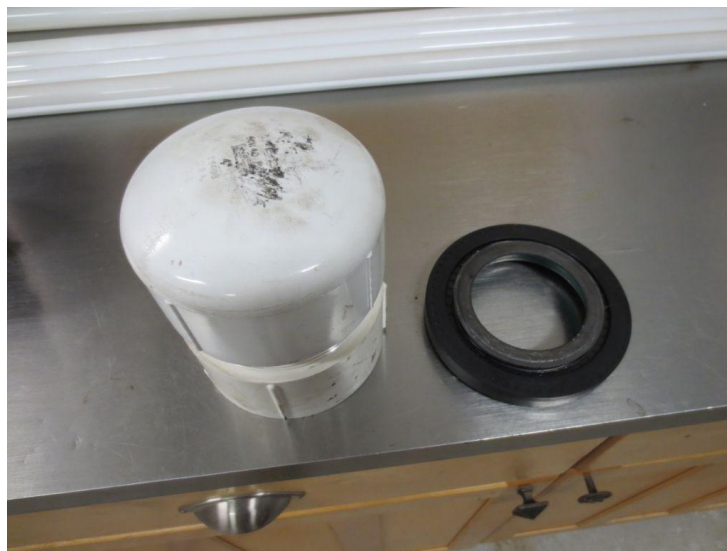
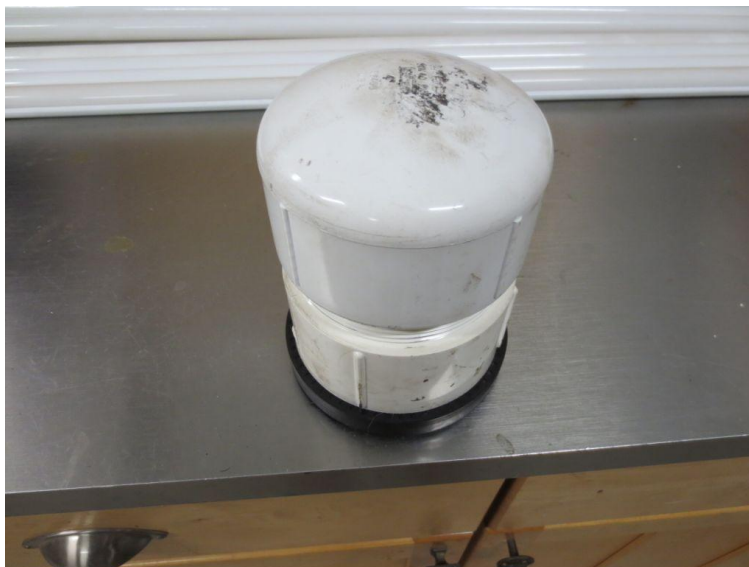
In a write up for a 7.3L ball joint procedure, the author states he got the knuckle seal just deep enough to seat the hub, then used the hub nuts to draw everything together. **YOU CANNOT DO THIS** - at least not on the 6.0L. There needs to be space between the outboard face of the knuckle seal and the inboard side of the hub. If you use the hub to "press" the knuckle seal, the rotating hub will grind the face of the knuckle seal, filling the area with metal shavings, destroying the knuckle seal and causing a vacuum leak. When you think the seal is pressed deep enough, dry fit the hub and ensure it spins smoothly and freely.

Below is what I used to pound the seal in. The OD of the PVC coupler is just shy of the seal OD, so while not ideal, it works in a pinch.
