Ball Joint Replacement for 2005 F-250 6.0L SuperDuty SRW, 4x4 with ESOF

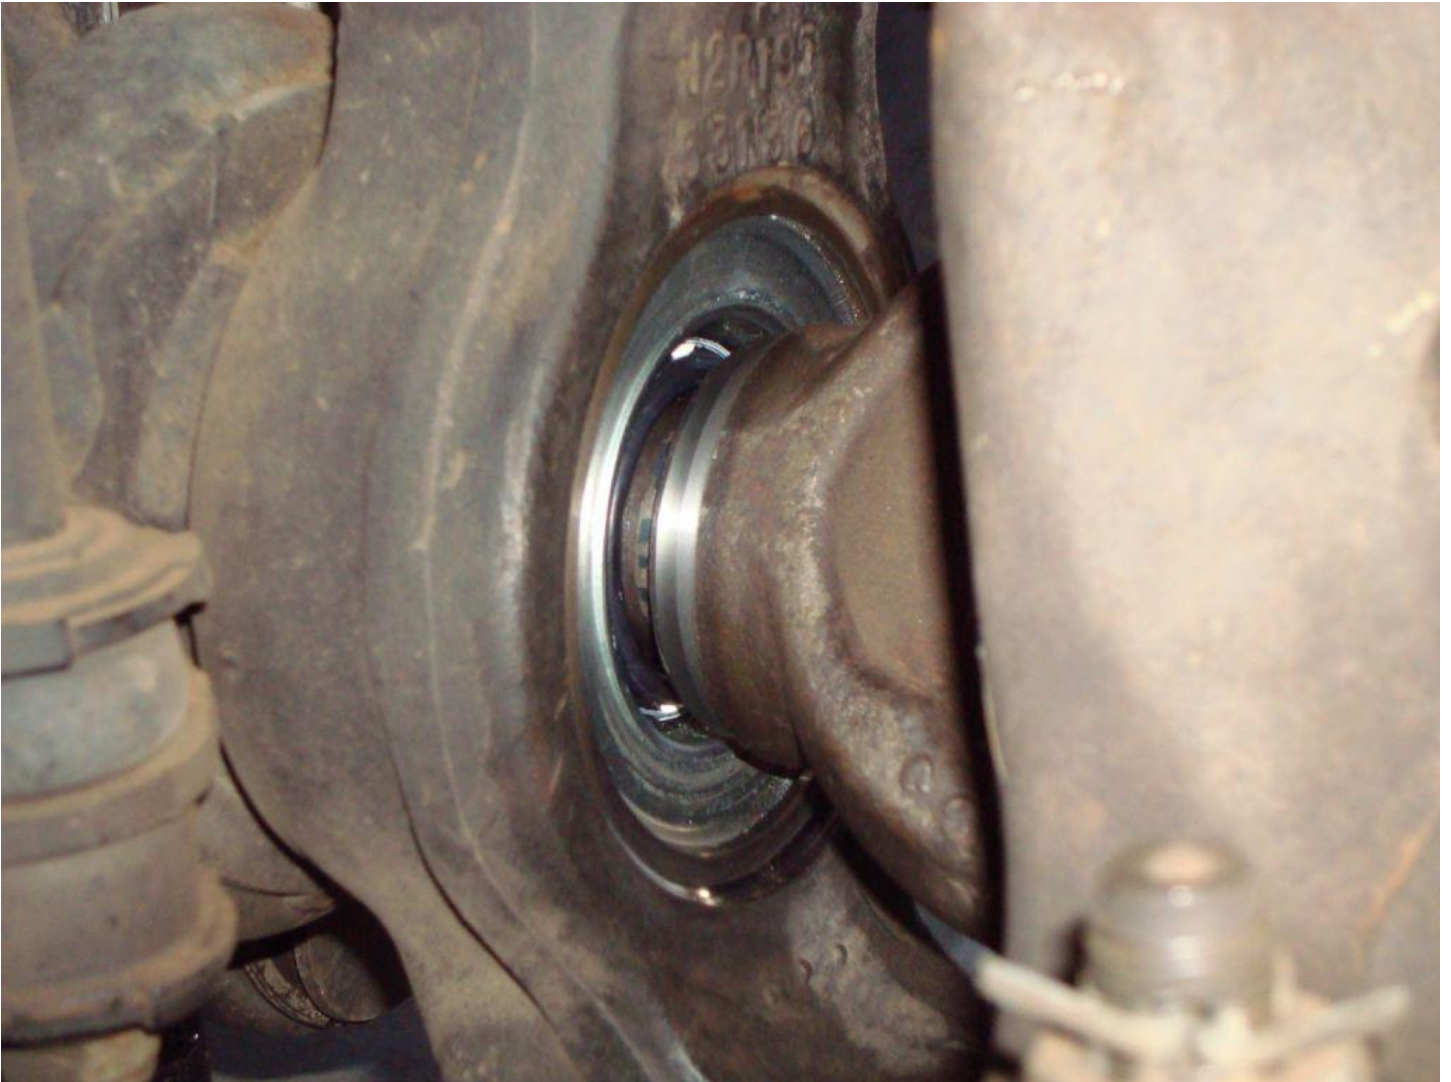
15) This is a shot of the axle installed with the new dust seal. It's a little alarming at first because it looks like the axle isn't completely seated, but this is just because the old seal that was seated on the shaft isn't there anymore, exposing a fresh, shiny metal surface:

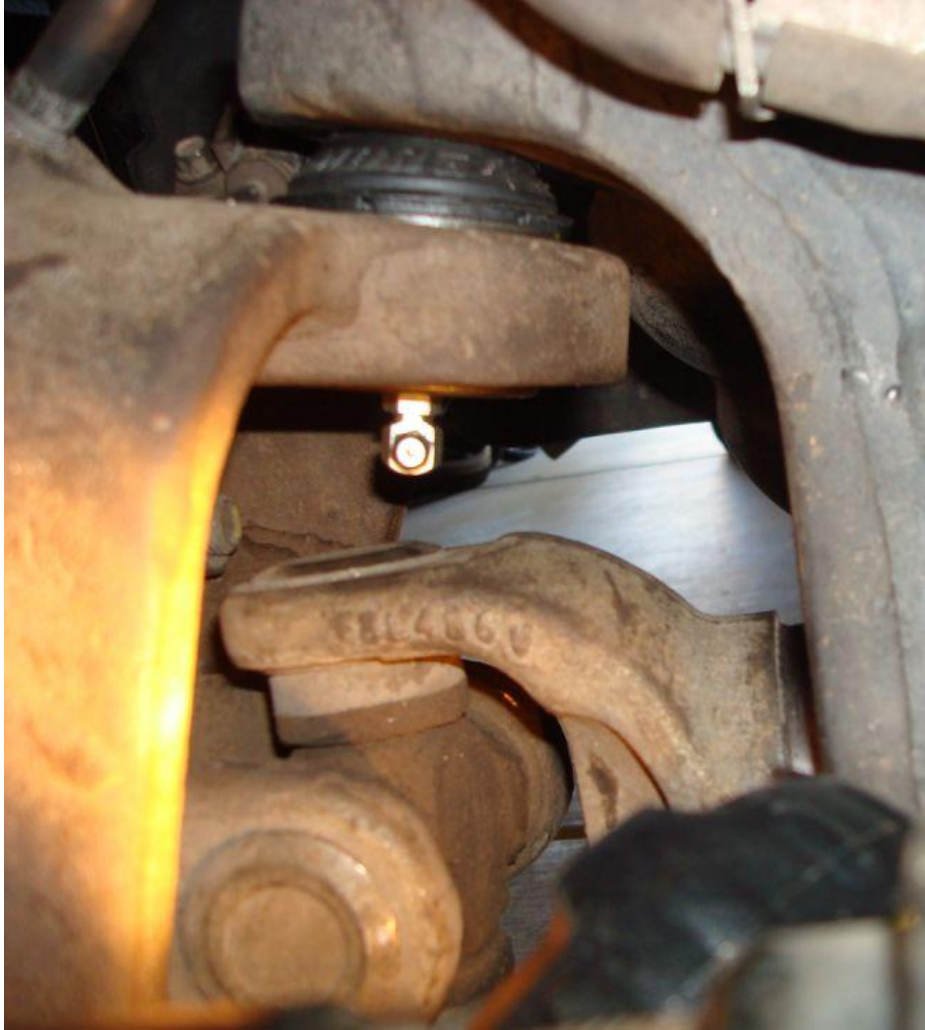
16) Sweet! The Moog ball joints come with Zerk fittings, and fortunately the upper one clears the u-joint on my model year. From the other ball joint write-ups, it appears this was a problem with earlier model years:
