TIPS – Chapter Eight

Airframe

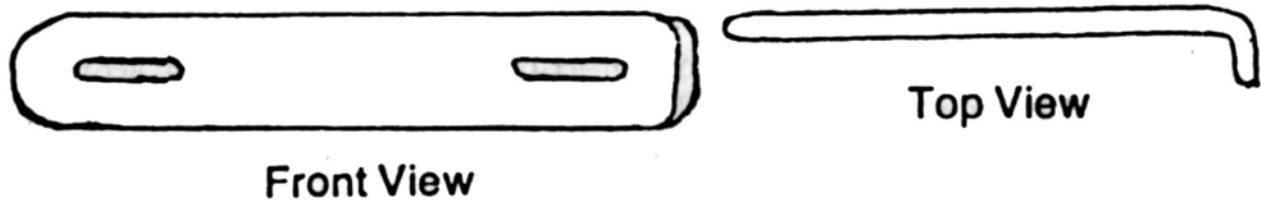
The manual flap system has a "tongue" that pushes a locking pin out of the way so that the cable tension (via your arm) can lower the flaps. Eventually the tongue will wear enough so that it doesn't push the locking pin completely out of the way and voila – you have flaps locked in the up position! Of course, removing the assembly, cleaning and new lubrication is desirable on a periodic basis.

There is a "stop" adjustment for the tongue that is: held in position by two screws. This stop faces you when you remove the wheel well liner and is located on the front of the mechanism that rotates when you lower the flaps. The flap rod end connects to this mechanism also. Simply loosen the two screws and remove the stop. It looks like this:

A small rat-tail file can elongate the holes somewhat so that the stop can be slid further inboard. Reinstall the stop and your flaps will now lower as the tongue has a greater travel to push the locking pin out of the way.

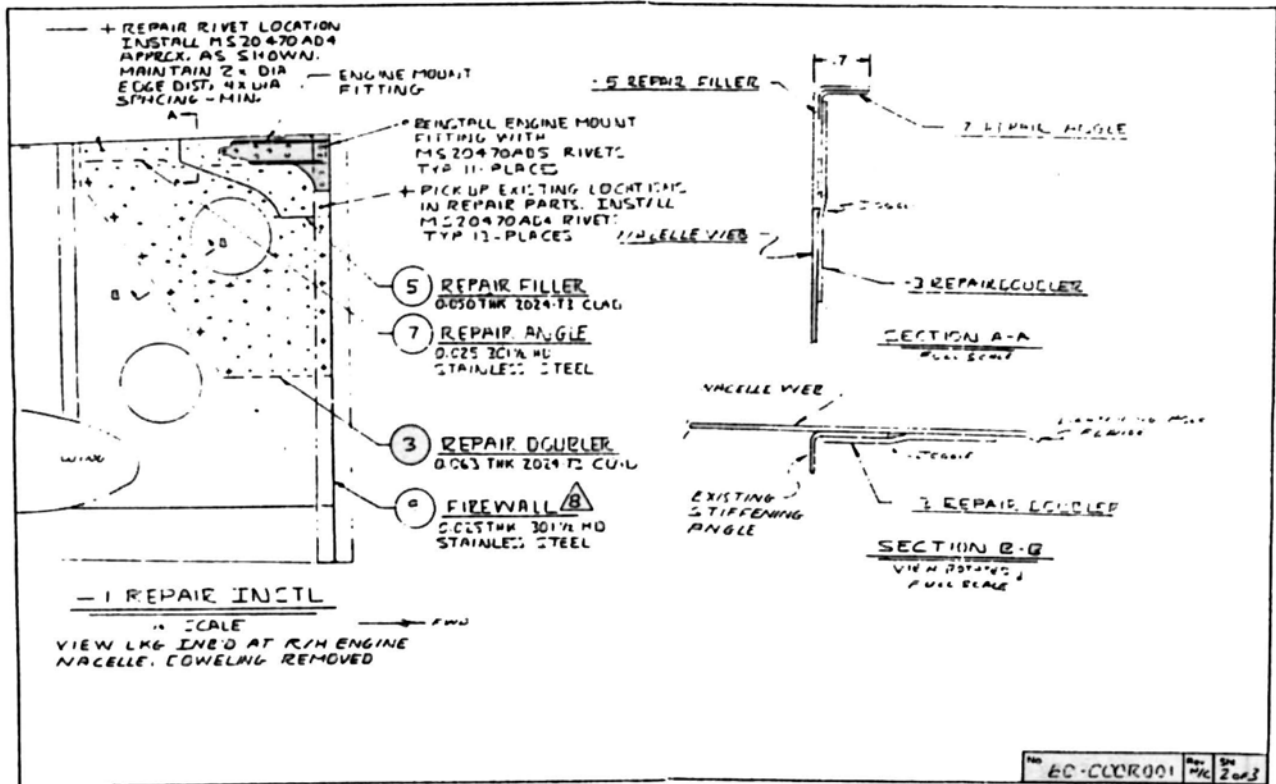
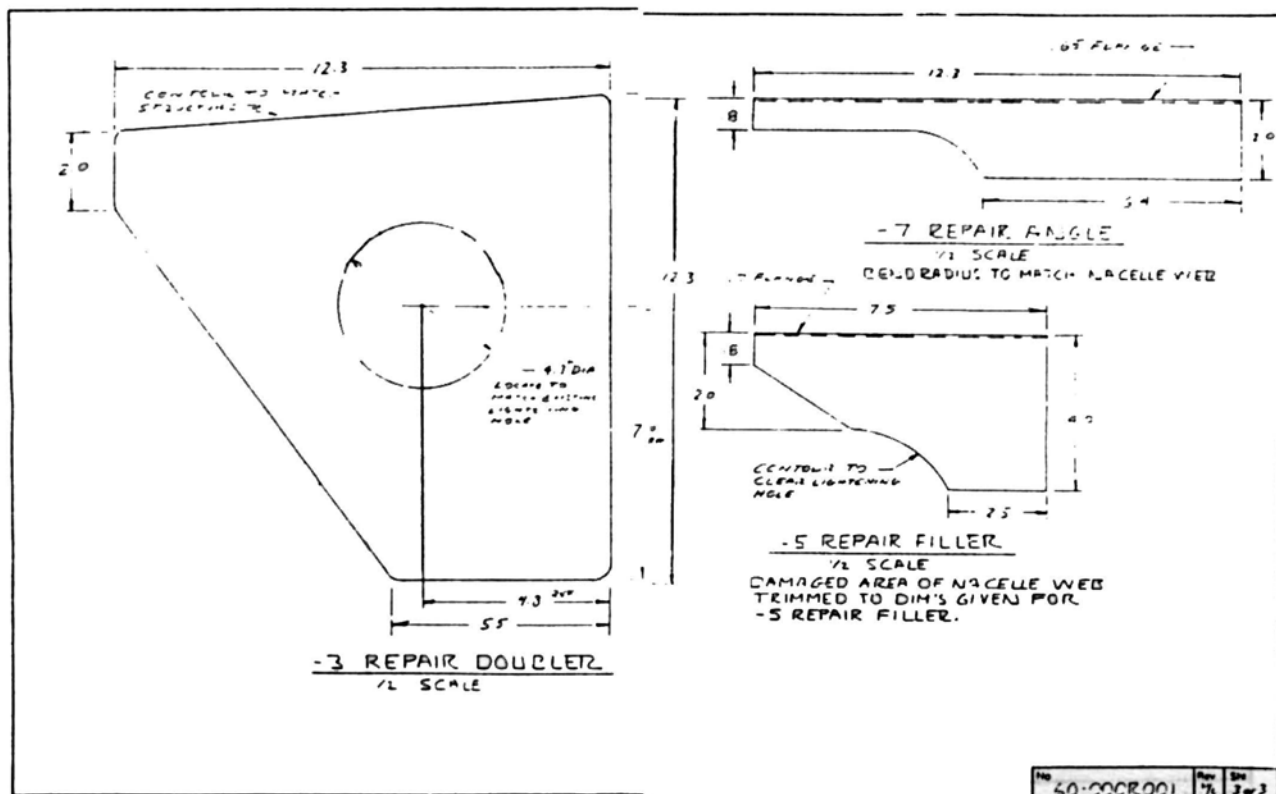
DATE: 5-17-90												
DESIGN: A. GEORGIAN	DATE: 5-17-90	TITLE: REPAIR, R/H ENGINE NACELLE STRUCTURE											
APPROVED:

During the annual inspection on my Comanche, a crack was discovered inside the right engine nacelle. The crack was located on the Outboard Engine Nacelle Bulkhead in the upper corner, where the bulkhead rivets to the Firewall and where the upper engine mount frame bolts to. The crack was approximately 3 inches long and had separated horizontally about 1/2 an inch. Additionally, the resulting vibration caused a crack in the Firewall itself, from where the lower engine mount frame attaches to the Firewall to the area where the Cowl Flaps bracket is attached to the Firewall.

The damage consisted of cracks found in the outboard nacelle web and on the firewall. The repair replaces the firewall, and trims out the damaged section of nacelle web.

The crack in the Firewall necessitated the replacement of the Firewall. The repair of the Nacelle Bulkhead was performed by Midcoast Aviation. As you can see by the enclosed analysis, and diagrams, it was necessary to cut away the damaged area, install a stainless steel filler and a stainless steel doubler to complete the repair. Since this damage was very difficult to see, I strongly recommended that the inspection plates on the engine nacelles be removed, and using a flashlight and a mirror, examine the area where the bulkheads fasten to the Firewall. If someone should find similar damage, they can reference the repair to the repair Midcoast has performed, and possibly save them the cost of a DER inspection.

Fabricate the -9 firewall using the original firewall as a template. Install using equivalent type fasteners. Note: Original mfr'd from 0.023 galvanized.
7. This drawing details repairs to the R/H engine nacelle. The outboard web was cracked at the upper outboard engine mount fitting attachment. The firewall was cracked at several locations.
6. The repair detailed in this drawing is applicable to a Piper Twin Comanche, Model PA-30, and was developed for S/N 30-958.
5. IT IS A MFG. OPTION TO RUBBER STAMP P/N ON EXPOSED SURFACE OF PART.
4. APPLY ONE COAT OF ZINC-CHROMATE PER MIL-TTP-1757 OR EPOXY PRIMER PER MIL-P-23377D ON APPLICABLE PARTS.
3. CHEMICALLY CLEAN ALL SHEET METAL PARTS PER MCPS 300-01 AND CHEMICALLY TREAT PER MCPS 360-02.
2. BREAK ALL SHARP EDGES.
1. MATERIAL PROCESS AND METHODS SHALL COMPLY WITH PERTINENT FAA AC NO. 43.13-1 AND -2 SPECIFICATIONS OR EQUIVALENT.

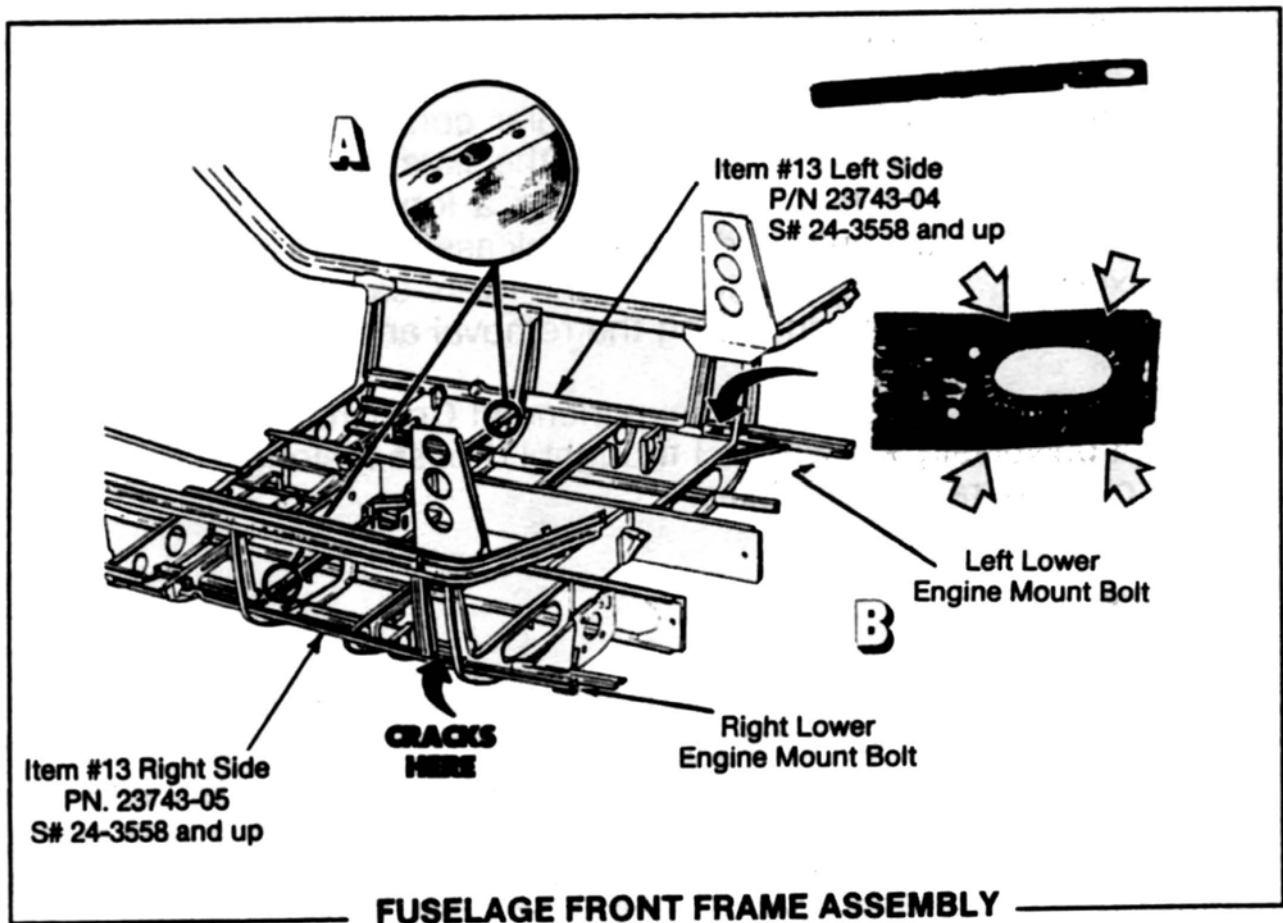
One of our members, Eugene Chiappe, ICS #07578, advises that he found the bulkhead cracked where the plate nuts are attached, which hold the back end of the seat rails (See "A" on attached drawing.) He made this discovery as he was changing some insulation in this area. He told me that the previous owner had put in new carpeting and then mounted the seat rails on top of the carpeting. This allows the rail to move every time a person sits on that seat. The seat rail should rest on the floor panels with nothing in between. The fix was the removal of the nut plates, the cracks stop drilled, a piece of 1/2" x 1/2" angle was applied to the full length underside of the bulkhead and the nut plates replaced. I want to thank Eugene for finding this potential booby trap and calling it to our attention.

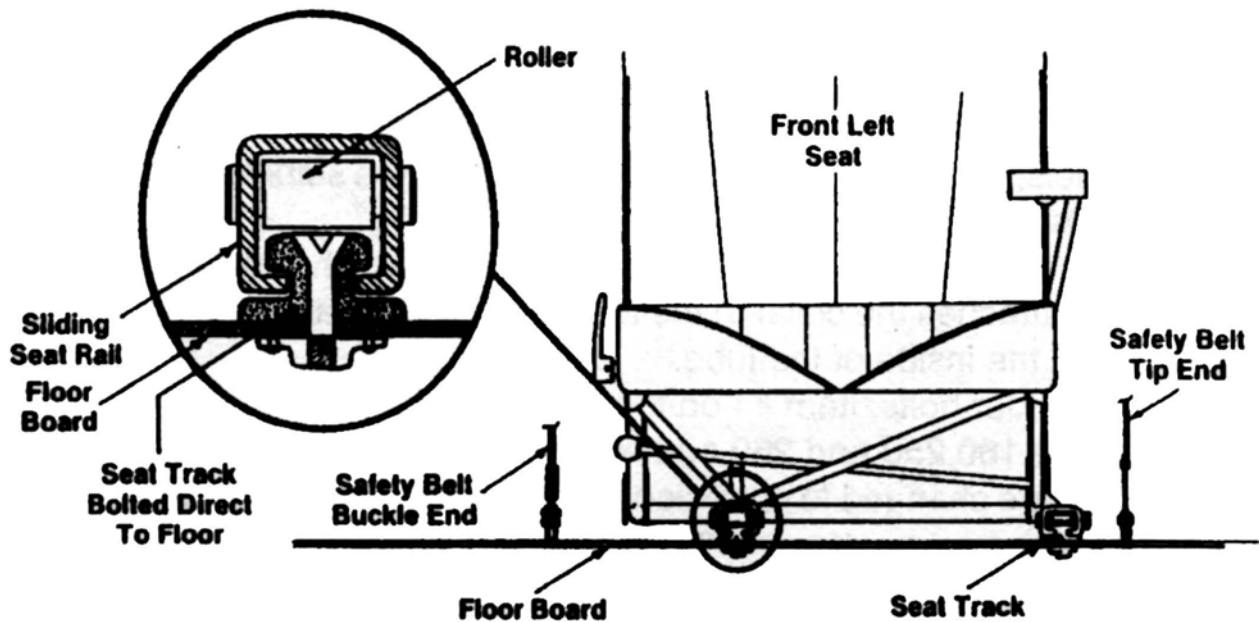
**Extract from Piper Drawing #26652
Seat Installation**

I am receiving many calls regarding the damage that this is causing. If yours are installed in this way, I strongly suggest that you get the rails down on the floor boards where they belong and inspect for cracks. Remove whatever is necessary to do this. But if you do not remove the carpeting from under the seat rails, plan at one of your next inspections to remove both side panels, take up the floor boards, which in itself is no easy task, and repair the damage. Then install the seat rails as shown in the drawing and this problem will not reoccur. This will require the completion of a Form 337 and FAA approval to return the aircraft to service.

I have included an extract from Piper drawing #26652 (See opposite page) showing the correct installation of the seat rails.

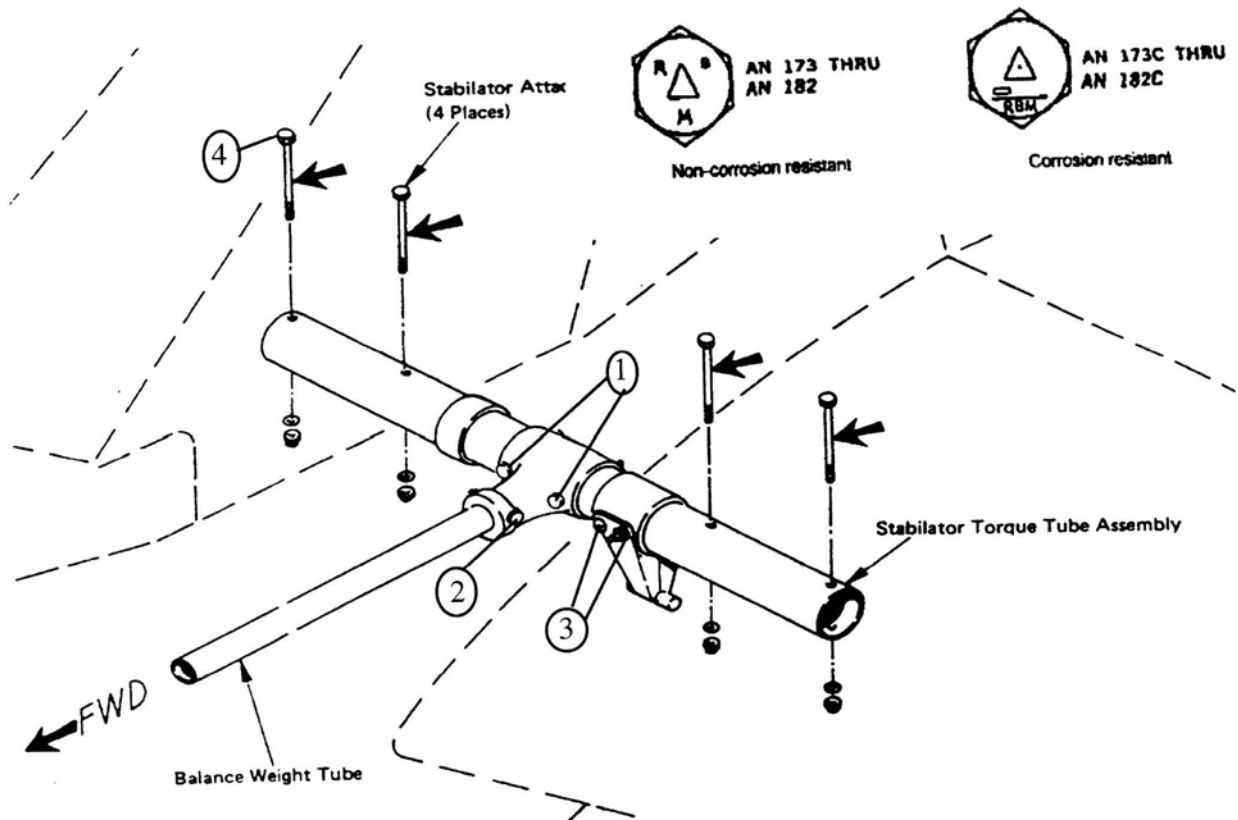
From what members tell me, looseness in the two bearings, part #452-363, is more common. This is Fafner #KP37BS. If checked as shown in the video, you can detect the slightest looseness in any part of the stabilator attachment. And, if you find any looseness or noise, have it checked and repaired as necessary with the above listed service bulletins.

Remember that, unlike the rest of the aircraft, the stabilator tube itself is not corrosion proofed. The inner race of the bearings is such a close fit that there isn't room for it. There have been several cases where this tube has been found to be rusty. In some cases, the rust has been on the tube inside the stabilator making it very difficult to get the stabilator off. If yours has not been off the airplane in some years, I suggest it be removed and the tube checked at the next annual. Corrosion-proof the inside of the tube with zinc chromate or an equivalent product, and then coat the outside of the tube with a product like Lps #3, which will help protect it from rusting.

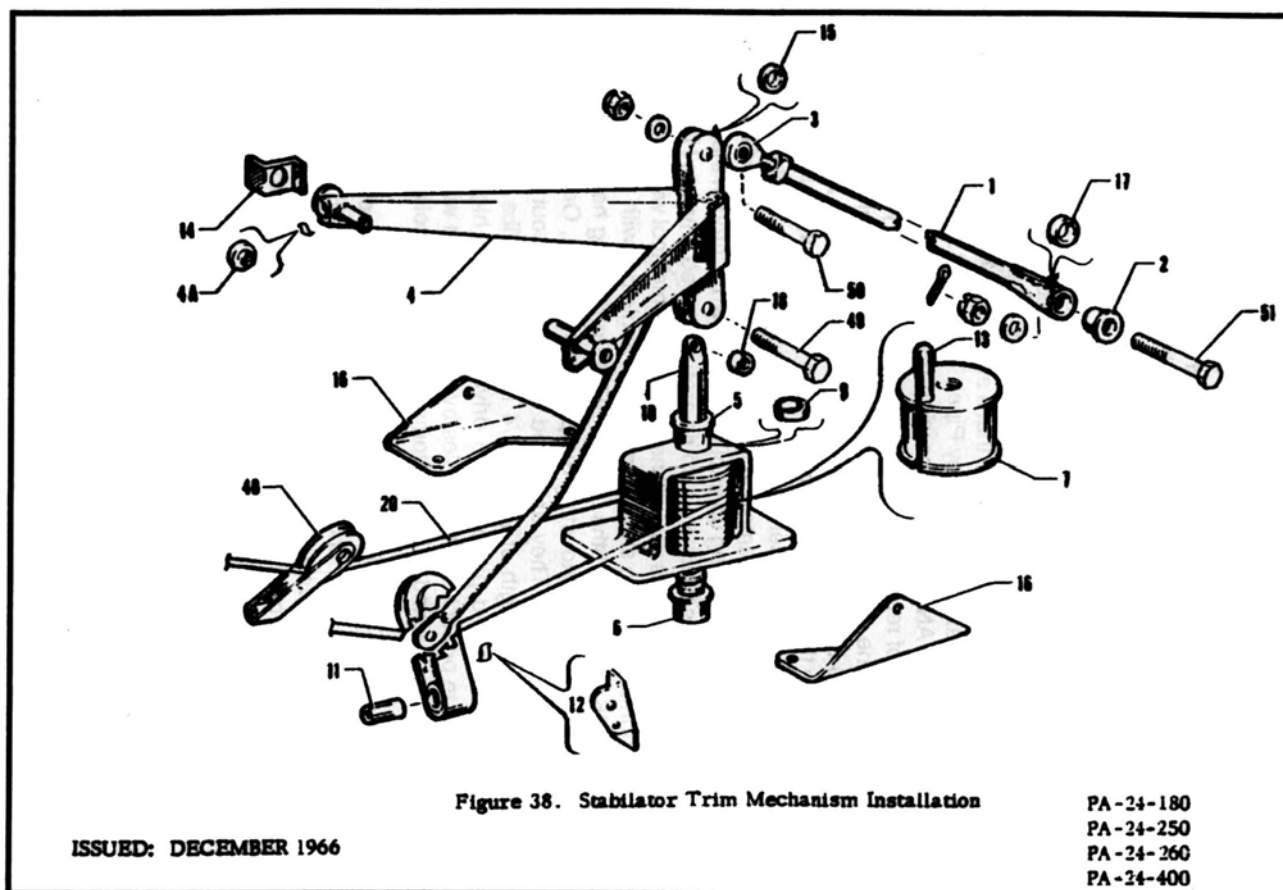
About now, I'm looking desperately at the Figure 38 in the Parts Manual. Suddenly, there it is. I noticed the trim stops (#5 & 6) have different part numbers – one for the top and one for the bottom. Therefore, the height (length) of them are different, i.e., one is about 1/4 inch longer than the other. And yes, you guessed it, I had them reversed. The long one goes on the bottom and the short one goes on the top. (And, unlike the illustration in Fig. 38, the flanges on the stops should go next to the trim drum (#7). The bottom one in the illustration is correct, but the top one isn't.) I passed this info on to Maurice, and even he didn't know that the trim stops (#5 & 6) were of different lengths. They have no identification on them as to part number.

So, after I switched their position, and reset the neutral position, the actuator arm (#4) adjusted properly. We buttoned up the tail cone, flew the bird for an OK flight and signed her off. Learning experience, yes! But how was I so lucky the first three jobs to get those trim stops (#5 & 6) correct?

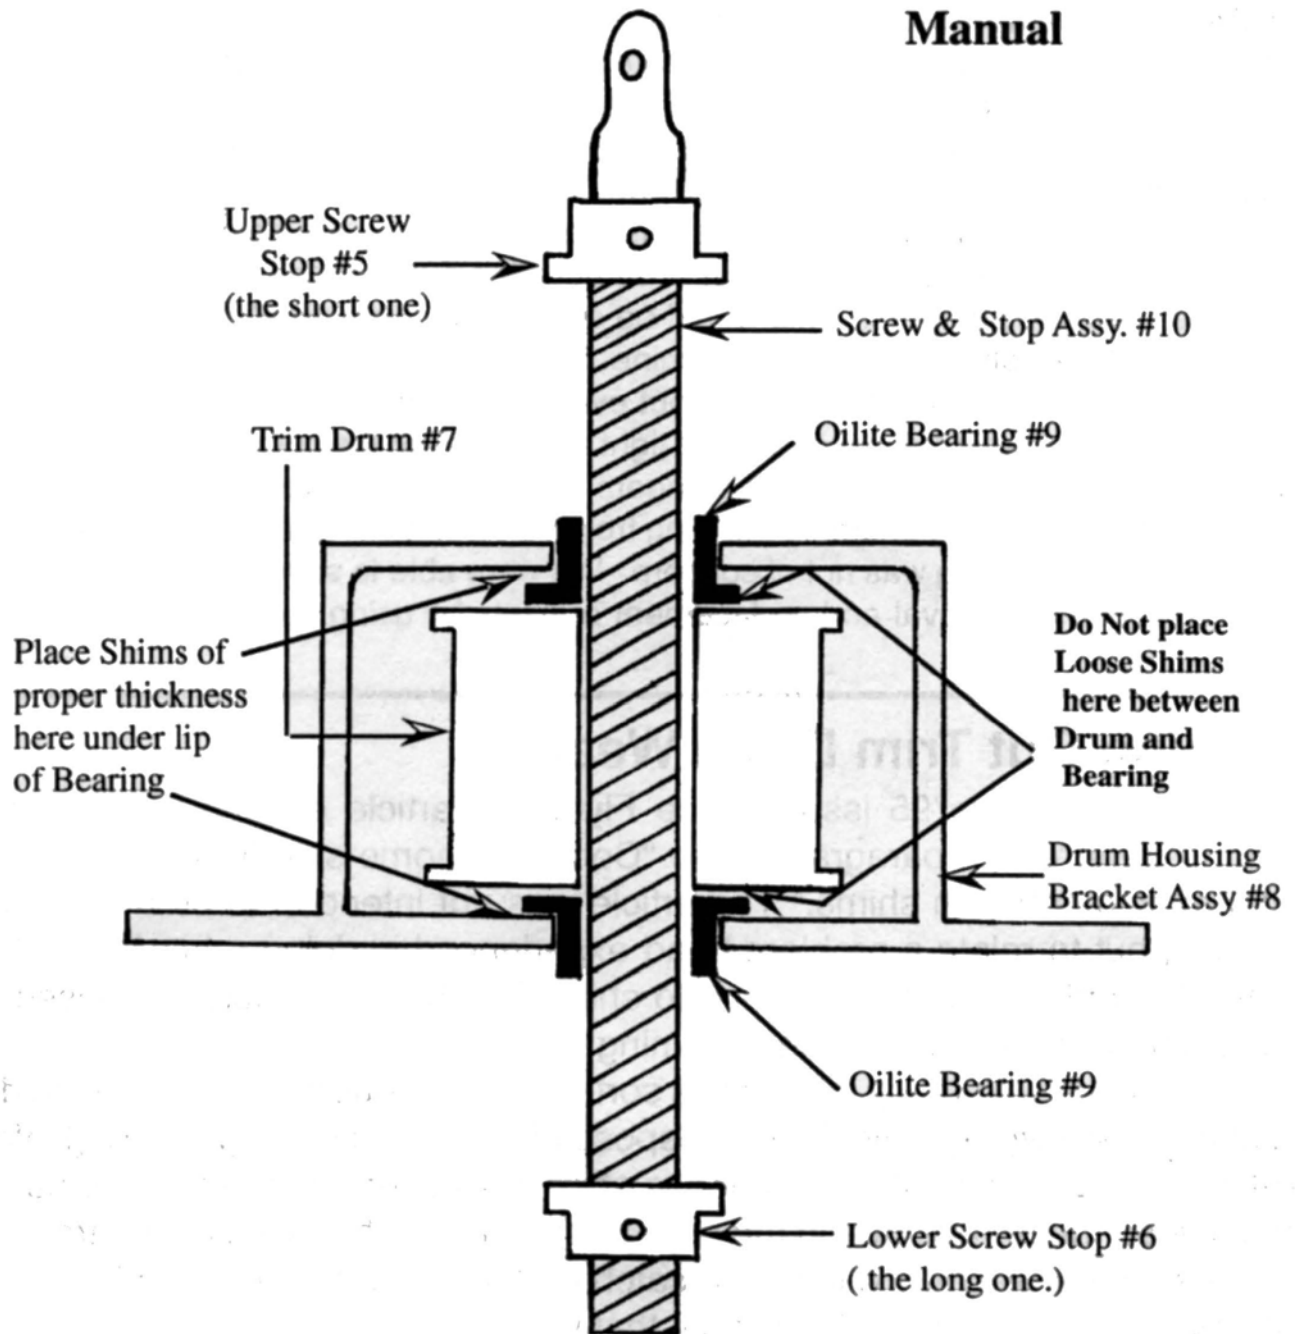
**Identification Numbers
refer to Fig. 38 in Parts
Manual**

In the January '95 issue of the *Flyer*, my article entitled "Errors and Omissions" referred (in paragraph 2) to "Corrected some slop in the trim drum (vertical movement) with shims." The article was not intended to be a "how to" type article, but to relate a problem I had experienced in doing a trim / stabilator overhaul. Nevertheless, the reference to shimming the screw actuator raised a couple of questions as to how the shimming is done.

The preferable way to solve this little problem is to polish off the wear from the drum (#7) and measure the slack between the drum and the oilite bearing (#9) with your feeler gages. Then, very carefully, and with proper support, press the oilite bearing (#9) out of the drum housing bracket (#8) and place shims of the thickness you previously measured, between the oilite bearing (#9) and the drum housing (#8). Press the bearing (#9) back into the housing (#8) and reverse the whole process. In this way, the bearing (#9) will be displaced in the amount of the wear (shim thickness) and zero out the slop. Then assuming that you've attended to all the other wear points (bolts, bushings, and rod end bearings), you will end up with a snug, tight trim system.
