ServiceNews

ASN 23219 (0110)

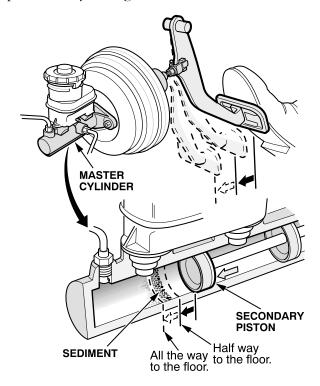
Press Brake Pedal Halfway to Avoid Piston Seal Damage

On all Honda models, if you're manually bleeding the brakes, make sure whoever's pumping the brake pedal pushes it only halfway to the floor. If the pedal is pushed all the way to the floor, you run the risk of driving the master cylinder secondary piston into any sediment or deposits that may have collected on the piston cylinder walls. If this happens, the piston seals can get permanently damaged and cause a leak.

You can also avoid this problem entirely by using any of the brake pressure bleeder equipment available through the Honda Tool and Equipment Program (call **888-424-6857**).
