Tektronix 49x/275x/279x-Series Spectrum Analyzer Service Notes

**John Miles, KE5FX
john@miles.io**

November 30, 2015

Errata and helpful notes on calibration/service procedures

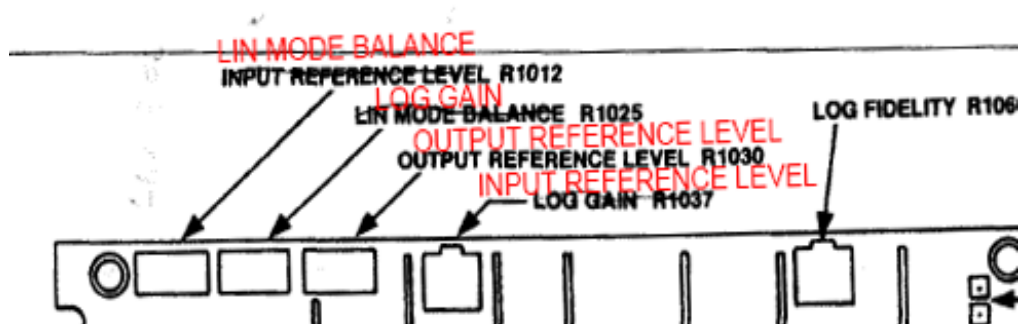
The first step in logamp calibration is to identify which of the three possible **Log and Video Amplifier test point and adjustment locations** figures (5-17 in 070-4416-00, or 5-13 in 070-5560-00 with two possible control layouts) applies to the module in your instrument. An analyzer with the older-style logamp uses figure 5-17 in the 494/P manual, while logamps in newer 492A/492B/494/495/497 analyzers and their 275x-series counterparts use the physical layout in figure 5-13 of the 494A/P manual.

The catch is that at least two different layouts were used for the controls in figure 5-13. At some point, probably around the time Tek redesigned the board using surface-mount components in the late 1980s-early 1990s, the trimmer functions were reordered *while their physical locations were left alone*. In earlier logamp assemblies, the order is as specified (left-to-right on the component side):

INPUT REFERENCE LEVEL R1012
LIN MODE BALANCE R1025
OUTPUT REFERENCE LEVEL R1030
LOG GAIN R1037
LOG FIDELITY R1060 (also called "log linearity" in some manuals)

In later assemblies, the correct control order is:

LIN MODE BALANCE R1025
LOG GAIN R1037
OUTPUT REFERENCE LEVEL R1030
INPUT REFERENCE LEVEL R1012
LOG FIDELITY R1060

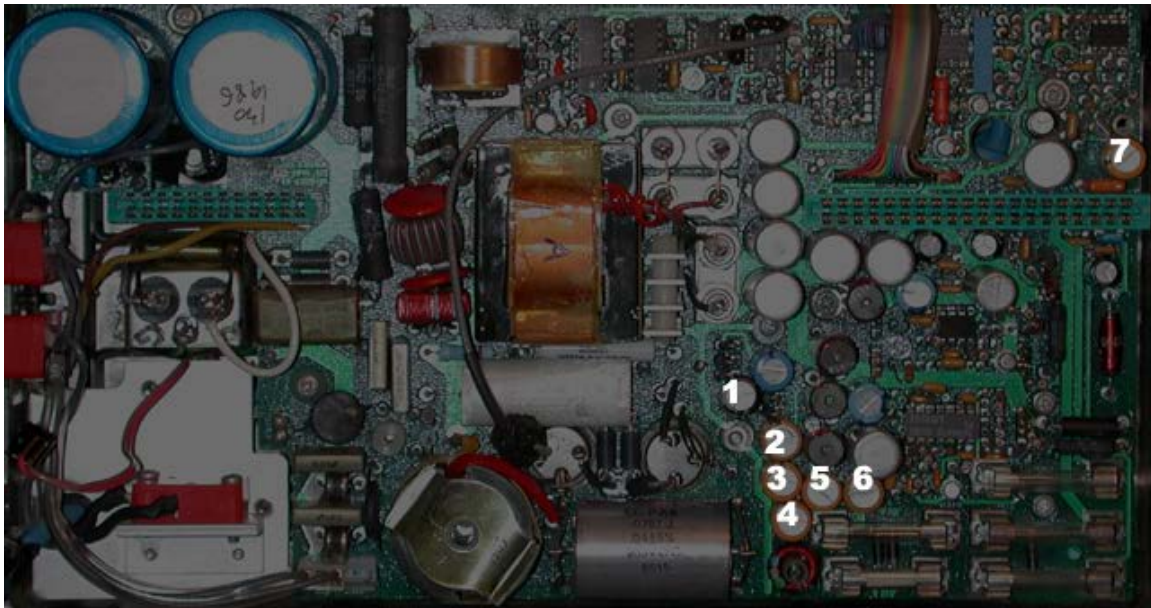
Regulation tolerances for the low-voltage supply buses are specified in service volume 1, and are not usually a problem. However, the +100V and +300V supplies are frequently below their specified values. If any 66-kHz ripple or sagging is observed, all of the miniature 2.2 uF/200V axial-lead electrolytic capacitors in the power supply should be replaced. These are inexpensive high-failure-rate parts, so they should be replaced in any event if the power supply is otherwise disassembled for service.

I recommend checking the ESR on any replacement high-voltage electrolytics as well. Several "new" capacitors in this voltage range have proven defective when obtained from surplus sources.

High ESR in the filter capacitors on the lower-voltage rails (+17V, +5V) has been reported as a cause of excessive power-supply temperature, so when servicing the power supply, you should check ESR on *all* electrolytics as a matter of habit. Check heat-sink fasteners for tightness, and renew the heat-sink compound while you're at it. Avoid losing track of the mica washers and aluminum spacers that may fall out when you remove the PCB.

Use 105 degree C-rated electrolytics where possible, e.g., 3.3 uF 350V 105C, [Digi-Key](#) part # 493-2046-ND. These can replace all of the smaller high-voltage capacitors in the power supply (6x 2.2uF/200V, 1x 1uF/350V).

The two large filter electrolytics on the AC line side seldom cause trouble. They can be replaced if necessary with Panasonic EETED2E821DA ([Digi-Key](#) P11644-ND or [Farnell](#) 1198619).

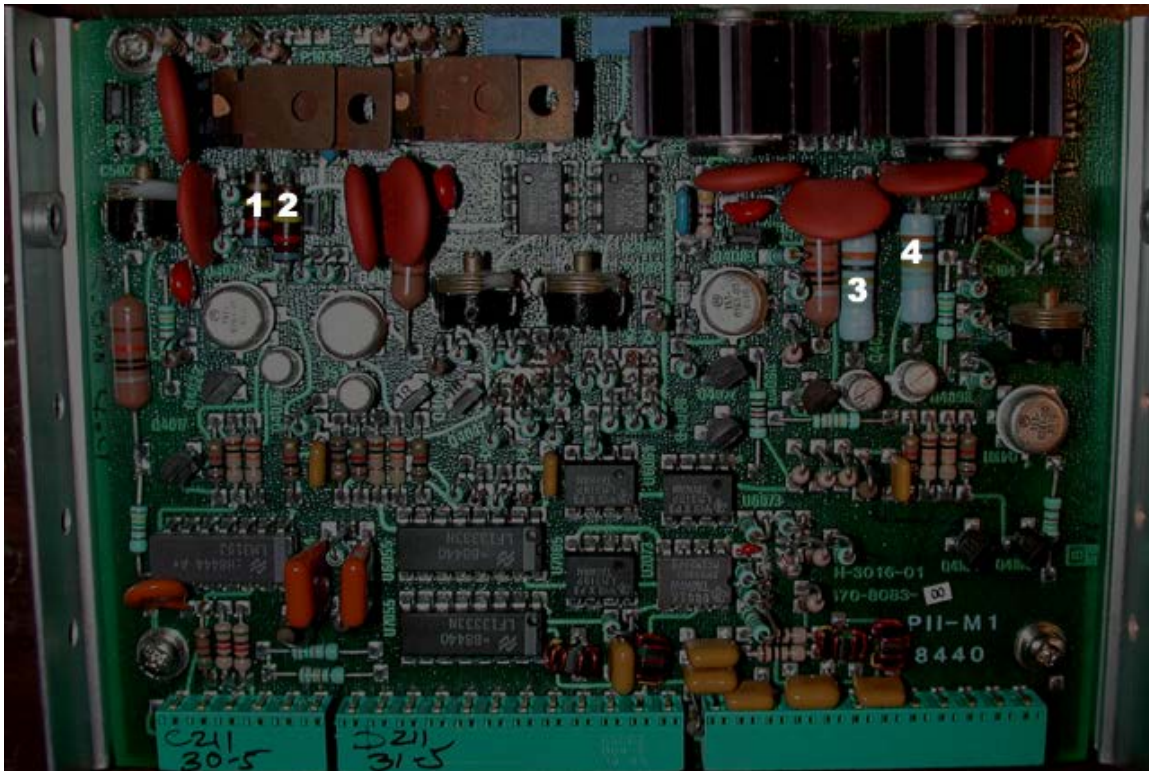
When servicing instruments with the pre-1988 deflection amplifiers, it's a good idea to replace the 620K and 300K carbon-composition resistors in the negative-feedback paths. Many of these resistors have drifted upward over time, and/or become noisy. Typical replacement parts would be [Digi-Key](#) P620KBBCT-ND (two each) and BC300KW-2CT-ND (two each). Calibrate the deflection amplifier and digital storage subassemblies after replacing these resistors.

This particular board already had 300K metal film resistors (3,4) in place, so they were left alone. The 620K, 5% carbon-composition resistors (1,2) were measured at 580K and 980K, respectively.

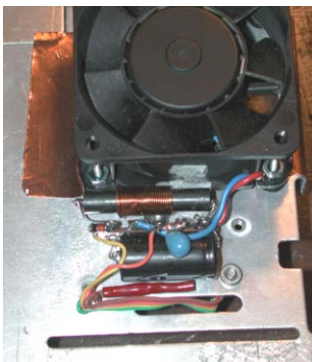
Failure of the high-performance tubeaxial fan is common on higher-mileage 49x/275x analyzers. The OEM fan is an exotic part which is unobtainable today. Especially on the newer analyzers with 10 Hz resolution, avoid the temptation to hack in a cheap CPU fan as a substitute. Chances are, it won't put out enough air to cool the entire analyzer safely. Additionally, the fan is mounted in close proximity to sensitive IF circuitry, so both EMI and mechanical vibrations *will* appear as excessive composite noise or sidebands at close-in offsets. It's a good idea to run a phase-noise plot before and after replacing the fan to make sure you haven't degraded the instrument's performance, watching carefully for spurs.

A more subtle consequence of using a replacement fan is extended warm-up time for the entire analyzer, assuming the fan is no longer temperature-controlled.

When a conventional single-phase DC fan is installed, the multiphase driver board will be unused. Ideally, the new fan will use some combination of the supply voltages available to the existing driver board (+9V, +5V, -17V, and ground). A 12-volt fan can be used on the -17V bus with a suitable Zener diode, for instance.

The original Buehler tubeaxial fan was rated for 31 CFM of airflow at 12 VDC, consuming 2.4 watts. Superficially, the EBM Papst 622HH model is a close substitute (33 CFM, 12 VDC, 3.5W), but its EMI characteristics are much worse than the original part, and also noticeably worse than the Papst 622H model (27.1 CFM, 12 VDC, 2.3 watts). This is most likely due to its higher current consumption. For most environments the 622H will be "good enough," although neither of these fans can be used without additional EMI filtering.

Various resellers for the EBM Papst fans can be located by entering part numbers such as "624HH" at <http://www.octopart.com/> or <http://www.findchips.com/>. Regardless of which replacement fan you select, it will be necessary to fabricate a mechanical shock mount with materials such as rubber/silicone grommets and/or gasket compound. Do not attempt to bolt the fan to the power-supply housing without a vibration-dampening mount unless you enjoy looking at noise sidebands.

Similarly, careful electrical isolation is needed to maintain the instrument's original performance. Twist the fan leads together and keep them as short as possible. Bypass the fan with a parallel combination of a large (470 to 1000 uF) electrolytic capacitor and smaller tantalum capacitor (~10 uF), and use a series choke with a value of 100 uH or more that's rated for the fan's supply current.

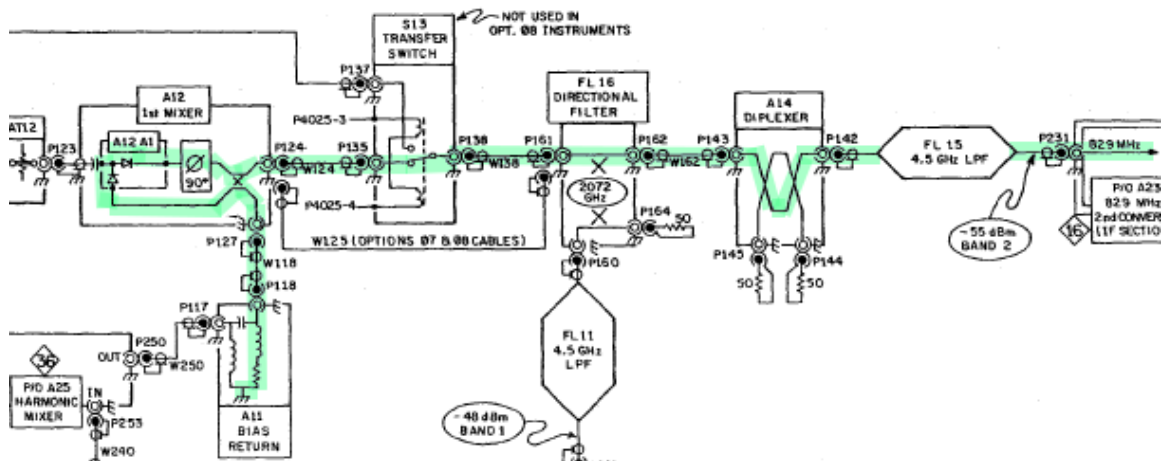
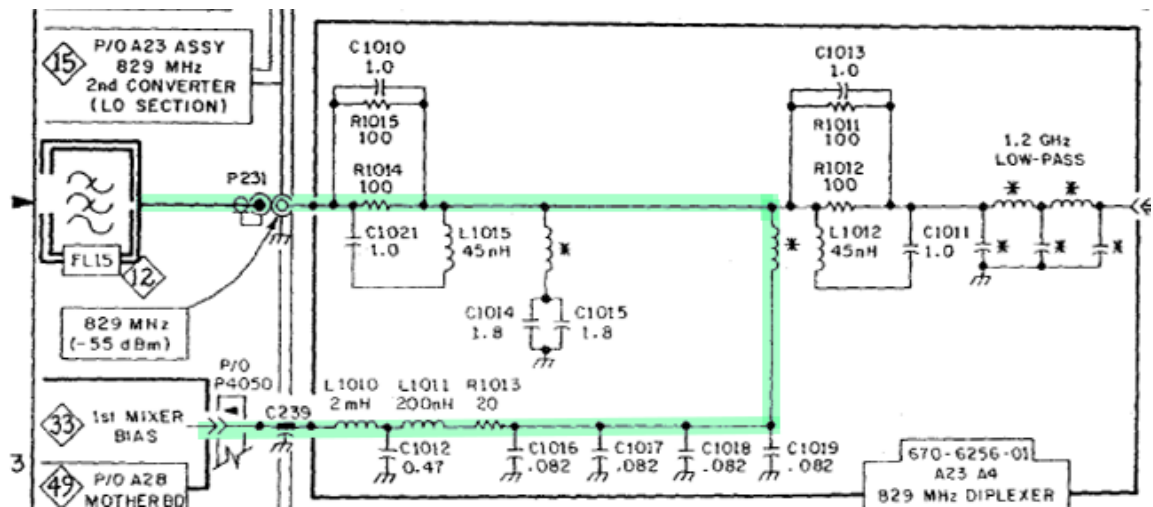
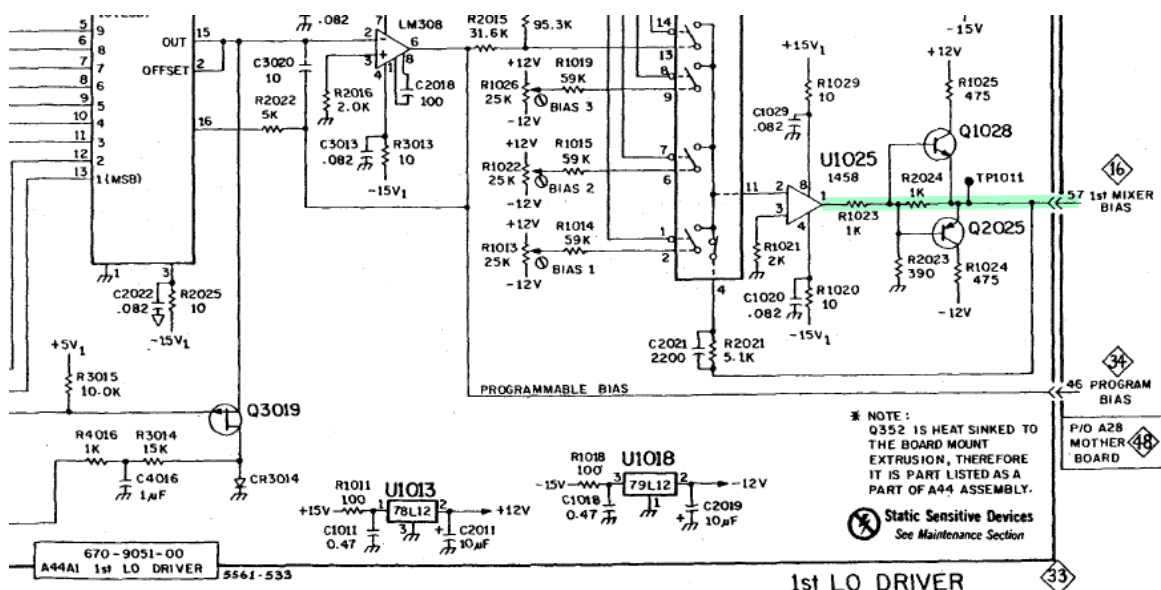
1st LO DRIVER

Before condemning the first mixer in the 21 GHz analyzers, for instance, make sure the DC bias path from the LO driver board to the mixer bias termination is OK. The front-end mixers in the 1.8 GHz analyzers were operated at zero bias, but the 21 GHz models used a circuitous bias path with several potential points of failure. Excerpts from the 494AP schematics appear below with the first mixer bias path highlighted in green.

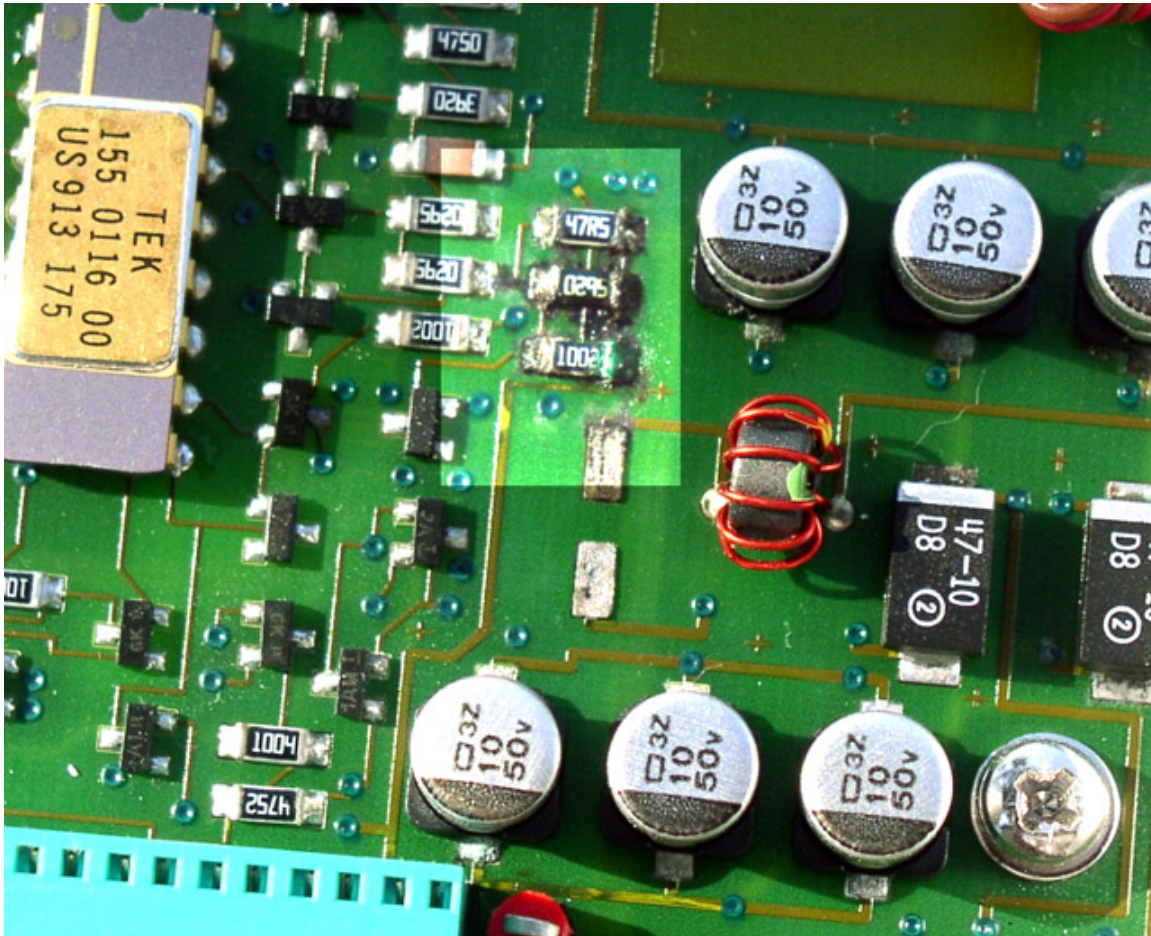
Amplitude instability in the newer units (e.g, later-production 494APs, as well as 495Ps with serial numbers after B030000) is becoming all too common, thanks to Tek's eagerness to adopt surface-mount technology at a time when component quality wasn't yet up to par with traditional through-hole tech. If you own one of these early-1990s vintage analyzers, chances are good that your logamp board (in particular) already looks like this:

The black “crud” in the highlighted area doesn’t originate from the resistors or from the soldering or assembly process. Rather, it’s caused by outgassing of corrosive vapors from one or more of the 10 uF/50V electrolytics nearby. Any corroded traces should be cleaned or bridged as soon as you spot the problem, and *all* of the aluminum-can electrolytics should be replaced.

50-volt capacitors aren’t needed in most cases -- 35V is fine for supply buses up to +/-15 volt -- and their exact type (tantalum or aluminum) isn’t important either. **Just get those old caps off the board!** Keep in mind that affected traces can be several inches away from the nearest capacitor. A careful inspection of the entire PCB is necessary when this failure occurs.

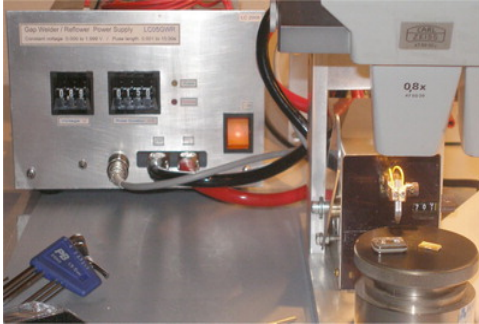
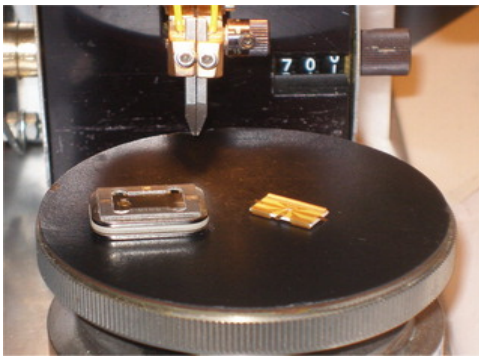
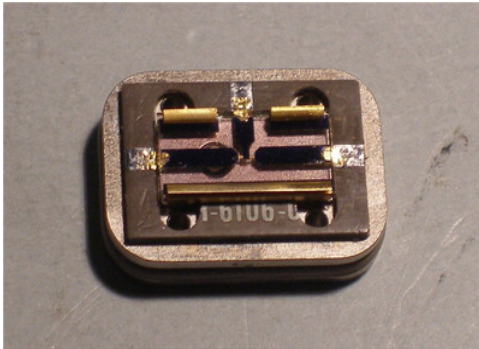
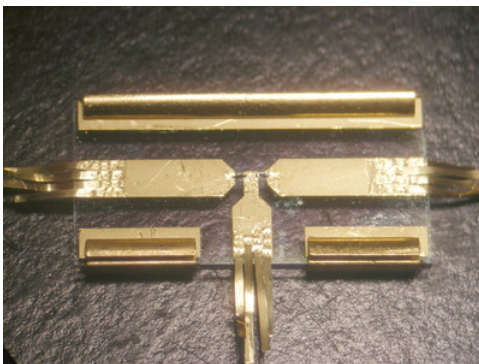
Inside the first mixer

Photos courtesy Luis Cupido, CT1DMK, of the [chip-hybrids](#) group, showing the diode carrier from the 21 GHz first mixer with its substrate removed, undergoing diode replacement.

The mixer diodes themselves are almost too small to see, even in the magnified view at bottom. Actual width of the entire substrate is approximately 15 mm.

It's been reported by Luis Cupido, CT1DMK that the beam-lead diodes can be replaced with either BAT30 low-barrier parts from Infineon or MSKN709 medium-barrier diodes from Metelics. Low-barrier Metelics parts should also be usable, as may similar diodes from MA/COM. Luis has found that the better-known HCSC9101 diodes need more LO power than the analyzer has available.

Although the mixer and its diode carrier are easy to work with on the bench, replacing the diodes on the carrier is another matter. Gap-welding capabilities are required for the gold ribbon-to-substrate attachment, while gap reflowing is used to attach the ribbons to the diode holder (although the latter operation may be performed with a small soldering iron). It may be difficult to preserve the original gold ribbons during disassembly; be prepared to replace them with new ribbon stock.
