Potential For Engine Compartment Fires, Campaign 88-C-24

Number 88-C-24 Date June/90
PRODUCT SAFETY CAMPAIGN - 88-C-24
Subject: LACK OF ADEQUATE SERVICE OR MAINTENANCE
MODELS AFFECTED 1985-88 PONTIAC FIERO MODELS
WITH 2.8L V6 ENGINES (RPO L44)
TO: ALL PONTIAC DEALERS

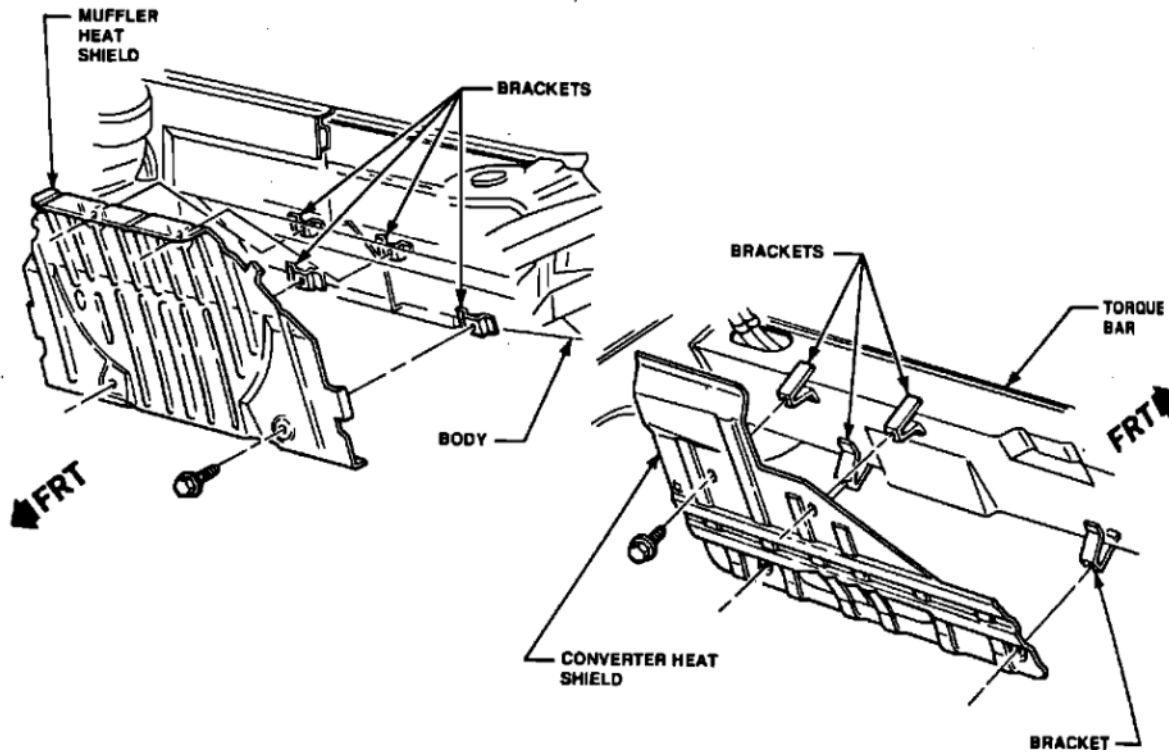
ILLUSTRATION G - HEAT SHIELD ARTWORK

Any missing heat shield for this application (ILLUSTRATION G).
