MODEL: **2005 CONCOURS™ (ZG1000-A20)**
TITLE: **SWINGARM PIVOT SHAFT LOCKNUT LOOSE**

FACTORY DIRECTED MODIFICATION

IMMEDIATE REPAIR

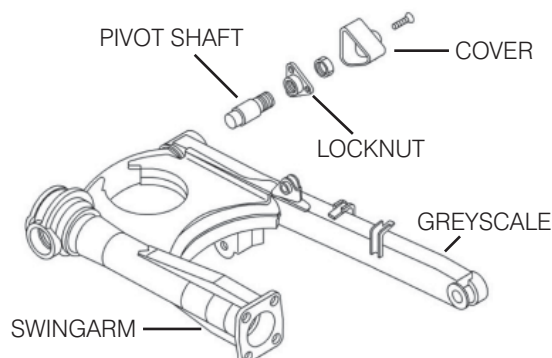
On eligible units, the locknut that secures the right hand swingarm pivot shaft may be not tightened to the specified torque. Use of the motorcycle with the pivot shaft locknut loose could shorten the life of the swingarm bearing.

Kawasaki has initiated a FDM campaign to repair all eligible units. The repair consists of tightening the pivot shaft locknut to the specified torque.
