# Health Safety and Environmental Alerts March Newsletter

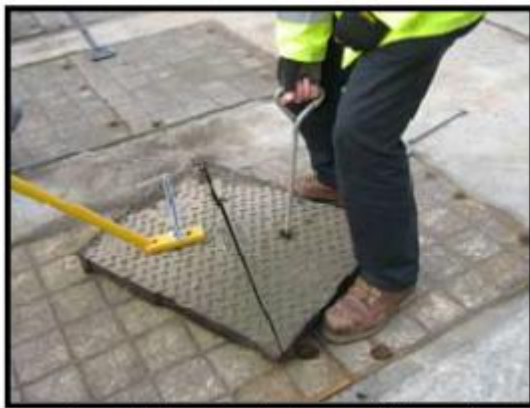
A subcontract employee injured his shoulder whilst replacing a manhole cover. Whilst lifting the 750x600mm cover with a colleague using manhole keys, one of the keys slipped out and the cover dropped into the opening leaving the injured party (IP) taking all the weight.

- Failure to complete a specific manual handling assessment for the task
- The use of short manhole keys not allowing for a good lifting posture (as illustrated bottom left picture)

(use of manhole key not allowing good lifting posture)

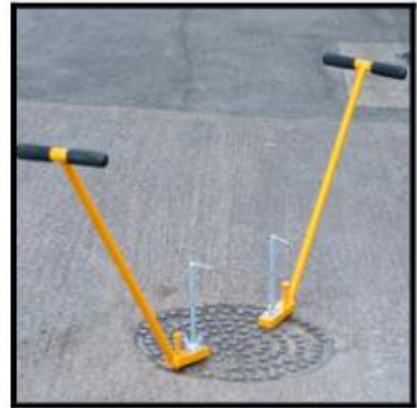
(2-man manual manhole cover lifting arms)

The subcontractor completed extensive trials after the incident to look at alternative equipment which allow for better posture and for the equipment to be fixed to the cover. The picture above (right) shows the alternative equipment selected for use by the Subcontractor post incident. The 2-man manual manhole cover lifting arms allow for:

- Better lifting posture to be adopted – i.e. no stooping
- Greater distance between the person lifting and the cover
- The lifting arm to be secured in place with a lock nut to prevent twisting
- The cover to be 'cracked' to remove the seal before lifting

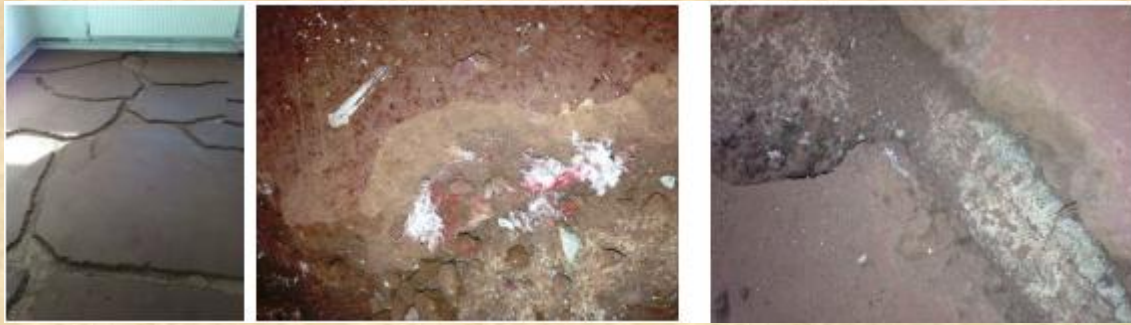
During some minor works within a block of flats, traces of asbestos were found underneath and within a concrete floor screed. This had not been identified in the asbestos survey, and was not apparent until the screed was being taken up.

The screed was identified as “Magnesite (Magnesium Oxychloride) Flooring.”

- Where work is required to a floor screed or laid toppings, check that the Refurbishment or Demolition Survey has included an investigation and sampling of floor screeds and it has not been assumed that it is a sand/cement screed.
- Teams working on an existing floor screed, must cease work if there is a reddish colour to the screed and obtain confirmation as to the nature of the material.
- All sampling and testing must be undertaken in accordance with the Asbestos Management Procedure by asbestos surveyors or analysts.

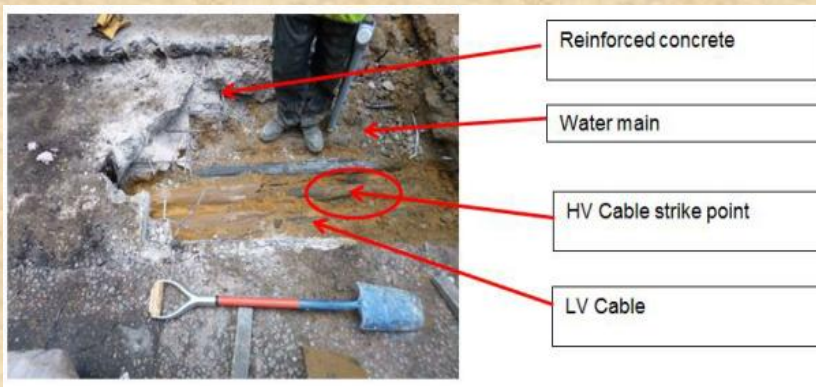
During a recent operation to lay a new water service in Central London an 11kV high voltage cable was struck by a machine mounted pecker. There were no injuries sustained. The utility drawings indicated two HV cables situated on the opposite side of the road. The team picked up a signal on the cables and thereby assumed the drawings were accurate. However they were not as a cable deviated to the side of the road the team were working in. This wasn't traced by the team.

- You must never assume that the drawings are correct. They are an indication only and should BE USED AS A GUIDE
- Whenever you use a Cat – You SHOULD ALSO USE THE GENNY, there are no acceptable excuses
- You should never use any form of mechanical tool in the 500mm exclusion zone until depth of services are identified

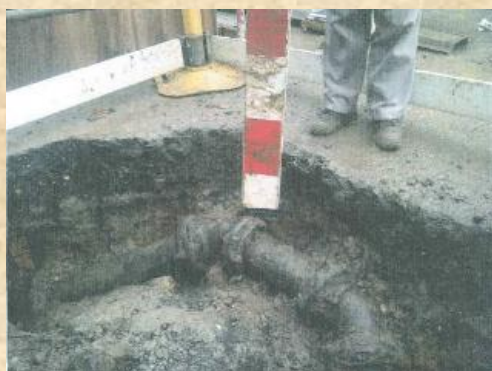
There had been no written report from National Grid, but there has been verbal confirmation that the cause of the leak was an open joint in their main.

When the excavation was elongated by National Grid to expose the joint they discovered that their cast iron pipe had been constructed with seven separate joints and the top of one flange was only 250mm below the surface. One of the joints in the main had become loose creating the leak. The joints and the depth of the gas main below the surface can be clearly seen in the photograph below.

- All shallow services should be reported on a hazard identification card.
- Reminder to all that pipes can deviate from expected routes.
- Always follow safe digging practices e.g. trial holes, safe dig packs and permits to break ground. On this occasion, had safe practices not been used this could have resulted in an explosion which could have resulted in injuries.

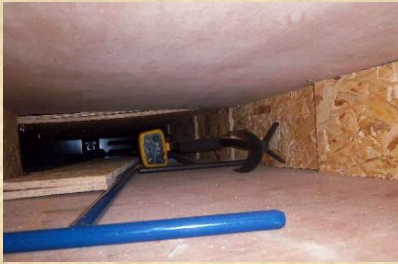
A technician was recently carrying out routine leakage detection work in a DMA, which involved operating sluice valves in a standard step test. When the technician went to get his valve key and bar from the back of the van he found that the racking had partially collapsed, trapping the long bar necessary for the job. He attempted to operate the valve with a shorter bar, and the reduced leverage caused him to exert greater force than normal resulting in a sprain injury to his hand.

- ALWAYS carry out a Site Specific/Point of Work Risk Assessment if a new situation develops
- If you are unsure or unhappy about any aspect of your task, contact your supervisor
- Only use the correct tools for the job, never 'Make Do'
- If a valve cannot be operated within your physical capabilities, raise a job request with your supervisor for hydraulic actuation
- Report any defects with your vehicle as soon as you become aware of them
- Never assume it won't happen to you!
- You are responsible for checking the safety of your equipment – this includes your van and its contents

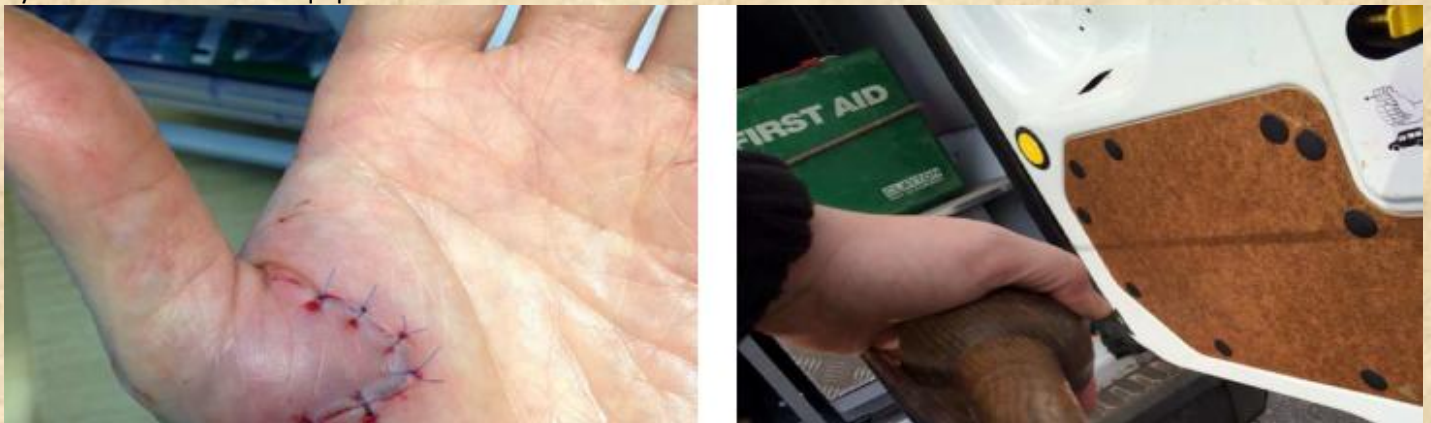
A Leakage Technician was carrying out routine leakage detection activities in a DMA. Water was found running into two manholes around 10 to 15 metres apart in a grass verge. The Technician began prodding the grassed area with a listening stick looking for signs of leakage, but on pulling the stick back out the wooden head the listening stick became detached. Not realising that this had happened, the Technician went to push the stick in again and his left hand came into contact with the sharp unfinished metal end of the stick. This resulted in a severe laceration to his hand which required hospital treatment and seven stitches. The Technician was unable to resume normal working within seven days and the incident has been reported to the HSE under the Reporting of Injuries, Diseases and Dangerous Occurrences Regulations 1995 (RIDDOR).

Upon investigation it was found that the Technician was not wearing PPE on his hands, and the listening stick was not Hydrosave-issued work equipment.

- NEVER use tools for a purpose other than that for which they have been designed.
- NEVER push a listening stick in to any ground.
- NEVER use equipment that is defective, but report it to your supervisor immediately.

- Always use your own equipment, NEVER borrow from another person.
- Always use the correct PPE for the task.
- Always report Near Misses, Undesired Circumstances or Hazards Spotted.
- Disciplinary action will be taken against anyone in breach of these guidelines.

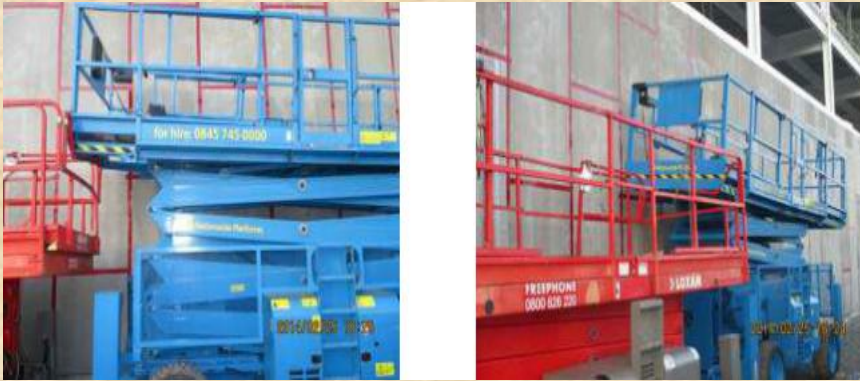
A scissor lift was being used to access the south elevation of a project in order to install curtain walling when it lowered uncontrollably by approximately three metres before the emergency stop activated. Fortunately, no one was injured in the incident.

The machine did not crash down but lowered uncontrollably as pressure escaped from the system. The incident happened at 16.15; prior to this, at 10.30, the machine underwent a full check by the supplier's service engineer who did not find any fault.

The scissor lift that failed is less than six months old, with a manufacture date of 16 October 2013.

- Scissor lift removed from service.
- Supplier's and manufacturer's engineers to conduct full inspection / investigation into incident.
- All scissor lifts from the manufacturer to be inspected.
- Any Model GS4390 removed from service pending results of investigation.

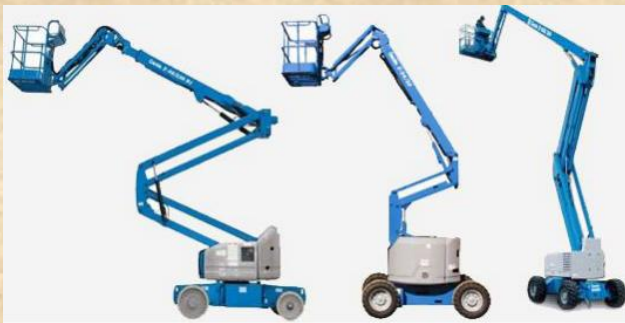
Genie has become aware of secondary boom angle sensor calibrations performed in the field in which the machine's service manual may not have been followed creating an improperly calibrated machine. An improperly calibrated machine can lead to machine instability resulting in a machine tip over.

Ensure prior to use that all Genie Z-135/70 machine have had this remedial works undertaken prior to operation. E.g. check service manual or speak to hire company. DO NOT OPERATE unless you are satisfied and confident that this has occurred.

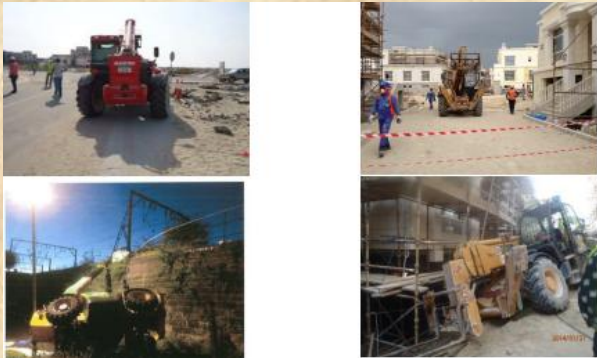
1. A site operative was killed when a tele-handler struck him. The tele-handler was reversing without the aid of a banksman and the man who was killed was not wearing a hi-visibility vest.

2. A site operative was injured by a tele-handler which was reversing a considerable distance without the aid of a banksman and the man struck was talking to colleagues at the time.
3. A tele-handler overturned while lifting a load that was too heavy for it. The driver was inexperienced and the lifting plan was inadequate.
4. A tele-handler fell into an excavation. The road was too narrow for the machine, the excavation was not marked or barricaded, and there was no banksman.

Where possible, segregate plant and equipment from people on site. Remember it is important to constantly review the traffic management plan as the site develops.

Ensure that the contractor provides a physical barrier to prevent vehicles and plant running into excavations.

Ensure lifting methods are in place and that everyone understands the lifting specification for each machine.

Check that all plant operators have the correct level of training and competency for the machine they are driving.

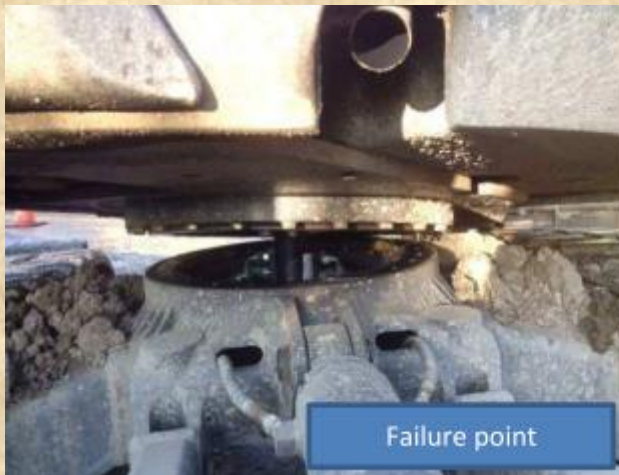
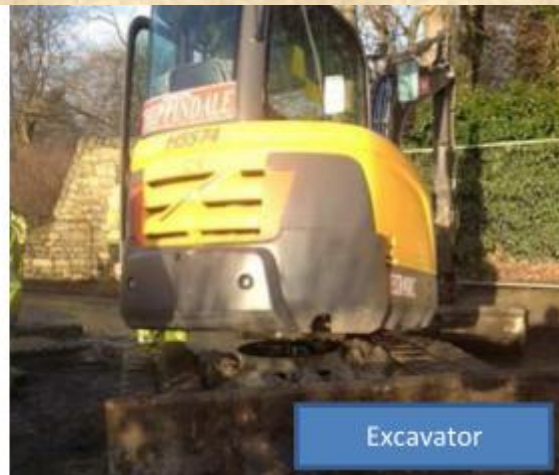
An incident has occurred at a site involving a 5 Tonne Volvo ECR48C 360 excavator (not a Cross rail site). Whilst tracking the excavator along the carriageway to commence excavation works the body of the excavator partially detached from the chassis. The arm of the excavator was positioned close to the ground, which held the machine. No injuries were sustained.

Volvo (Manufacturer) and Chippindale Plant (Hire Company) are currently carrying out a full investigation into the failure.

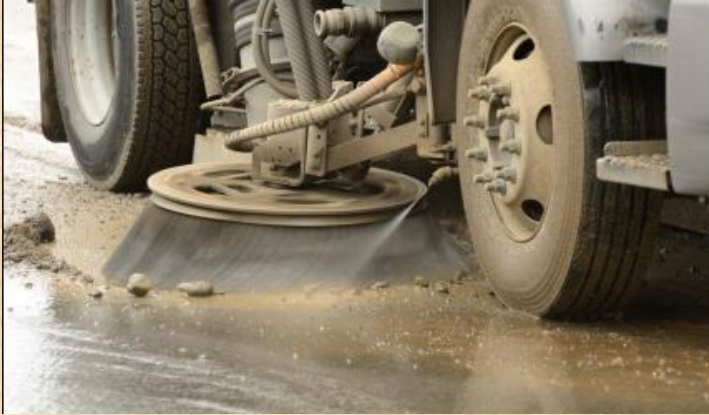
A road sweeper operating for a Crossrail contract was observed depositing waste water from its tanker into a gully by the side of the road.

If a road sweeper is emptied in an unauthorised location such as the verge of a public highway, this is flytipping. If a road sweeper is emptied into or near

drains or rivers without an appropriate water discharge permit or trade effluent consent, this may cause pollution. These are offences, and the environmental regulator could prosecute.

- Do you know the ultimate destination of your road sweeping arisings?
- Is the disposal location suitable for the material?
- Is the correct paperwork in place e.g. waste carrier licence, waste transfer notes, permits for disposal?
