# Troubleshooting Torque Converter Clutch Cycling on Dodge Trucks

*Easy Solutions for a Common Problem*

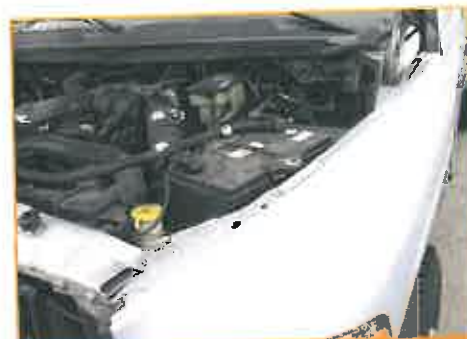
Load, or impedance test the batteries. Clean the battery terminals (figure 1) even if they don't have any apparent "fuzz" on them. All it takes is a little oxide buildup between the battery post and cable clamp to cause trouble. Diesels have two batteries, so be sure to clean and test both. Also, follow the negative battery cable back to the engine block and clean the powertrain ground connection. A bad battery or added resistance from corroded or loose battery terminals or grounds reduces the battery's ability to buffer the charging system. This causes increased generator ripple and charging voltage fluctuations.

**Figure 1:** Clean the battery terminals and load or impedance test the batteries. Follow the negative battery cable back and clean the connection to the engine block.

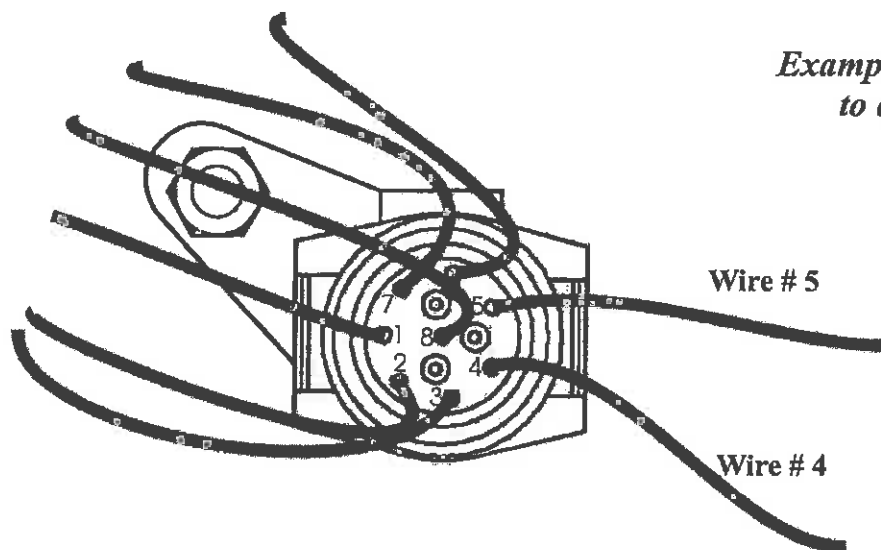
Figure 15 is an example of what would be observed with a 2nd gear start complaint due to a defective governor pressure sensor (Transducer). To make this diagnosis, what should be noticed is that the pressure gauge indicates 10 to 12 psi at 0 miles per hour. This amount of governor pressure will keep the 1-2 shift valve stroked in an up shifted 2nd gear position. Comparing this chart to the one seen in Figure 12, it is noticed in Figure 15 that with 10 pounds of governor pressure the sensor is sending to the computer a 0.66 volt reading. This indicates to the computer that there is 0 psi in the circuit when actually there is 10. At 10 pounds of pressure, approximately 0.9 volts should be observed as seen in Figure 12. With the computer thinking that it controlled the governor solenoid to produce 0 psi due to faulty data produced by the sensor, it did not attempt to energize the solenoid any further. Changing the sensor will solve this complaint.

*Example of a 2nd Gear Start due to a defective transducer*

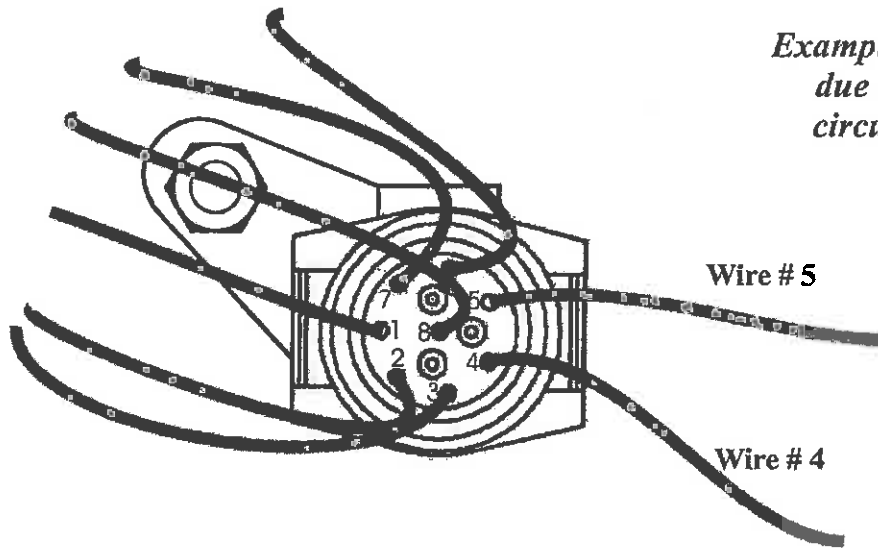
Figure 17 is an example of what would be observed in a no up shift situation due to a leak in the governor circuit or a clogged inlet port to the governor solenoid. Notice that the computer is trying to raise governor pressure by turning the solenoid off. The pressure gauge indicates 0 psi in the governor circuit and it never rises. The governor sensor remains at a 0.66 voltage indicating to the computer that governor pressure is not rising which means the sensor is working properly. By 30 mph the computer has turned off the governor solenoid as indicated by the full system voltage observed on the ground wire (#5). A leak in the governor circuit or a clogged inlet port to the governor solenoid can then be concluded.

*Example of a no up shift condition  
due to a leak in the governor  
circuit or a clogged inlet port  
to the solenoid*

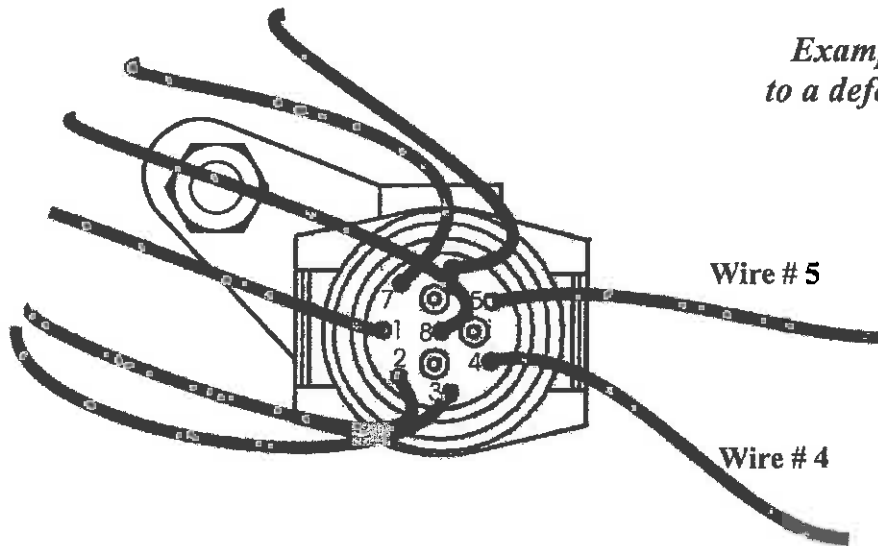
Figure 18 is an example of a third gear start problem due to a mechanically failed governor solenoid. Notice how governor pressure is at a full 60 psi. The governor sensor is sending a 2.95 volt reading which tells the computer that governor pressure is at 60 psi. The computer then begins to increase current draw on the governor solenoid to try to bring down governor pressure. Notice how the voltage is dropping on the # 5 wire. Remember, the voltage seen on the # 5 wire is voltage not being used. The lowest voltage reading observed is 6.3 volts. If you subtract that from 13.5 volts, the computer used as much as 7.2 volts in an attempt to bring down governor pressure based on the information it was receiving from the sensor. With the pressure gauge verifying that governor pressure was high as well as having a third gear start problem, a mechanically failed governor solenoid would be the logical reason for this complaint. It just so happened that this example was taken from a vehicle where the magnet that was in the pan was improperly placed onto the solenoid. The magnet kept the solenoid in a fully applied position causing full governor pressure to remain in the circuit. Another point is that this was a pre 96 vehicle making it a TCM version. Notice that after the computer used as much as 7.2 volts in an attempt to bring down governor pressure it suddenly went to 13.8 volts. This action means the computer had decided to shut the solenoid off going into a failsafe mode. If this was a 96 and later vehicle, the relay would have been turned off cutting the supply voltage to wire # 1 and wire # 5 would have gone to 0 volts.

*Example of a 3rd Gear Start due to a defective solenoid mechanically*

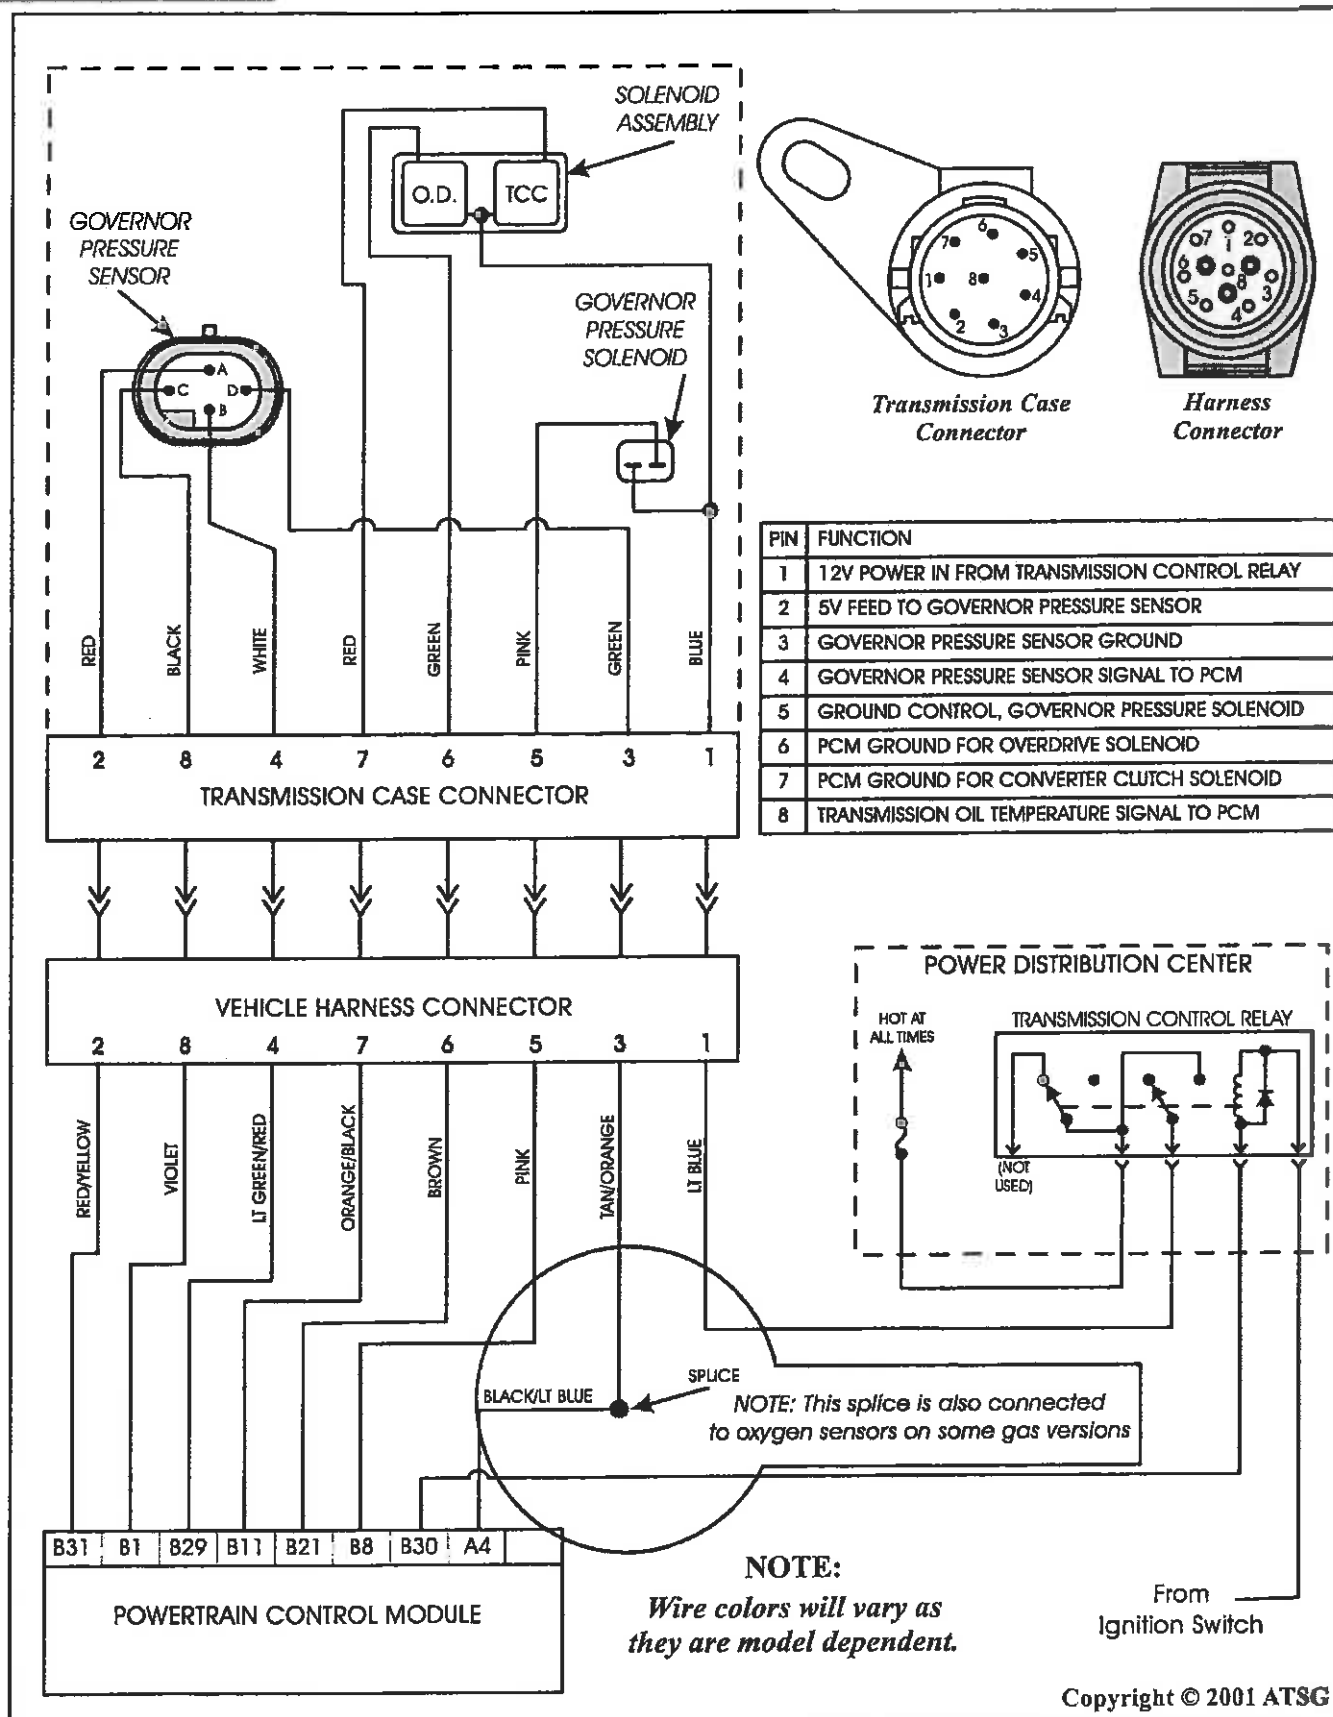
Figure 1

1. One cause could be that the ground circuit for the governor pressure sensor has been compromised (See Figures 1 and 2).
  - a. Faulty governor pressure sensor
  - b. Faulty battery temperature sensor
  - c. Faulty heated oxygen sensor(s)
  - d. Faulty wiring, splices, other shared sensors or the PCM
2. Another cause could be that line pressure is running above factory specification. This could be the result of a valve body modification or a valve body malfunction.
3. A malfunctioning alternator producing voltage spikes or high charging voltage would be another consideration.

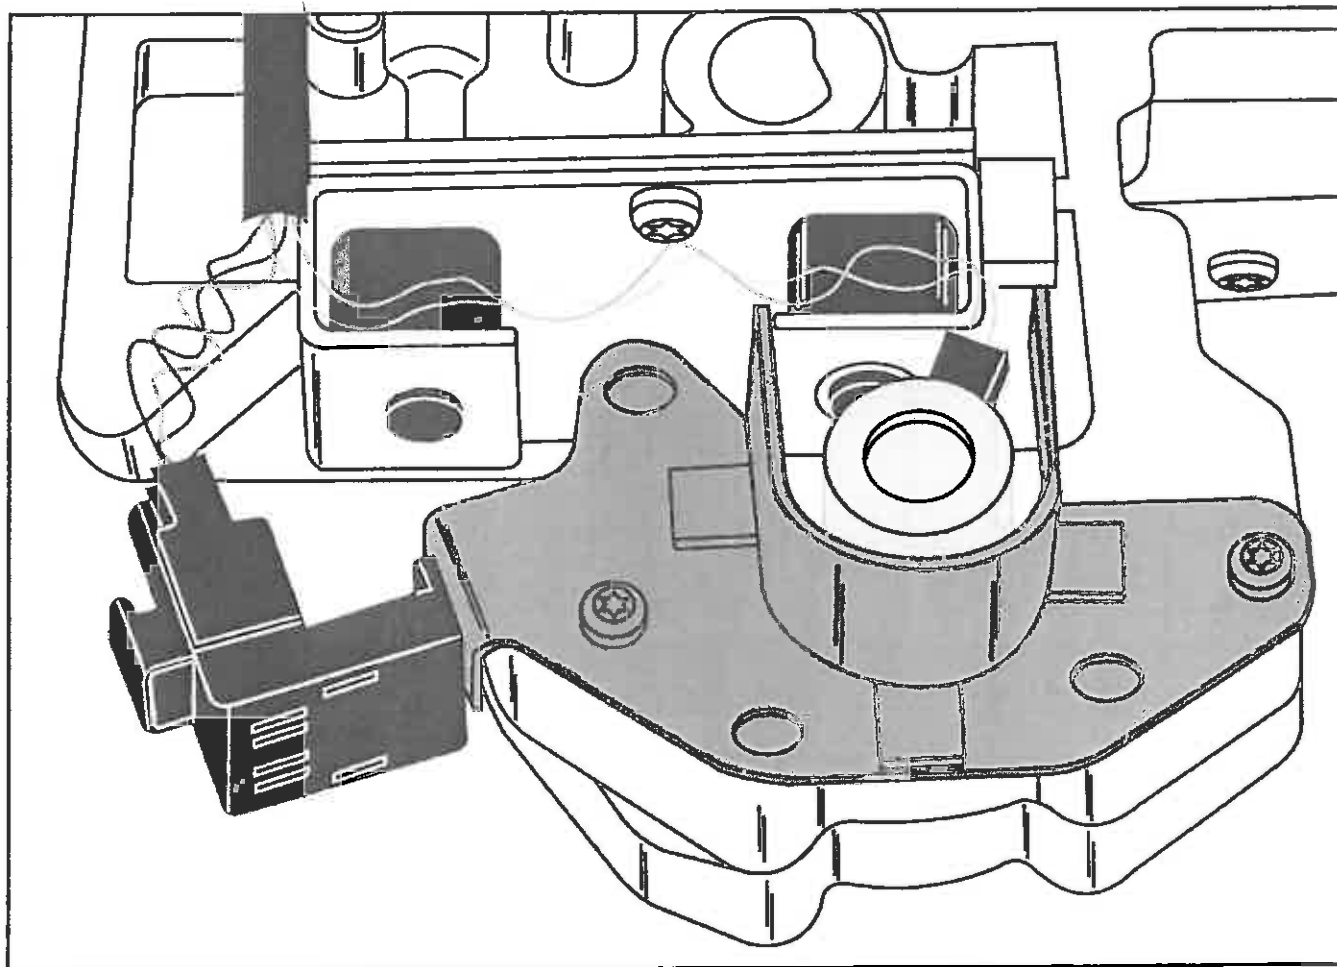
Figure 1

**CAUSE:** The area of the valve body where the governor pressure control solenoid and the governor pressure sensor are located is warped (Refer to Figure 1).  
When this area is warped governor pressure from the solenoid to the sensor is leaking causing erratic governor pressure which causes the erratic sensor signal voltage (See Figure 2). This results in oil at the tip of the sensor to vary which causes the sensor to vary the signal voltage. The PCM will react by varying the solenoid operation which will result in erratic governor pressure.

**CORRECTION:** Check the crush on the solenoid/sensor gasket which might reveal warpage in this area. Flat sand the solenoid/sensor mounting block as well as that area of the transfer plate section of the valve body (Refer to Figure 3).

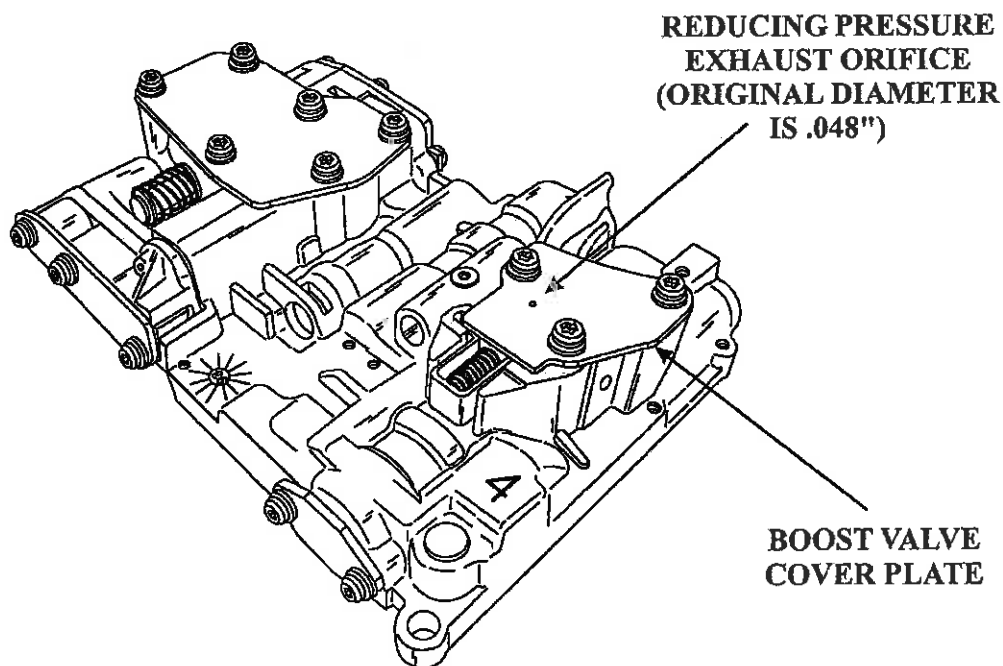
Figure 1

**CAUSE:** The cause may be, a Reducing Pressure Exhaust orifice that is too small, which delays the pressure increase needed when the Torque Converter Clutch is applied. Refer to Figures 2 and 3 for a partial hydraulic schematics explaining the Boost Valves function.

**REMOVE THE BOOST VALVE COVER PLATE AND ENLARGE THE REDUCING PRESSURE EXHAUST ORIFICE TO .069"**

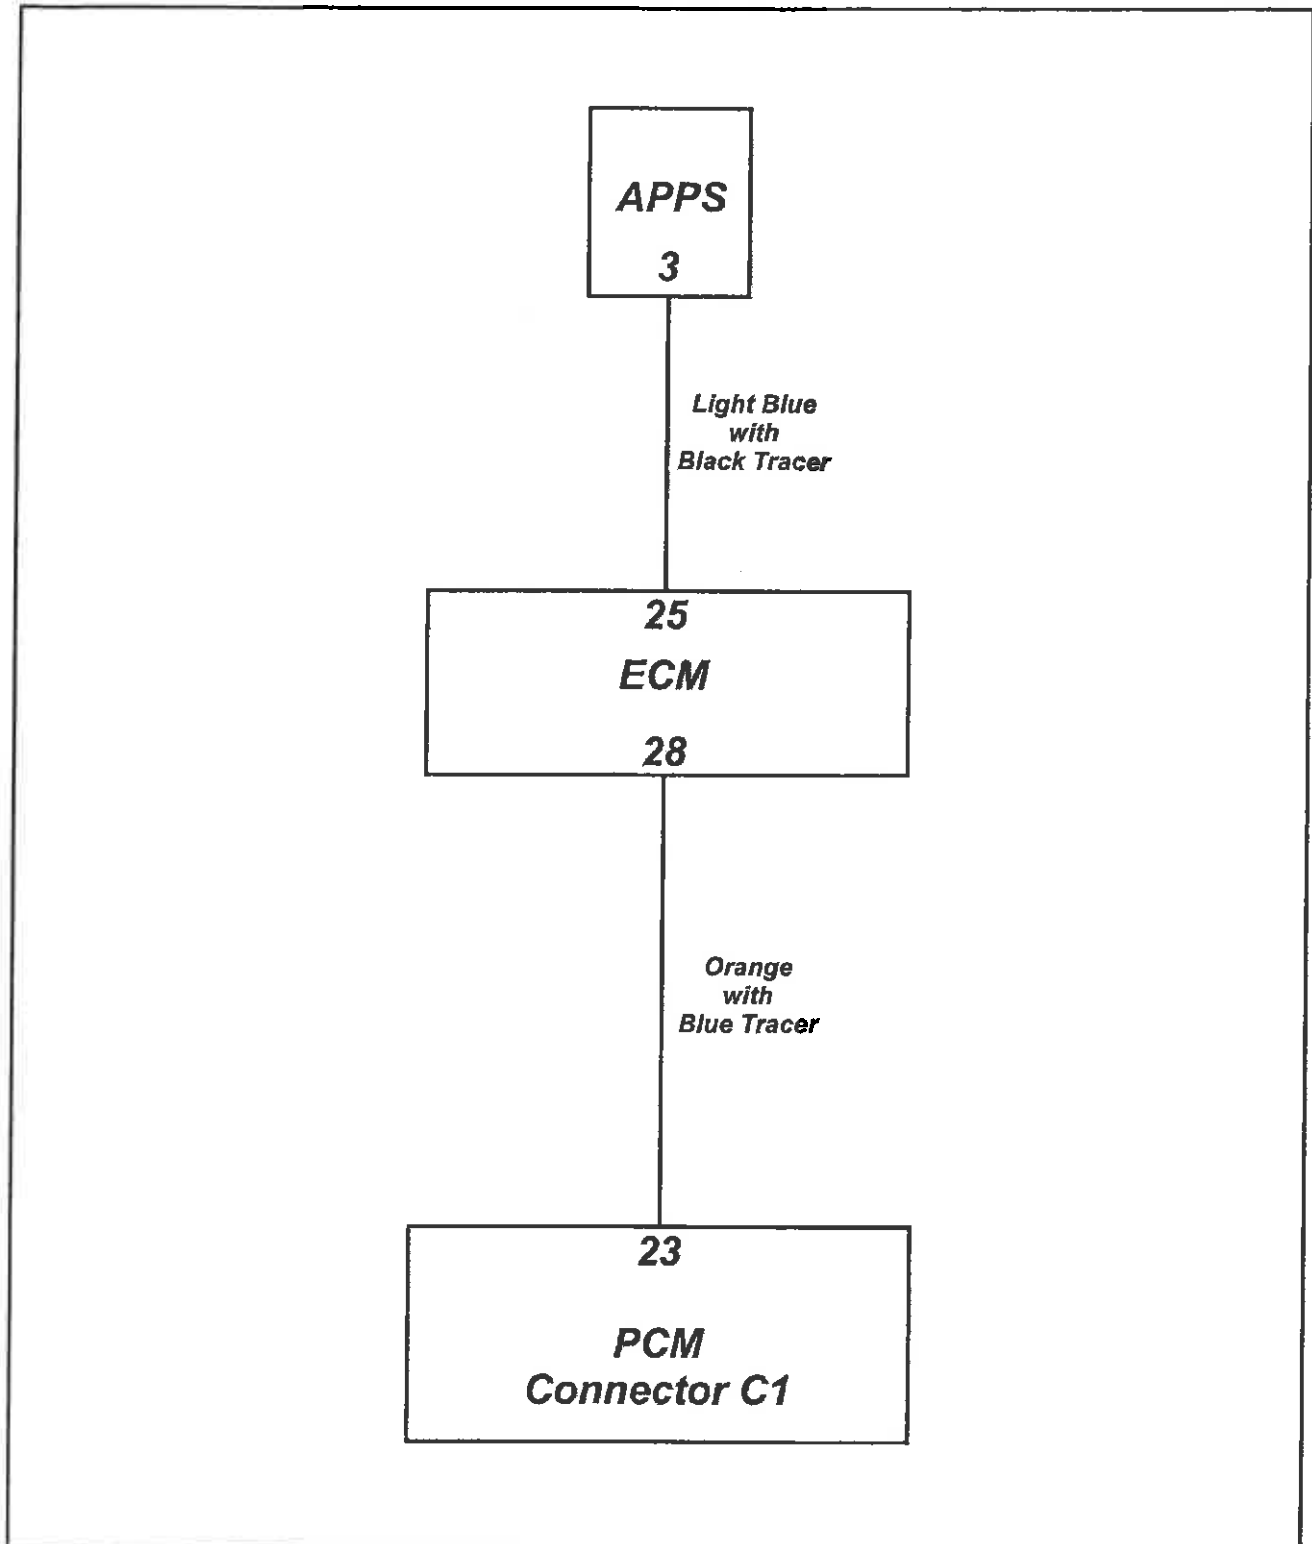
Figure 1

**CAUSE:** There are many possibilities such as a malfunctioning brake switch or brake support bracket. Temperature sensors, alternators, throttle position sensors, vehicle speed sensors to name a few. Chrysler has even issued a reprogramming procedure (Bulletin #18-02-99) for 1996 and later vehicles which compensates for alternator or TPS noise correcting this complaint. Reports of TCC shuttle has also occurred while driving with a scanner attached to the data link connector. Unplug the scanner and the problem goes away. One other possibility that may go overlooked is a defective ECM with 1998 and later vehicles. These vehicles are equipped with an Accelerator Pedal Position Sensors (APPS) rather than a TPS. The APPS sends a typical TPS signal to the ECM and the ECM sends that signal to the PCM. Should the ECM malfunction, the incorrect signal is received by the PCM causing the shuttle shift complaint (See Figure 1).

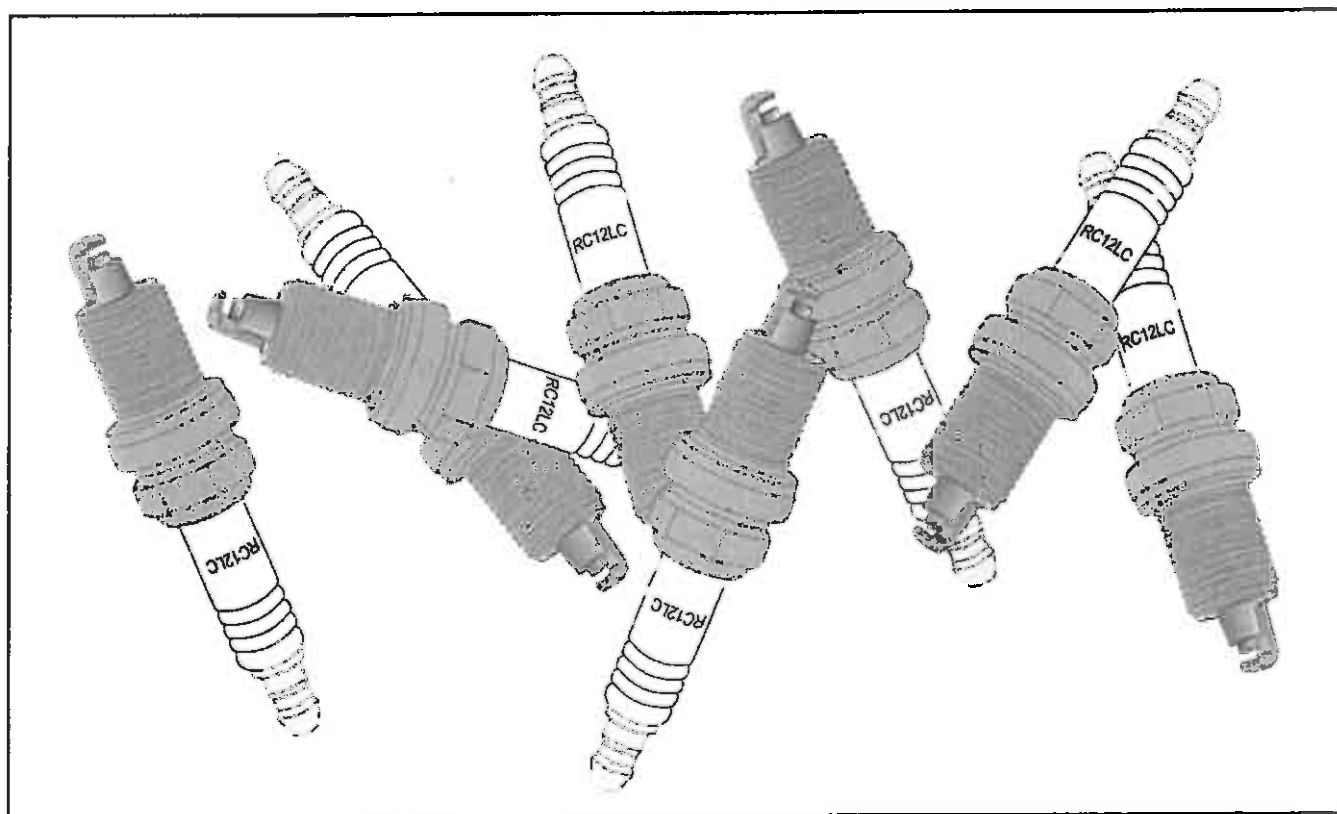
Figure 1

**CAUSE:** This 1999 Dodge 4x4 with 5.2L engine and 46RE transmission had 126,923 miles (204,264 kilometers) on the odometer. Worn spark plugs (See Figure 1) were the cause of the above mentioned complaints.

**CORRECTION:** A new set of Mopar spark plugs and an extensive test drive indicated that the problem was gone.

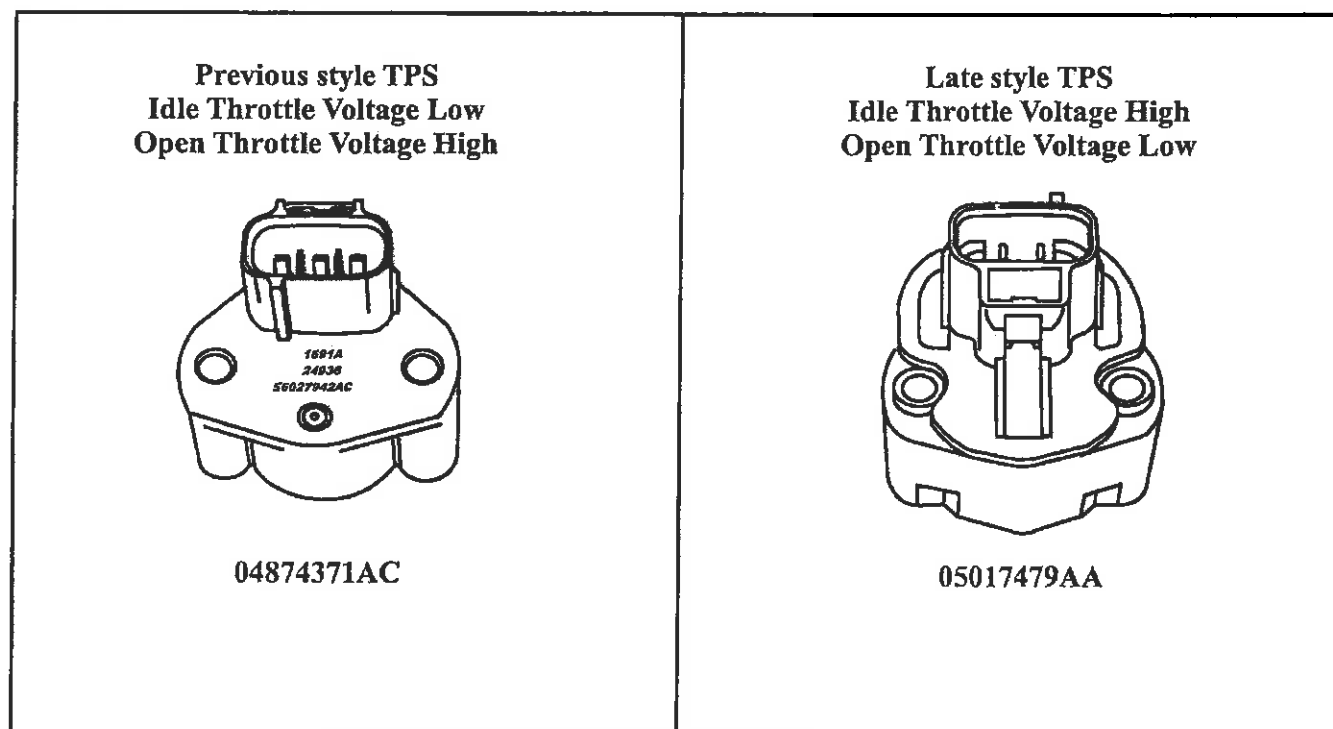
Figure 1

**CAUSE:** Mid 1999 and Later 4.7 liter Jeep Grand Cherokees had a design change to the TPS where idle voltage is at approximately 4.5 volts and wide open throttle voltage at approximately 0.5 volts (See Figure 1). This is opposite to the typical 0.5 volt to wide open throttle 4.5 volt Dodge/Jeep TPS (See Figure 1). If these TPS's are installed incorrectly, there will either be a no up shift condition or a stacked up shift condition. Although these TPS's have a significant difference in design, they both have the same style connector allowing the installation.

**CORRECTION:** Install the correct TPS.

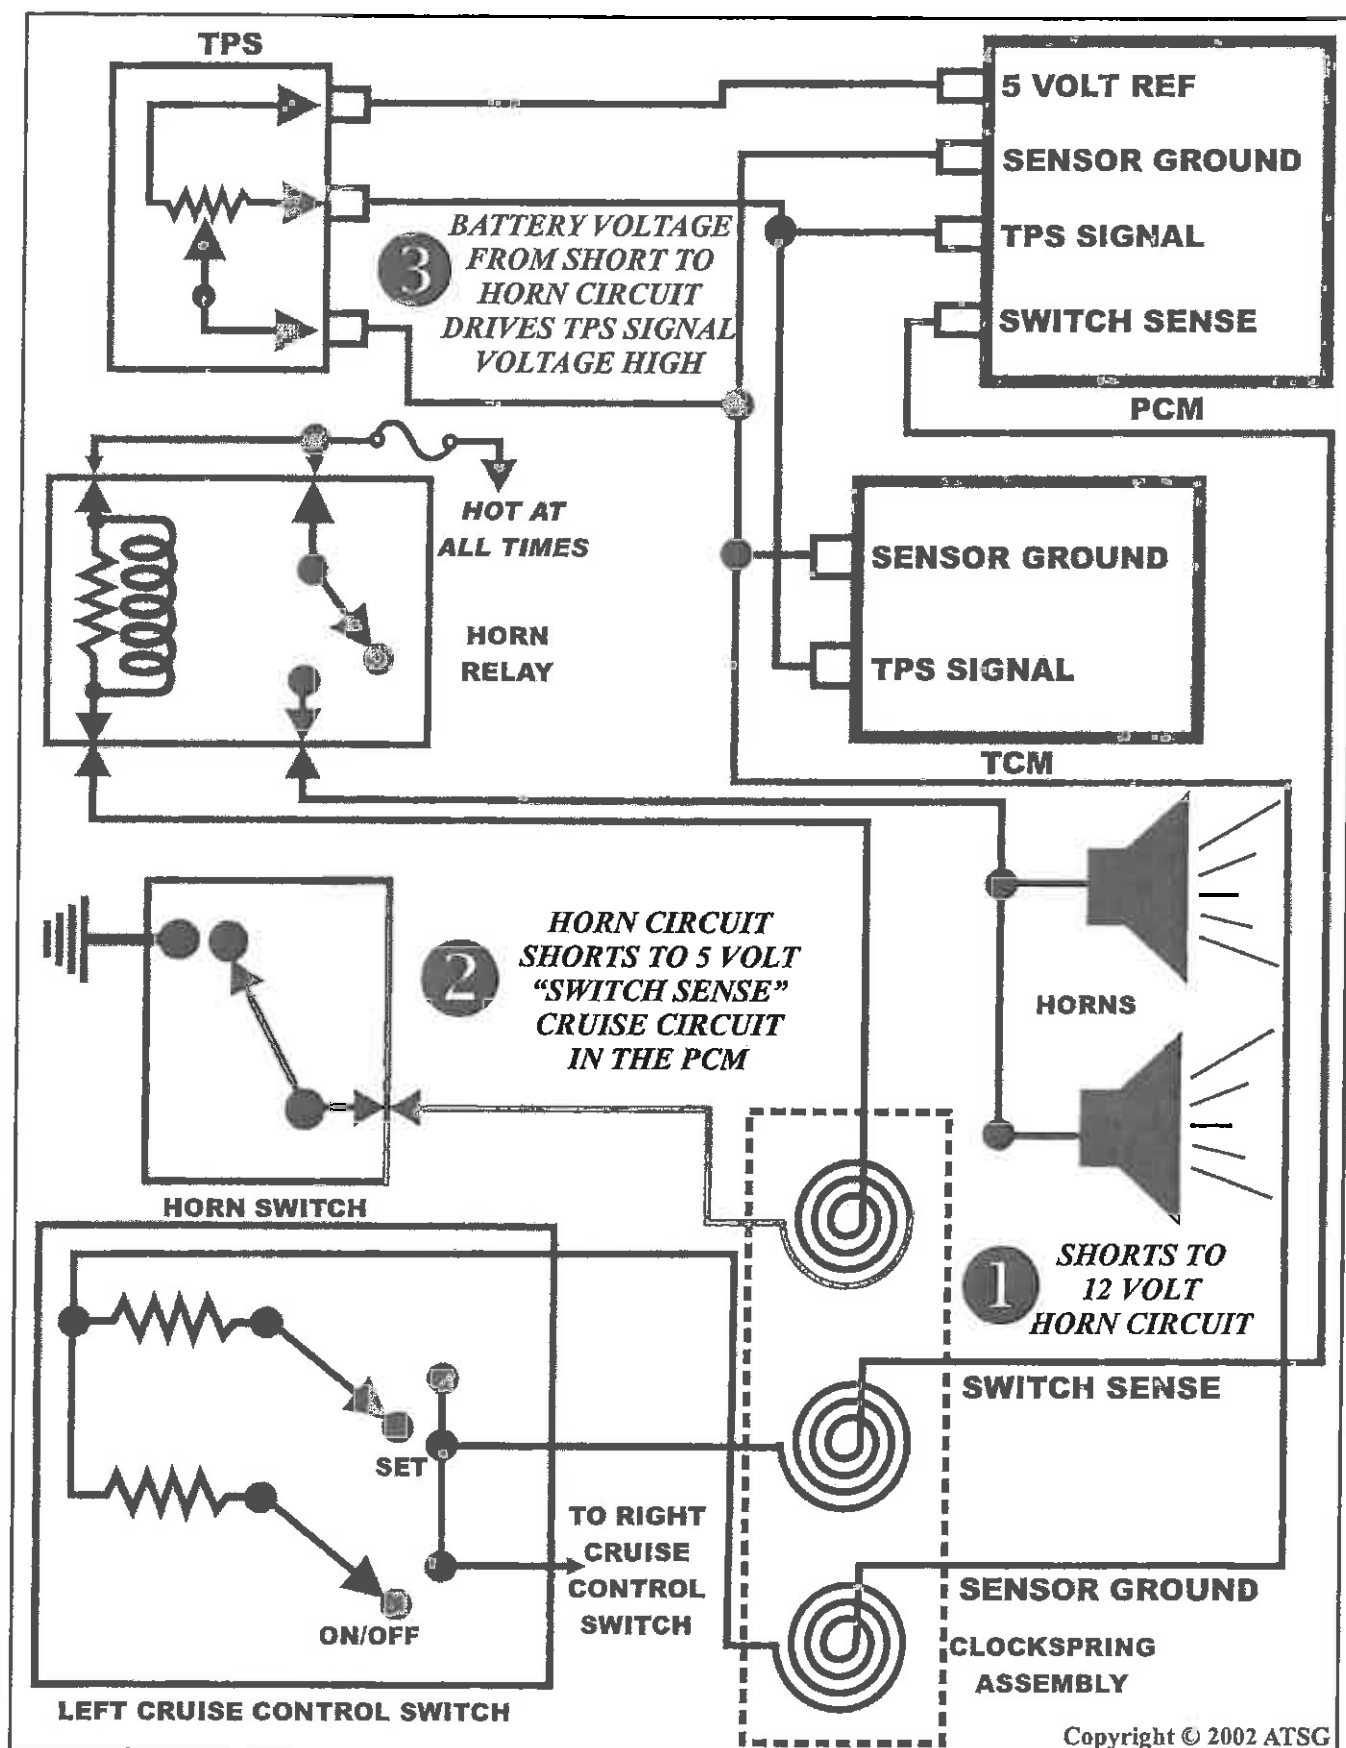
Figure 1  
Automatic Transmission Service Group

- A replacement TPS does not cure the problem, neither does replacement of the PCM or TCM.
- CAUSE:** The Switch Sense circuit in the Clockspring in the steering wheel hub has shorted to battery voltage from the horn button circuit. When the Switch Sense Circuit shorts to the 12 volt HORN circuit the TPS signal voltage is driven high and remains there as shown in Figure 1. This is because the 5 volt reference voltage used by the Cruise "Switch Sense" circuit and the TPS are shared inside the PCM.

- CORRECTION:** Replace the Clockspring assembly. Once the Clockspring has been replaced, be sure to check the sensor 5volt reference voltage at the PCM to insure that circuit has not been damaged by the short to power. Also check the TPS signal range to insure the TPS has not been fried.
