# Service Information

## FUEL INJECTION PUMP TIGHTENING TORQUE SERVICE MANUAL REVISION

One of the tightening torques in the 'Fuel Injection Pump Tightening Torques' service manual (Publication No. EE10E-11012) has been revised.

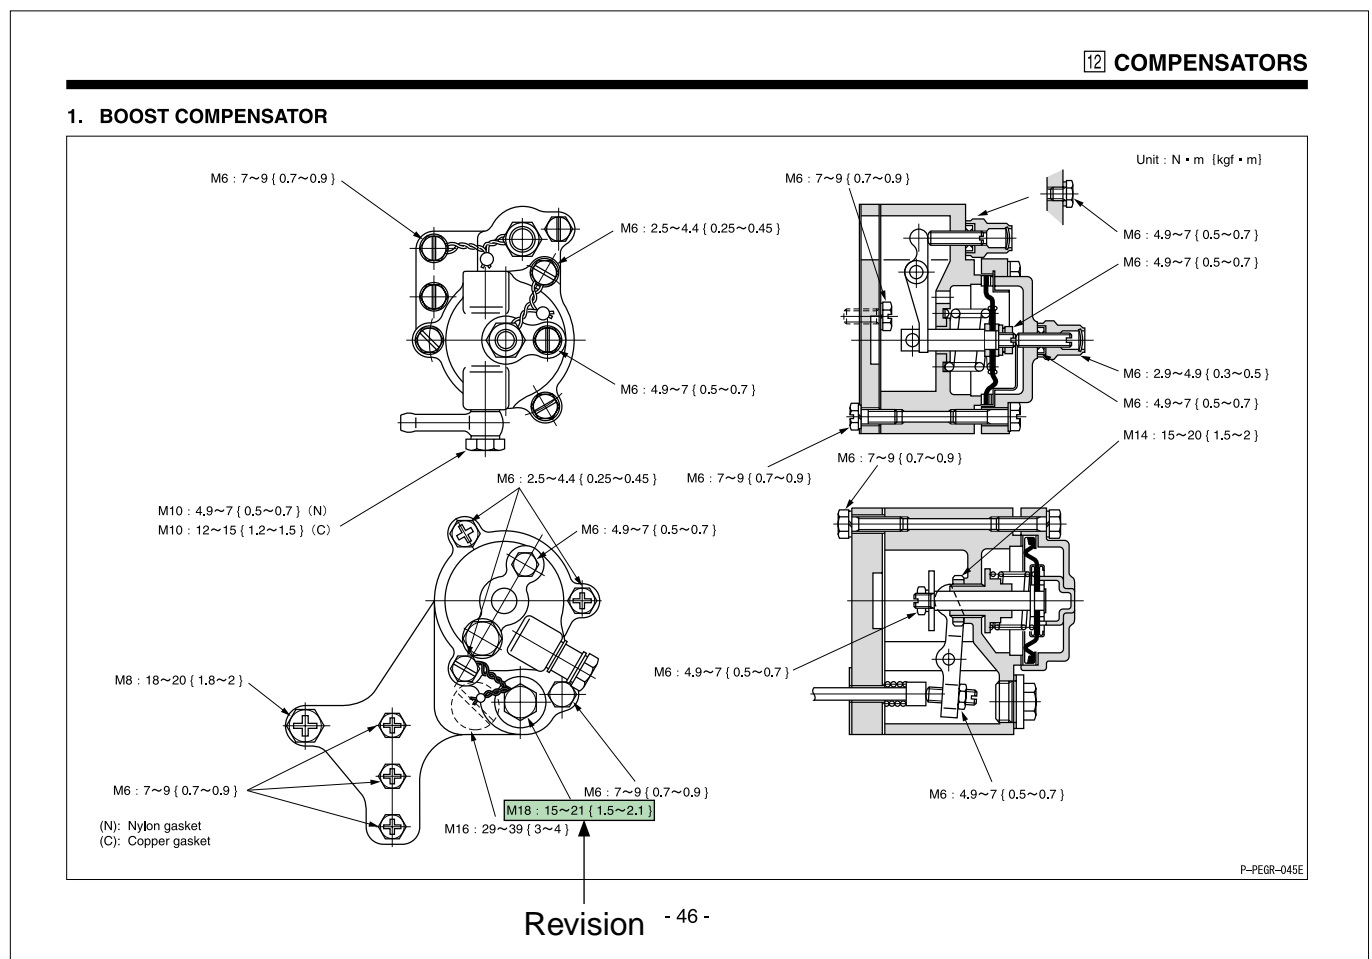
It was found that there was a difference between the torque specified by the Design Department and that implemented by the Manufacturing Department.

- Location of revised torque value: Refer to 'Revision' in the figure below.
- New torque value: 15 ~ 21 {1.5 ~ 2.1} (Previous: 29 ~ 39 {3 ~ 4})

As a result of verification by the Design Department, the torque value was revised to that implemented by the Manufacturing Department.
