EXHAUST SILENCERS

Subject: exhaust silencers

Model: Brevia 750

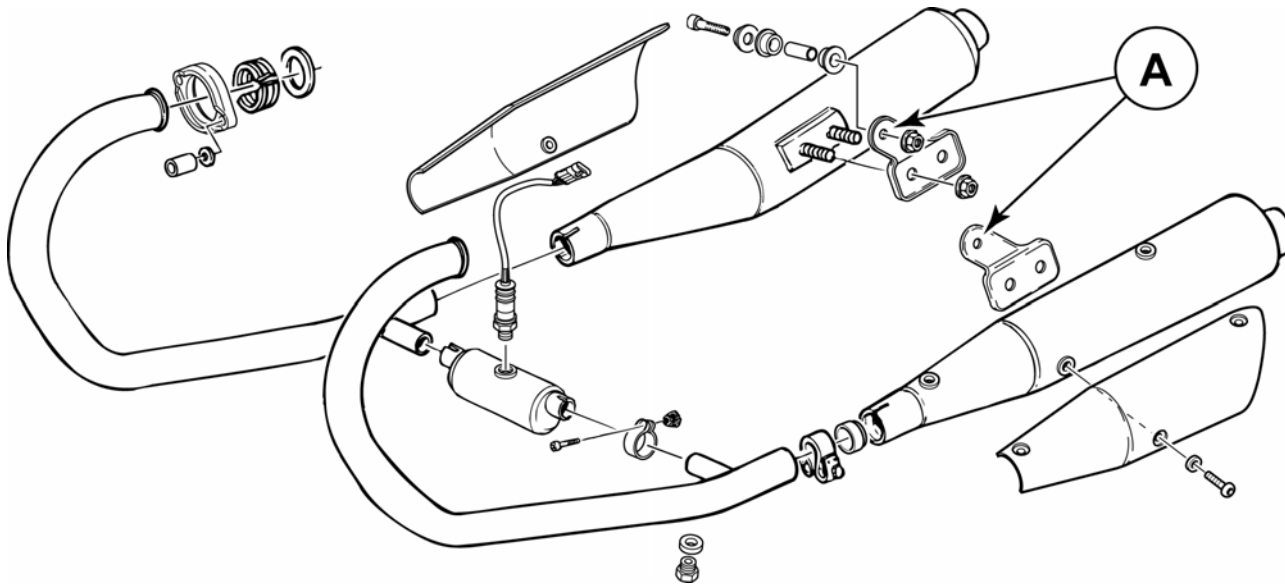
The exhaust silencers come off due to the inadequate length of the exhaust pipes.

For the new bikes, the exhaust pipe length has been changed.

For the bikes already manufactured, the problem can be solved by cutting slots on the silencer brackets (A).

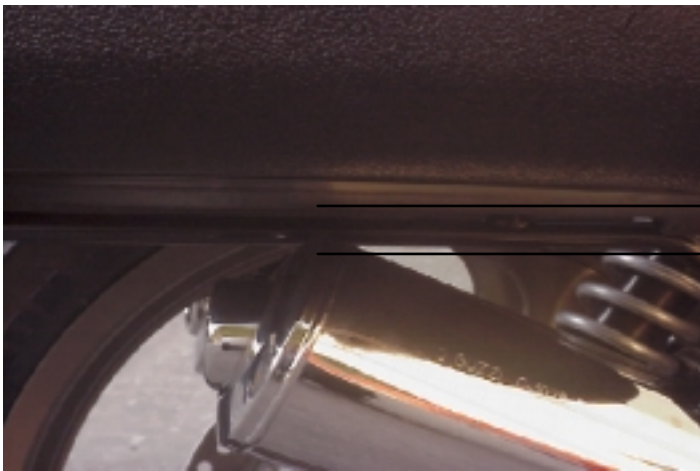
After mounting the side bag attachments, it is necessary to check that the distance between the top of the silencer and the bottom of the bag is 15 mm at least.

Should this minimum distance of 15 mm not be complied with, the bags could be damaged due to the heat produced by the exhaust fumes.

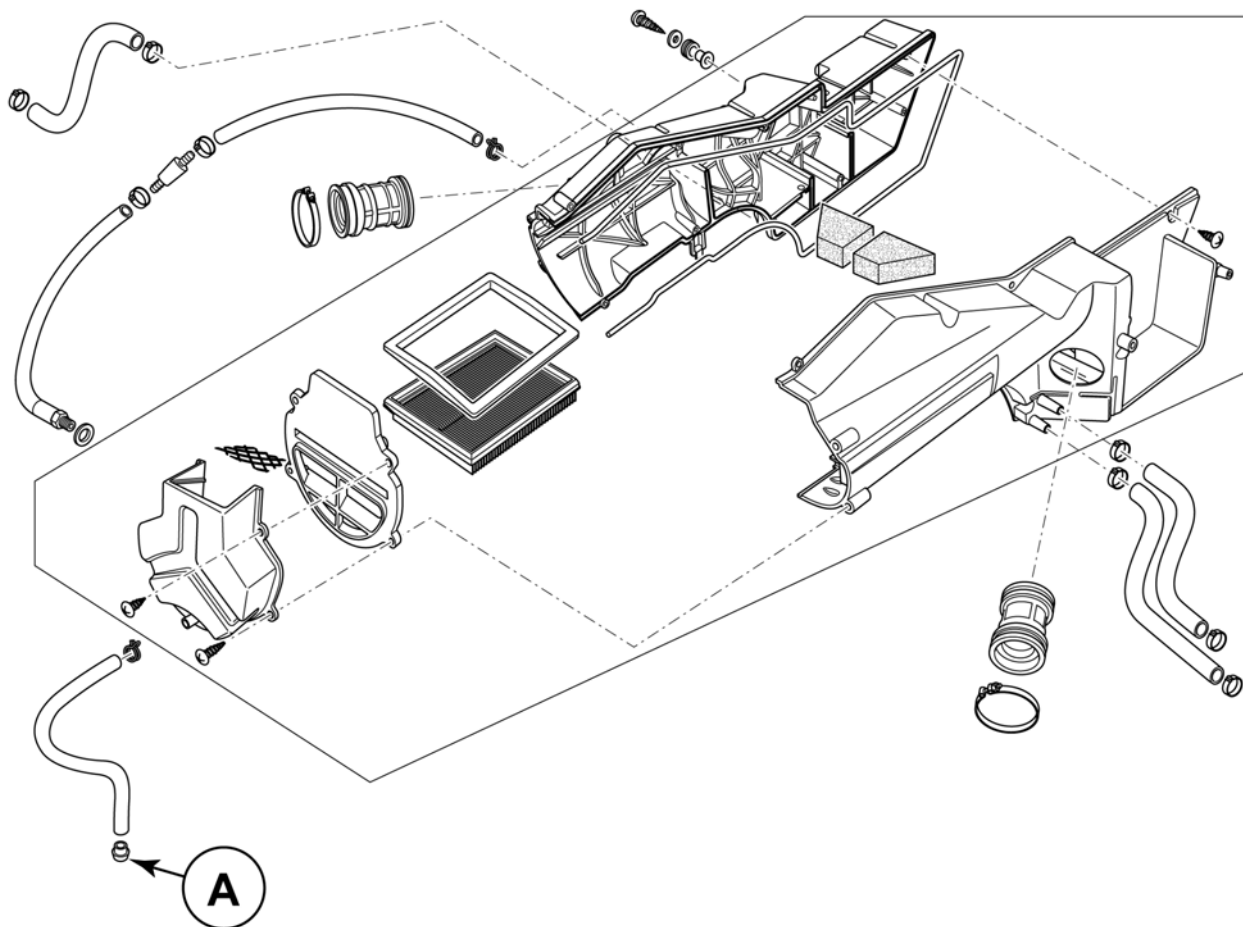
oil entering in the air box stays in the box bottom and goes out of the joints or the plug (A) fitted at the drain pipe end.

The problem was claimed on demo bikes or on bikes belonging to the first series produced only.

before fitting the air box to the vehicle, we check the air box sealing carrying out a leak test with air under pressure.

The plug (A) has been changed with a watertight plug.

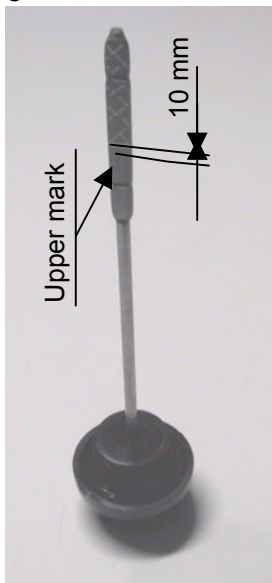
Fault experienced on vehicle: excessive quantity of oil extracted from the oil recover circuit.

Main cause: excessive quantity of engine oil.

An excessive quantity of engine oil can cause an increase in the oil extracted by the crankcase gas recover circuit. In exceptional cases an oil present in the transparent recovery tube, which extends from the filter housing to the rear joint of the right half cradle, type of anomaly can be experienced.

Technical solution: check and restore correct engine oil quantity (1.8 kg).

Check the correct engine oil level to avoid this inconvenience.

The checking operation can be easily carried out by using the oil filler cap dipstick. The correct quantity of oil wets the dipstick up to around 10-11 mm under the maximum level reference mark. The highlighted part in the photo shows the section of dipstick which must be wet. The check must be carried out with the engine warmed up, after around 20 minutes that it is running.

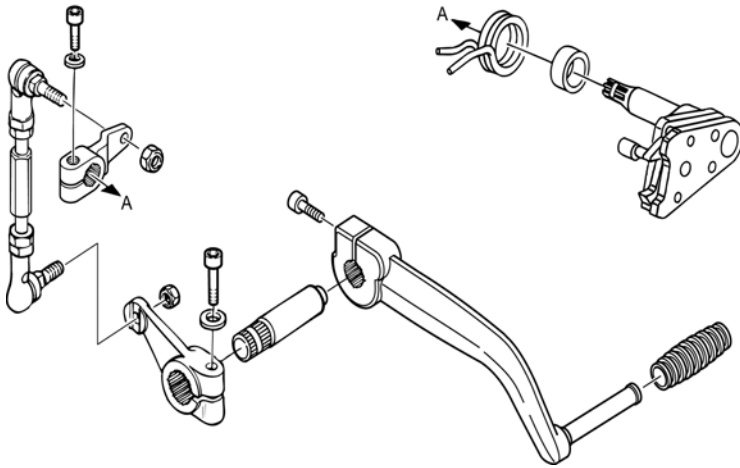
the slide inside the preselector might jam when in contact with the two pins (A).

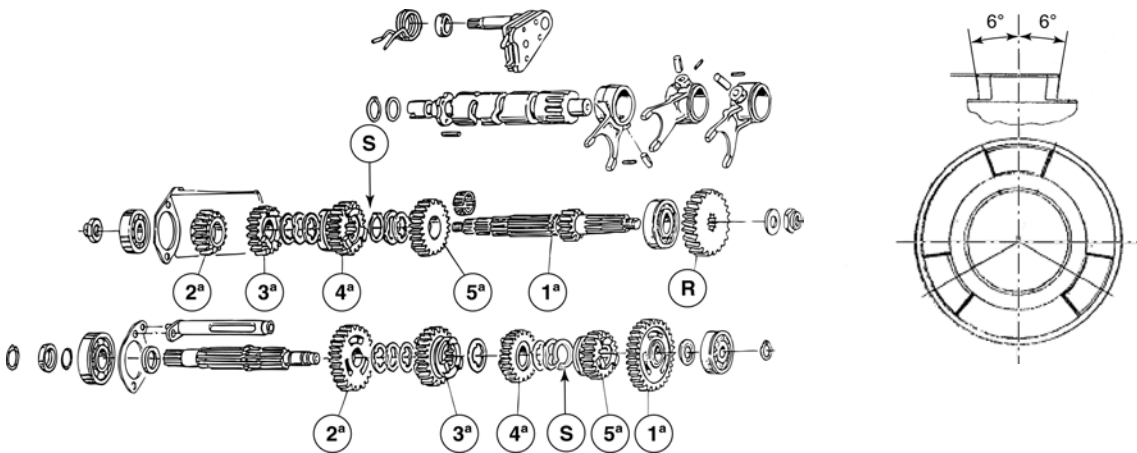
the **3rd** and **4th** gears slip out.
We highlighted two causes:

1. The circlips (**S**) doesn't keep the washer in place.
2. After inspecting the **3rd** and **4th** gears clutch dogs, it was noticed that the angle was not correct (should be **6°**) maybe due to wrong machining or because it was exchanged with one for the Brevia 750 gearchange.

1. it was fitted the circlip for the Brevia gearchange (**inner diameter undersized by 0.5 mm part no. 90271124**).
2. Changing the gears that do not comply with the drawings.

NOTE : the gear for the Nevada 750 gearchange is marked with number 6

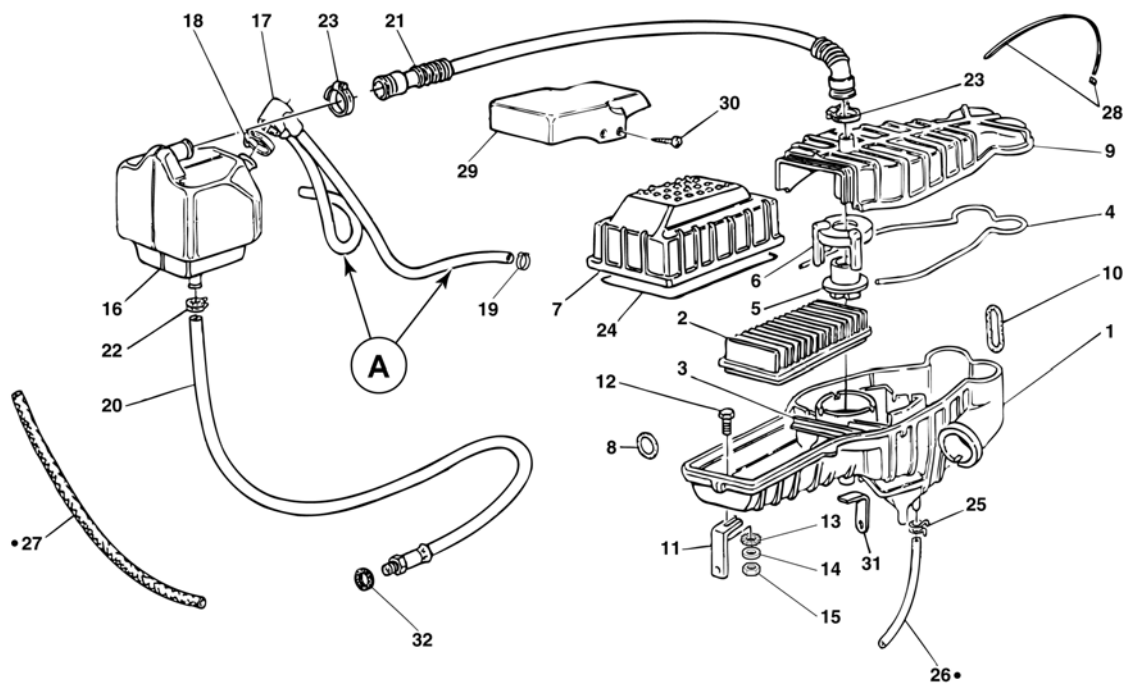
too much oil in the air box

The presence of oil in the decanter box and -following oil vapours circuit- in the air box has two main causes:

- too high oil level
- high pressure of the gases inside the crankcase

- Check that the two hoses (A) taking the oil vapours from the head covers to the decanter are not squashed due to their flexibility; if so, change them with more rigid hoses.

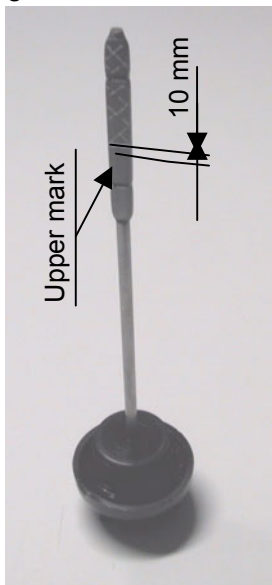
Fault experienced on vehicle: excessive quantity of oil extracted from the oil recover circuit.

Main cause: excessive quantity of engine oil.

An excessive quantity of engine oil can cause an increase in the oil extracted by the crankcase gas recover circuit. In exceptional cases an oil present in the transparent recovery tube, which extends from the filter housing to the rear joint of the right half cradle, type of anomaly can be experienced.

Technical solution: check and restore correct engine oil quantity (1.8 kg).

Check the correct engine oil level to avoid this inconvenience.

The checking operation can be easily carried out by using the oil filler cap dipstick. The correct quantity of oil wets the dipstick up to around 10-11 mm under the maximum level reference mark. The highlighted part in the photo shows the section of dipstick which must be wet. The check must be carried out with the engine warmed up, after around 20 minutes that it is running.

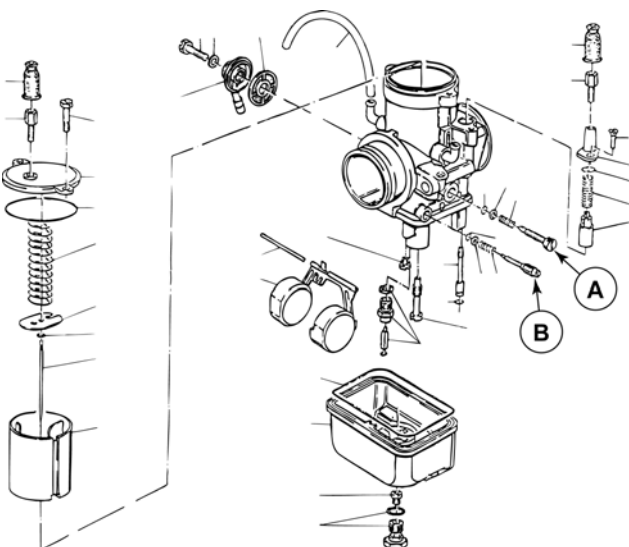
the problem might come out in different ways during a ride.

- Backfiring when releasing the throttle
- Erratic idling after acceleration
- Air leakage in the air box

- Check that the float needle valve (carburettor) is screwed in. If it is not so, change the gasket as per techn.bulletin no. 001-2003 dated 16 Jan. 2003 before tightening it.
- Connect the intake pipe take-up points to a vacuum meter.
- Start the bike and let it warm up to operating temperature.
- Set idling speed to 1150 ± 50 rpm.
- Balance the cylinders, make sure that idling speed stays the same. The idling speed adjusters (**A**) are the same that are used for balancing the vacuum on the intake pipes. It is necessary to slightly rev up, using the throttle grip, and balance the vacuum in the intake pipes using the threaded adjusters. Check that the play of the throttle drive cable is 1 mm at idling speed.

Use the mixture adjusters (**B**) to adjust the carburetion.

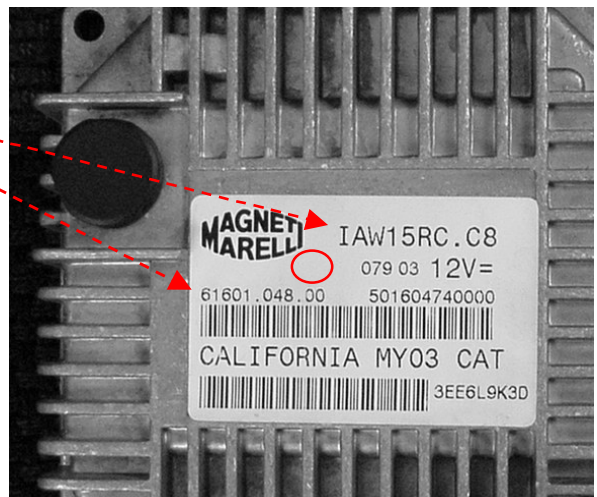
Defect found on vehicle: engine's irregular delivery

Possible cause: wrong gauging of the electronic control unit

Technical solution: control unit's replacement

Should the control unit assembled on the vehicle be incorrect, replacing it is indispensable.

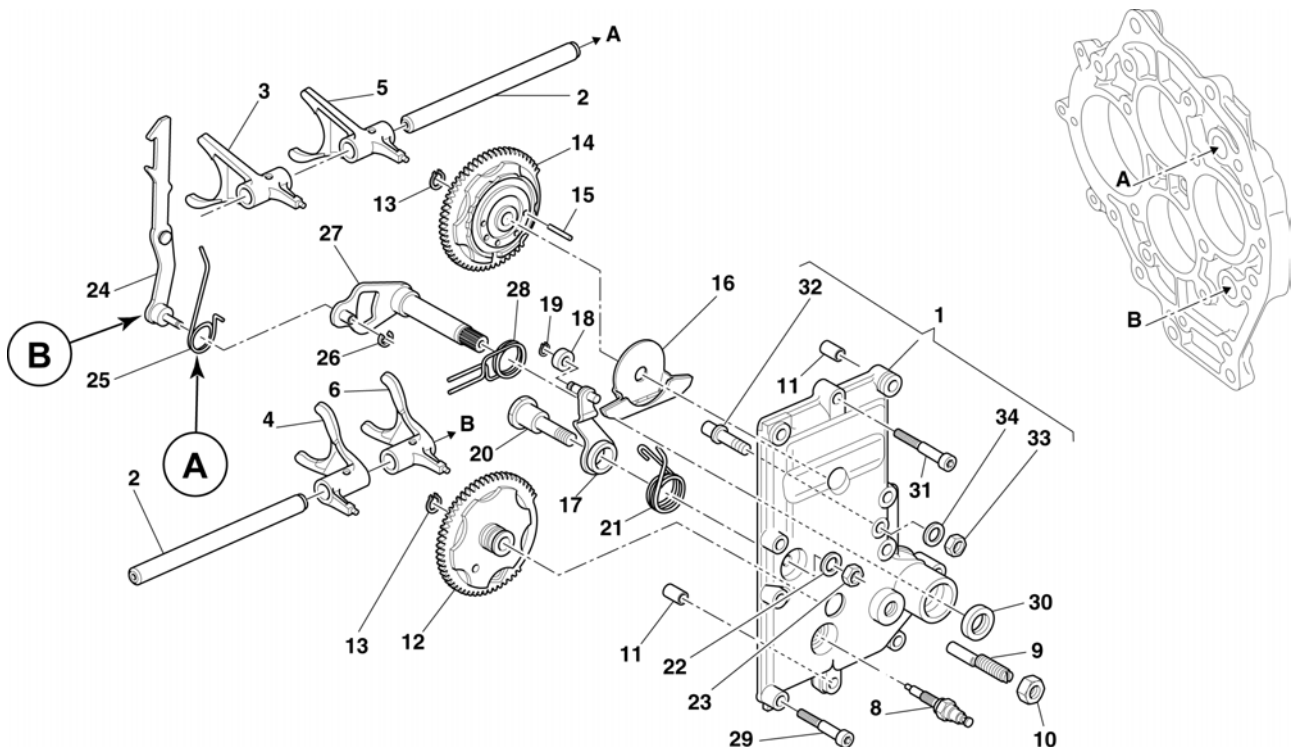
broken gear change pawl spring

In case of breakage of the pawl spring (**A**) in vehicles with frame numbers before **KT111435 - KS112350**, the pawl (**B**) should be changed (when asking for the spare part, you automatically receive the pawl updated version).

The change consists in the reduction of the diameter on which the spring rests from 16 mm to **15 mm**.
