Intel[®] 80303 and 80302 I/O Processors

Specification Update

May 6, 2003

Order Number: [273355-010](#)

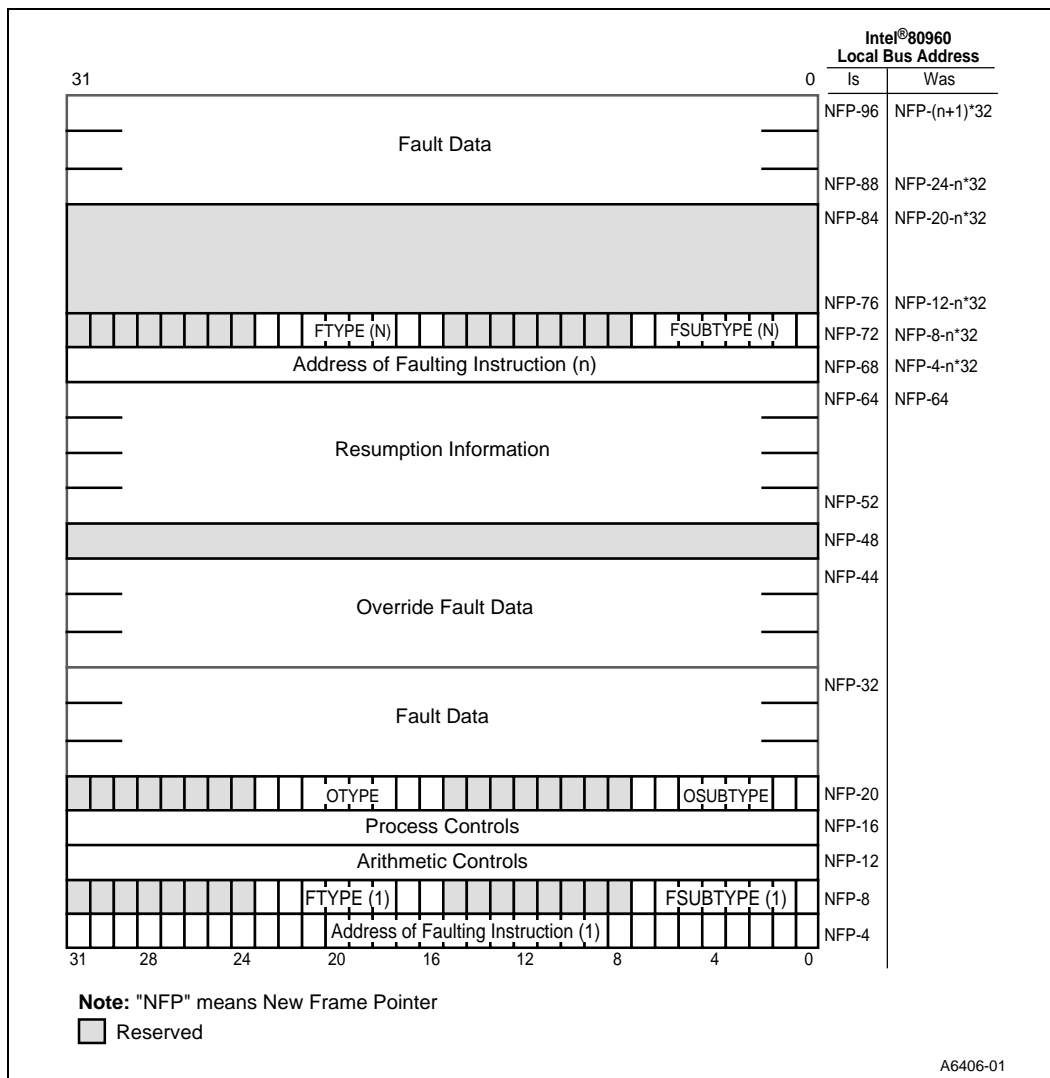
2. Figure 9-3 on pg 9-9 did not print correctly

Problem: Figure 9-3 on pg 9-9 did not print correctly.

Workaround: Replace Figure 9-3 with the following:

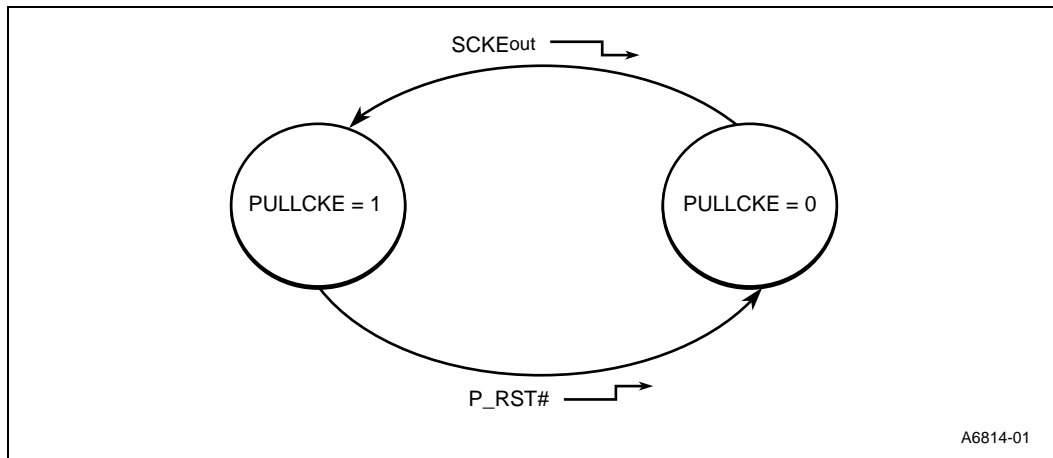
3. Figure 13-22 on pg 13-40 did not print correctly

Problem: Figure 13-22 on pg 13-40 did not print correctly.

Workaround: Replace Figure 13-22 with the following:

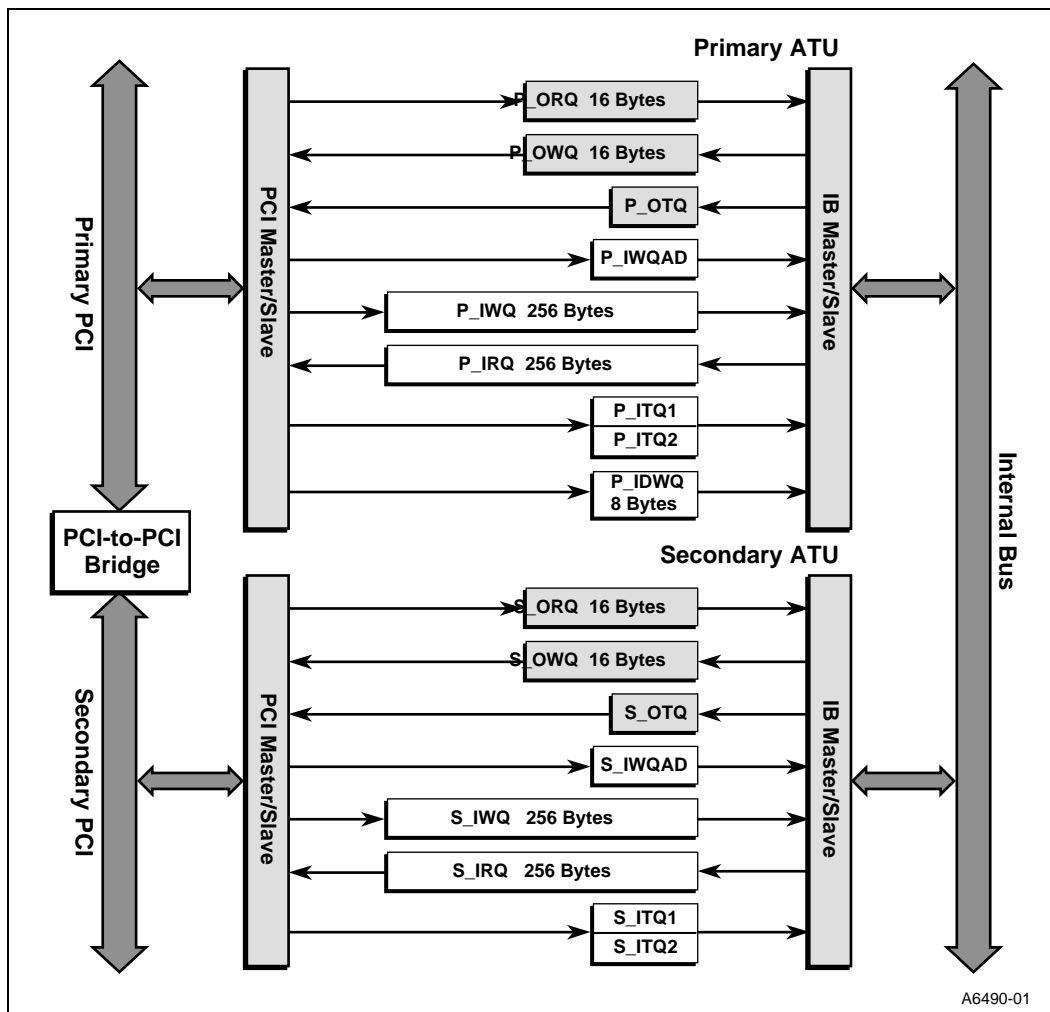
5. **Figure 15-2 on pg 15-3 did not print correctly**

Problem: Figure 15-2 on pg 15-3 did not print correctly.

Workaround: Replace Figure 15-2 with the following:

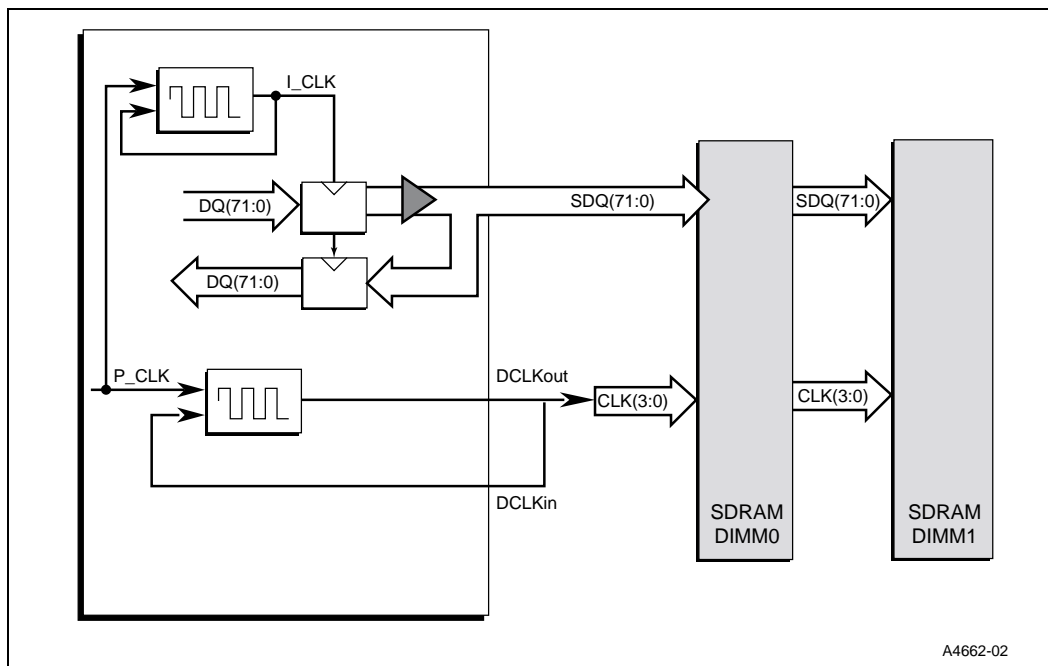
Problem: Figure 25-2 on pg 25-2 did not print correctly.

Workaround: Replace Figure 25-2 with the following:

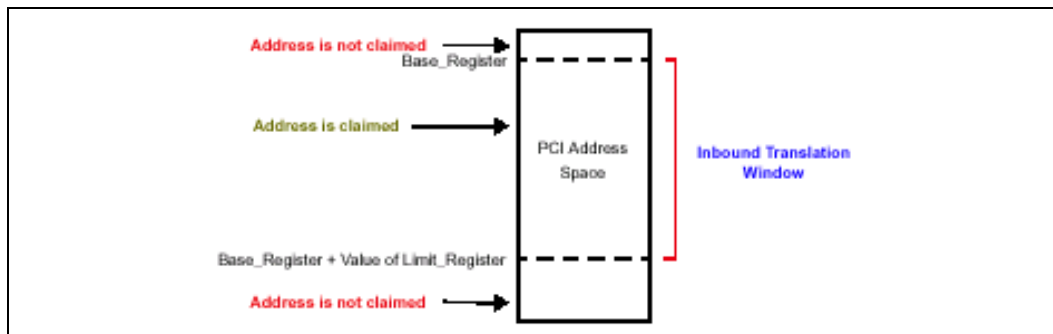
18. Figure 15-3 on page 15-7 has missing text

Problem: The figure shows 'se_Register + Value of Limit_Register'. It should be 'Base_Register + Value of Limit_Register'.

Workaround: Replace Figure 15-3 with the following:

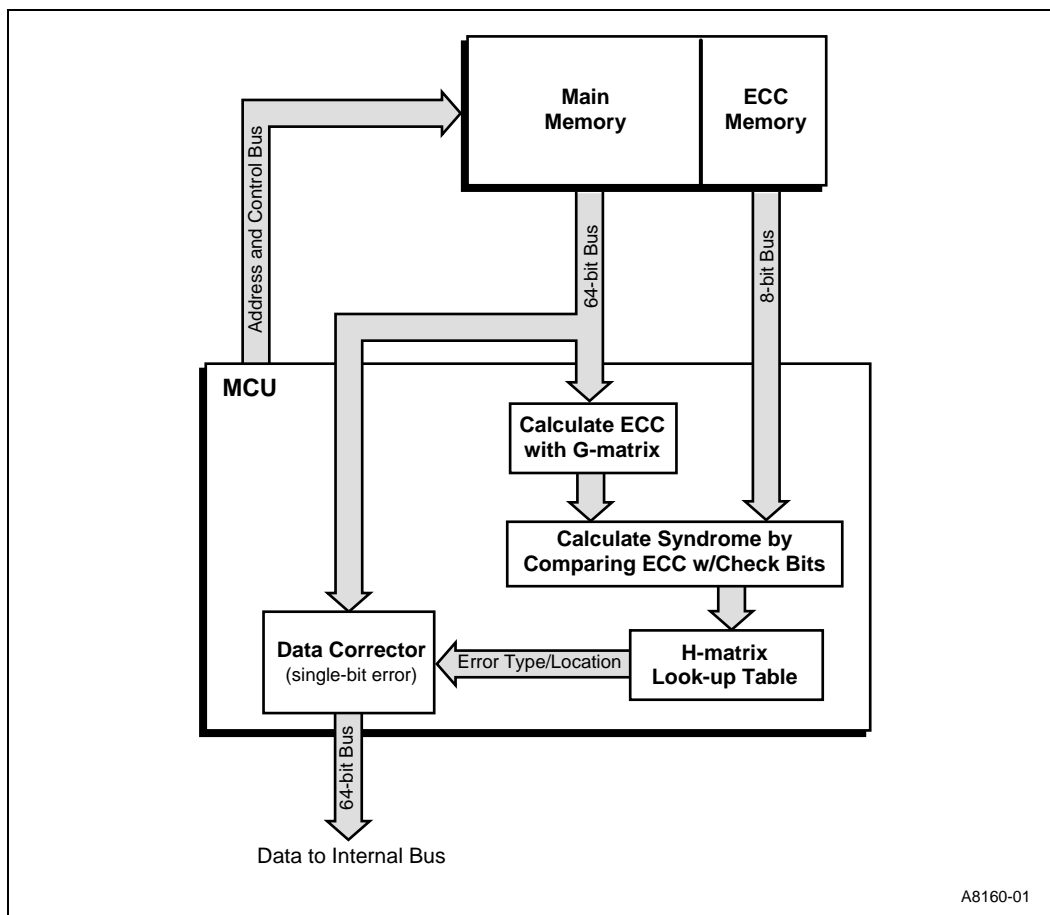
Figure 13-16. ECC Read Data Flow

Figure 13-16 shows how the data flows through the ECC hardware for a read transaction.

Workaround: Replace Table 13-13 with the following and, add the adjacent paragraph with “new” Figure 13-16:
