# Intel<sup>®</sup> DBPXA250 and DBPXA210 Development Platform for Intel<sup>®</sup> Personal Internet Client Architecture

Specification Update

*July 2002*

Order Number: **278555-002**

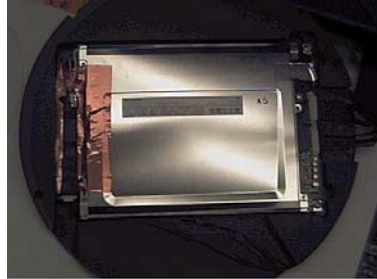
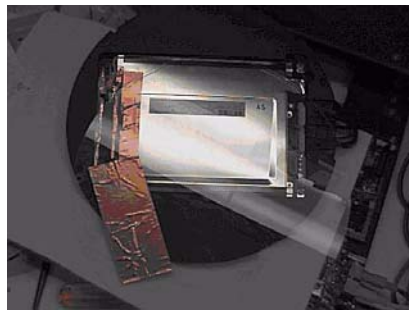
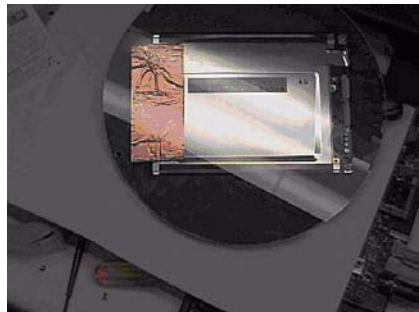
**14. LCD Touch Screen Intermittently Fails**

**Problem:** LCD screen is open to excessive noise disruption on the touch screen.

**Implication:** Excessive noise disruption reduces LCD screen display quality. The touch screen may not work correctly.

**Workaround:** Fix this problem by covering the back light inverter with copper foil shielding tape to decrease the electrical noise transferred to the LCD and Touch Screen.

1. Disassemble the BBPXA2xx development baseboard touch screen enclosure.
2. Remove the back light inverter.
3. Cut a piece of heat shrink tubing (1"x3") and place over the inverter.
4. Heat the tubing until it collapses on the inverter.
5. Cut a 2"x5" piece of copper tape and place on clear plastic disk covering the inverter. The adhesive side should face the plastic.
6. Cut a 2"x5" piece of copper tape and place on the black plastic disk under the inverter. The adhesive side should face the back of the LCD metal enclosure.
7. Reassemble the touch screen enclosure.

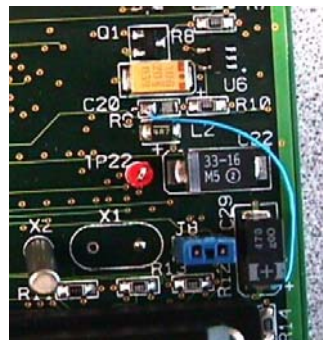
**Figure 6. R9 Pad to C29**

### 3. VCC\_PLL And VCC\_CORE Pin Voltage Must Be Equal

**Problem:** The Intel® PXA250 and PXA210 Application Processors Developer's Manual states VCC\_PLL requires VCC\_CORE voltage instead of a separate voltage supply.

**Implication:** The PXA250 processor may not work if VCC\_PLL is not equal to VCC\_CORE.

1. Remove R9.
2. Add a 30-AWG wire from the R9 pad (inductor L2 side) to the positive side of C29. This can be done on the top of the board.

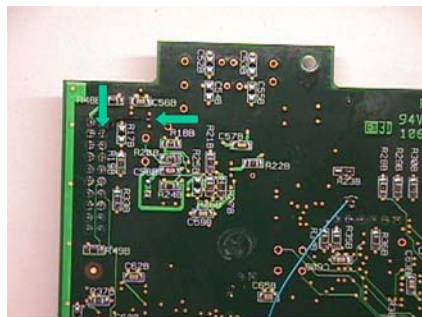
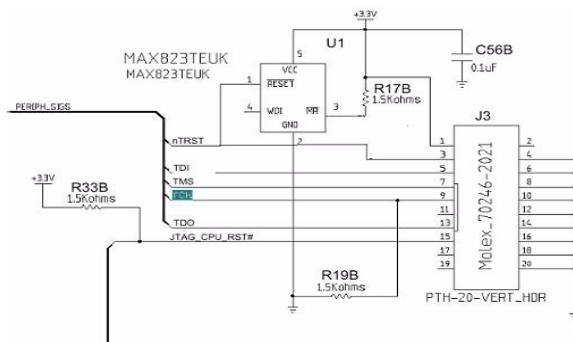
**7. For ARM\* Multi-ICE\* JTAG Use**

**Problem:** JTAG connection fails when using ARM Multi-ICE tools.

**Implication:** No JTAG debugging facility is available with ARM Multi-ICE.

1. Cut the trace on the top of the processor card between U1 pin 3 and via to the right.
2. Add 30-AWG wire from the J3-3 to the via of U1 pin 1 on the bottom of the processor card.

3. Add a 30-AWG wire from J3-2 to +3.3 V.

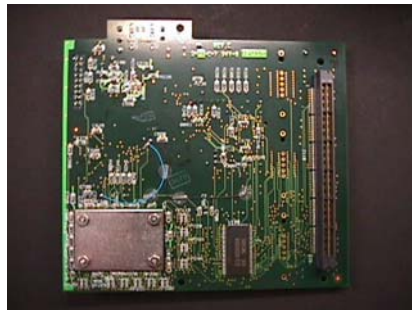
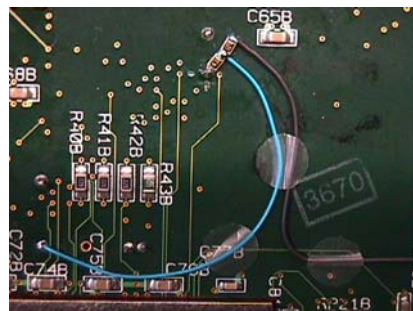
## 8. Excessive Oscillator Output Voltage to PEXTAL Pin

**Problem:** On systems using an oscillator to drive PEXTAL, the 3.3 V output from the oscillator is too high.

**Implication:** Possible damage to chip.

**Note:** These steps bring the oscillator voltage down to 1.1 V. The oscillator and core voltages need to be equal.

1. Attach one side of a 430-ohm resistor to the bottom (on the bottom of the processor card) of TP19 (ground).
2. Attach a 30-AWG wire from the remaining side of the 430-ohm to crystal X1 (The pin closest to the edge of the board).
3. Attach one side of a 620-ohm resistor to the junction of the wire and the 430-ohm resistor. The two resistors will “sandwich” the wire going to X1.
4. Attach another 30-AWG wire from the +3.3 V oscillator output (bottom of U7) to the open end of the 620-ohm resistor.

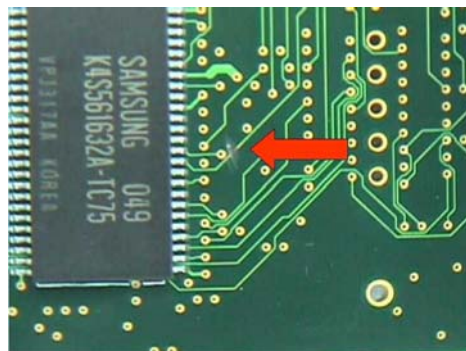
**Figure 11. U10B Trace Cut Pin 38**

**10. Signal Integrity Problems On SDCLK**

**Problem:** Signal integrity problems on SDCLK.

**Implication:** Unstable operation with 100-MHz SDCLK.

1. Cut the trace exiting U10B, pin 38 on the bottom of the DCPXA250 processor card.
2. Update CPLD U4 with latest code. Refer to <http://developer.intel.com> for latest CPLD updates. This adjusts the voltage (VCC) from +1.2 V to +1.4 V.
