HP LaserJet printer product update

March 2004 • Volume 23

HP LaserJet 4200 printer—torn fuser film service note

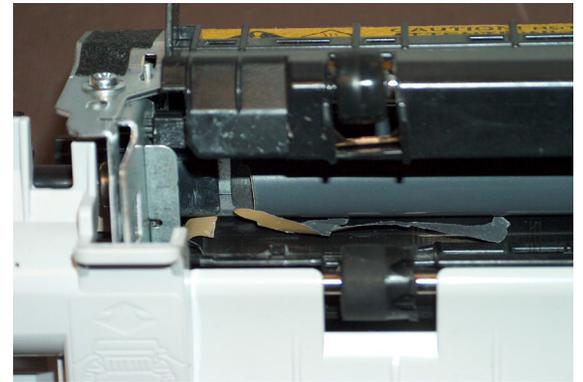
To determine if the fuser film is torn, lift the fuser tray guide and examine the film. Film in good condition appears as a solid gray roller, film in poor condition exhibits the film sleeve shifting to the left and shredded film pieces. If the film is torn, replace the fuser. When this issue occurs before the end of the fuser's 200,000-page life, customers are not charged for the fuser replacement.

Torn fuser film

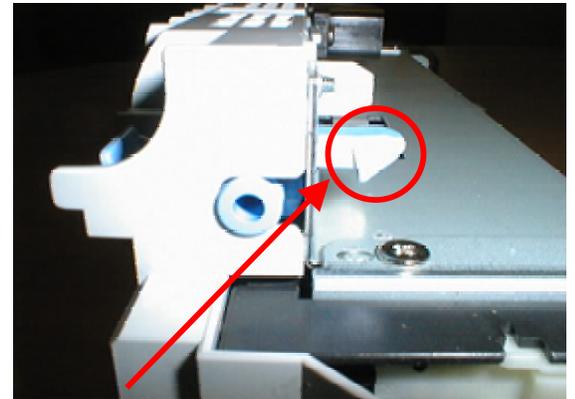
Fuser latches have been breaking before the end of the fuser’s life. The latches in question are the blue grasping latches at the back of the printer used to insert the fuser into position and lock it in place. The latch closest to the gear or drive side of the fuser is most commonly discovered to be broken. Symptoms associated with this issue are a noticeable crack on the latch (see picture, top right) and a resulting break that may cause a grinding noise and paper jams.

Cracked fuser latch

Please replace fusers that exhibit cracked or broken latches; part numbers are below:

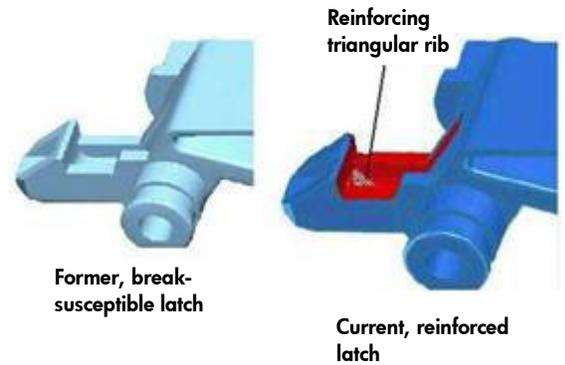
A production countermeasure, implemented in October of 2003, consists of a triangular tab in the middle of each latch to help reinforce the plastic in the stress area most susceptible to breaking (see diagram, bottom right). The part numbers have rolled.

Fuser latch countermeasure diagram

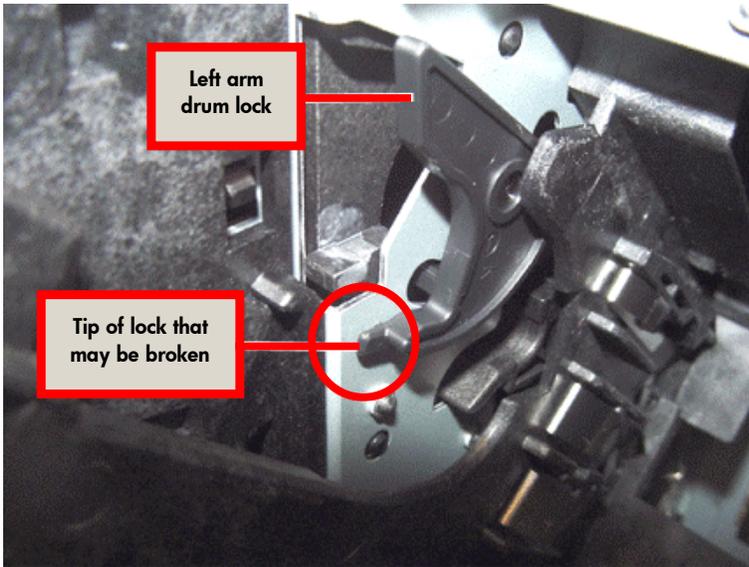
Left arm drum lock

- 5 Check the left arm drum lock in the upper left of the printer. If it is broken, it will be in the down position.

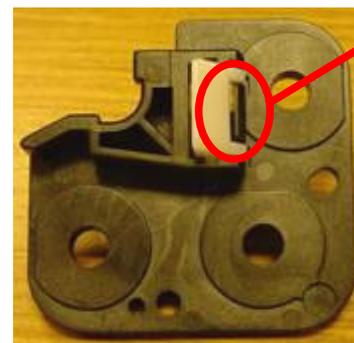
Cartridge alignment knob

- 7 Check the cartridge alignment knobs on the left side of the printer. If the small white latch is missing, or the black piece immediately behind it is broken, the printer must be replaced. This part may not be replaced in the field due to the delicate alignment necessary to ensure correct cartridge positioning. If the piece is missing, the door may have some difficulty in closing and all of the cartridge shutters may not shut. If all the other steps have been taken and this piece is identified, the printer must be replaced.

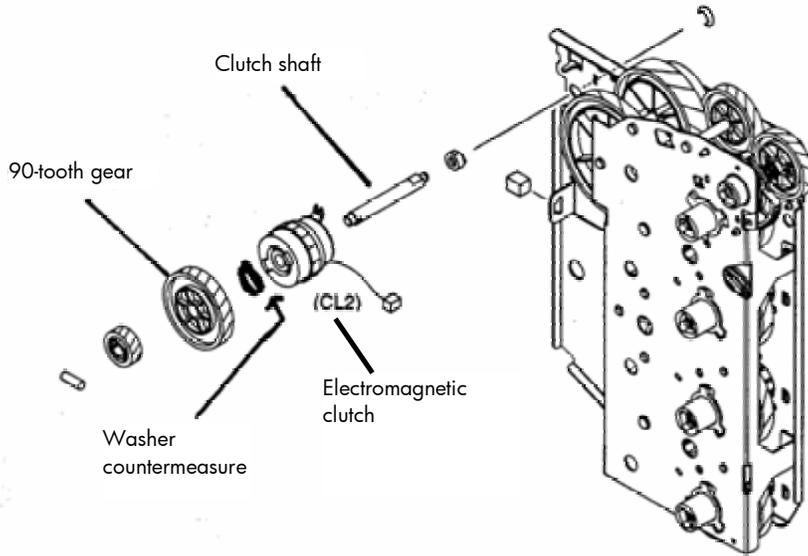
Black toner cartridge drive assembly

The black toner cartridge drive clutch (CL2) may make a chattering sound that can occur early in a printer's life expectancy. In order to stop the chattering noise, insert the washer countermeasure as depicted below. The washer's part number is XD1-1108-229CN.

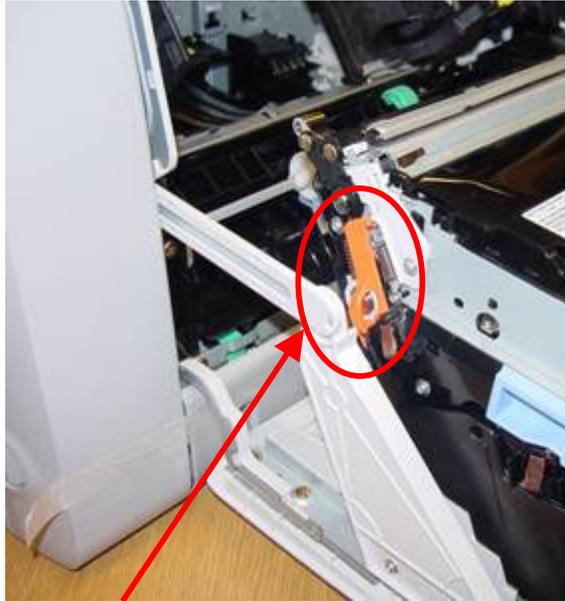
Left ITB shipping lock

If a new ITB (image transfer belt) has been installed and color plane registration problems occur, the shipping locks may not have been removed from the ITB. The photo below depicts the orange shipping lock on the left side of the ITB—there is another lock on the right side.

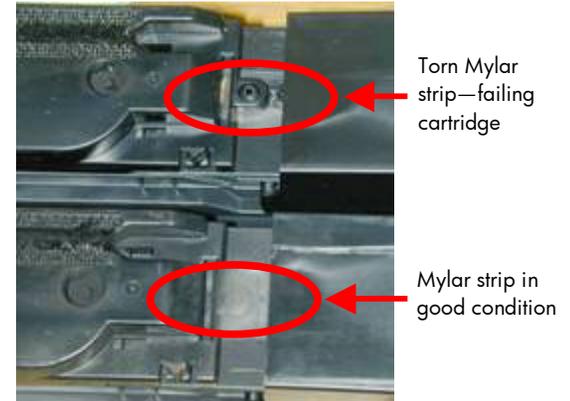
Please replace the print cartridge that is causing the error. Cartridges with lot code 3D23XX or earlier have been identified as having a defect which causes the automatic pull strip embedded in the cartridge not to release correctly when the cartridge is initially installed.

The image below shows what a typical failing cartridge pull strip looks like, compared with a good cartridge. The cartridge is shown with the shutter pulled back, in the installed position.

Print cartridge Mylar strip in poor and good condition

In addition, check the lot codes of the printer's remaining three print cartridges. If any of the cartridges have a lot code 3D23XX or earlier, check the clear plastic pull strip on the bottom of the cartridge, under the shutter, for damage. Replace any print cartridges with damaged pull strips. The error message is likely to appear for these cartridges as well when toner runs low in the image drum.
